PRELIMINARY DOCUMENTATION REPORT

Demolition of Structures at RAAF Williams – Point Cook, Victoria

(EPBC 2019/8514)

November 2023

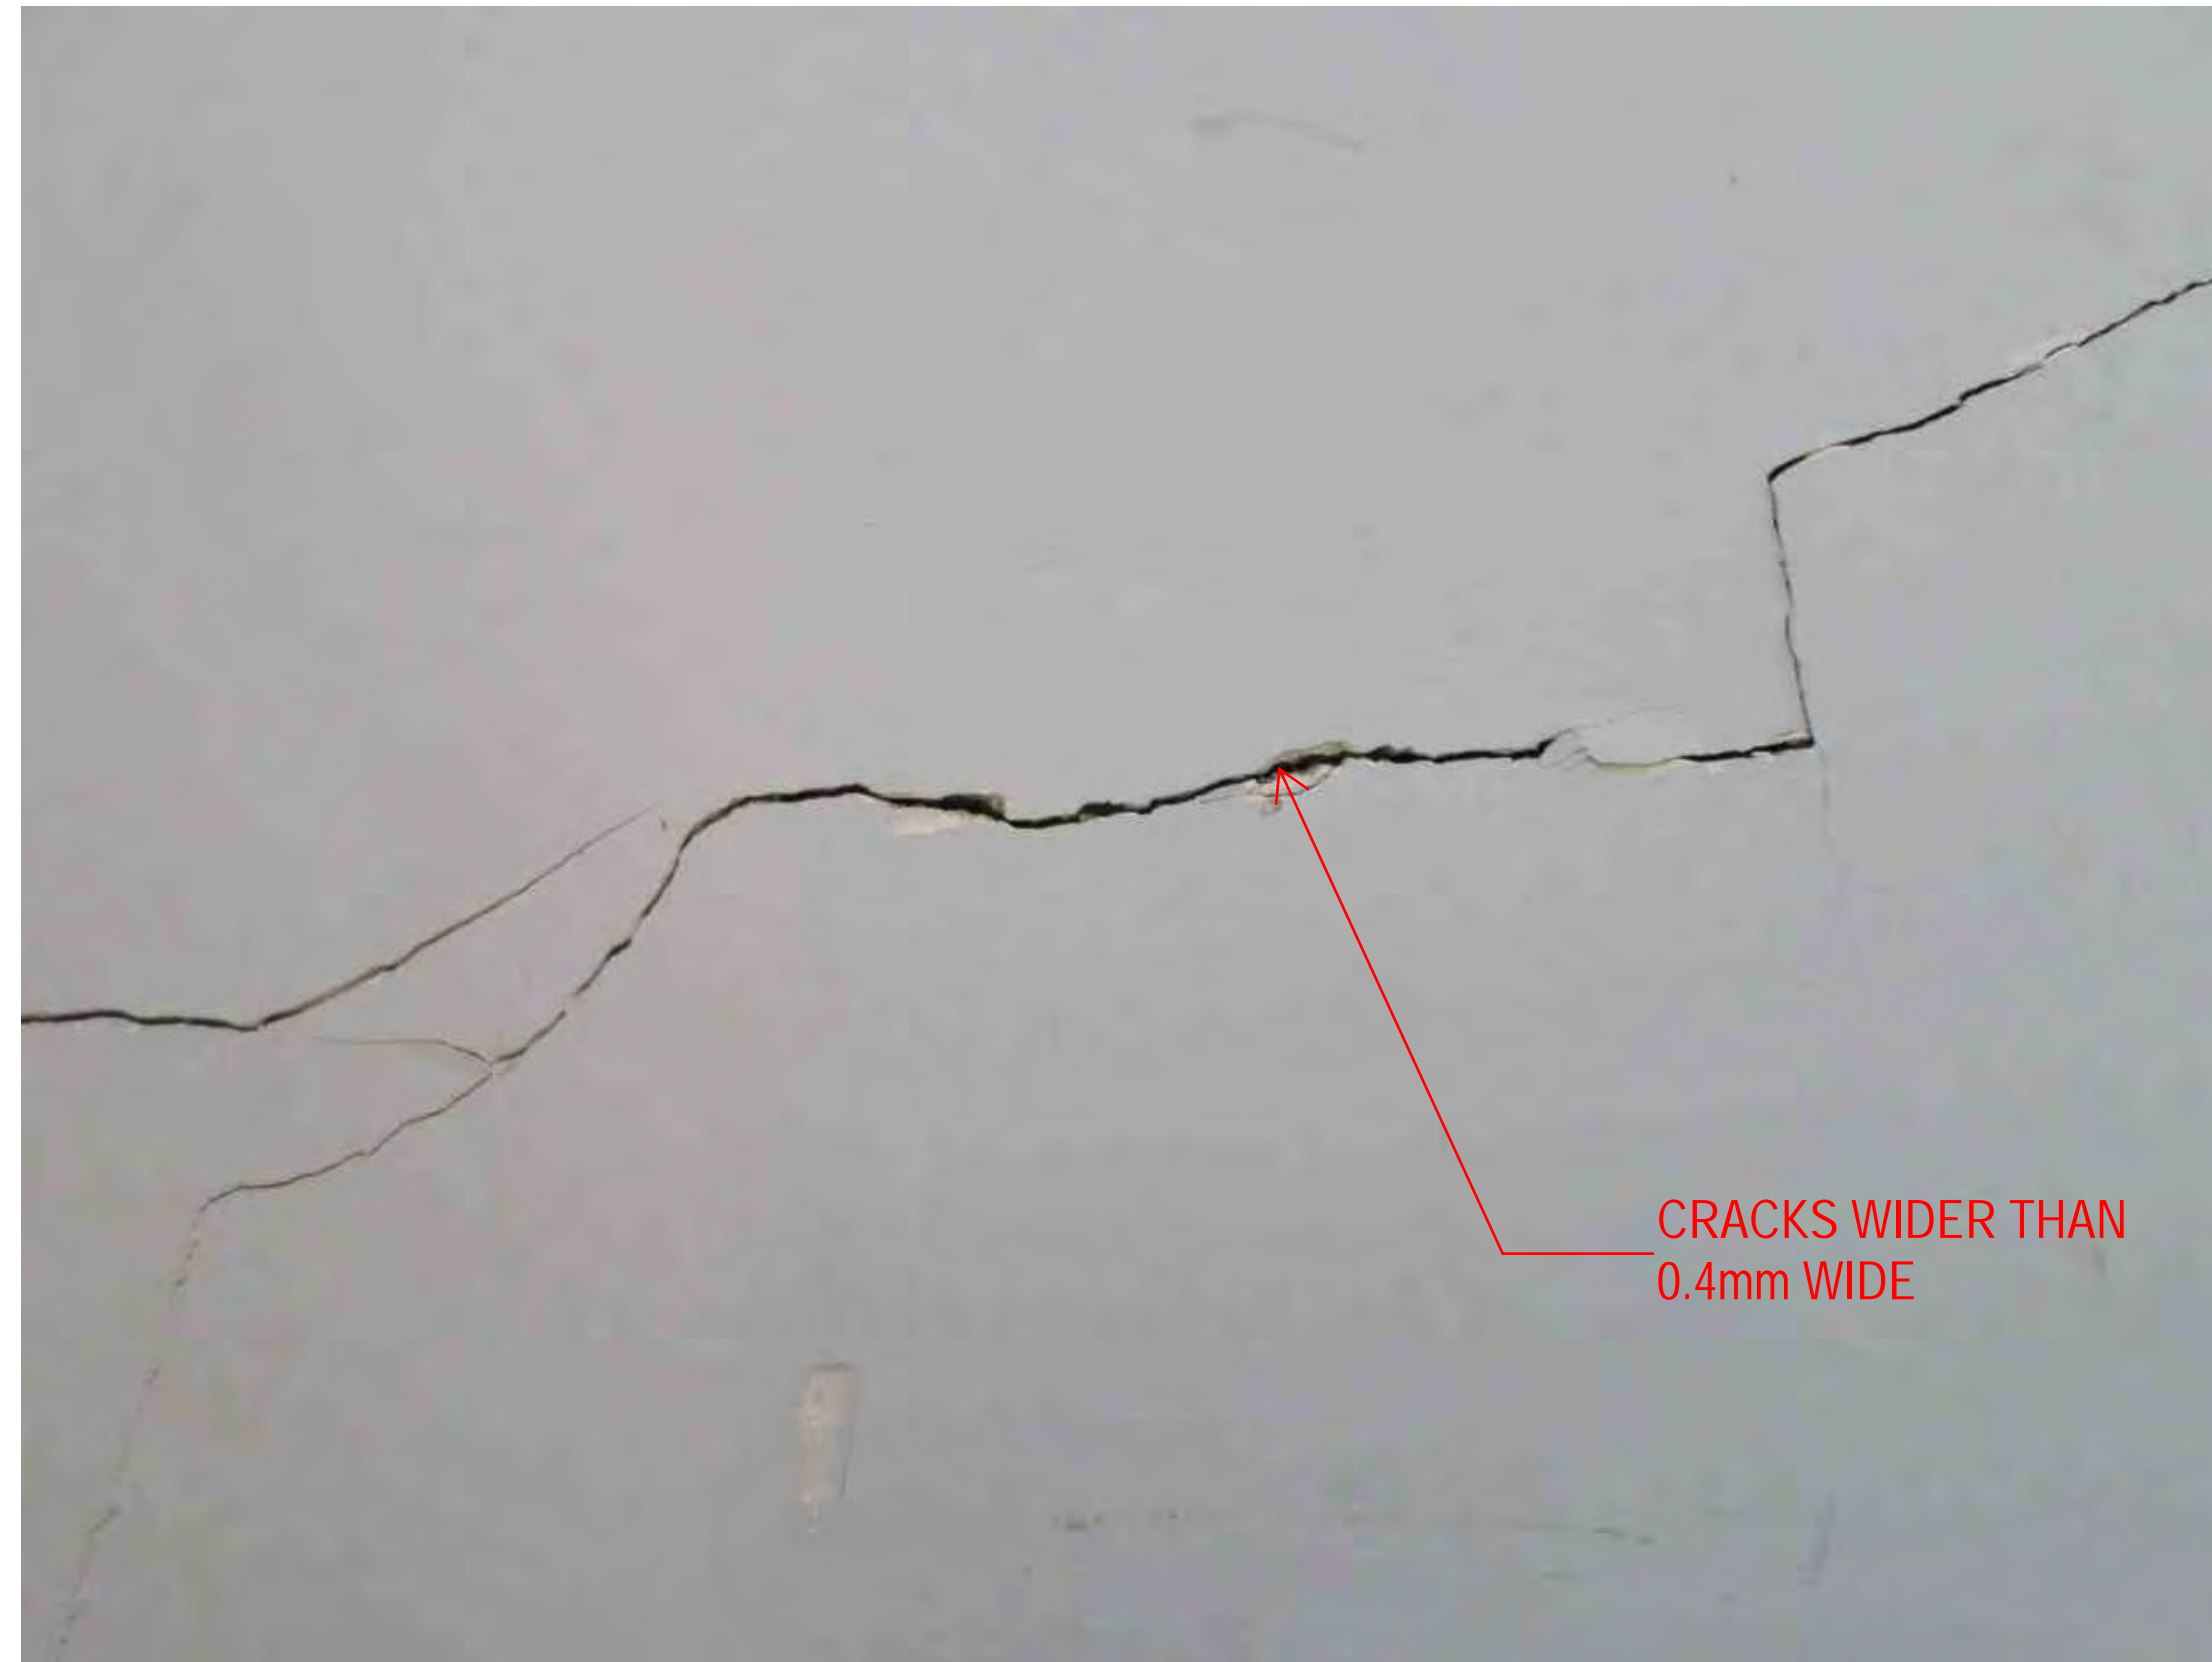
Rendered brickwork cracks

1. Remove all loose mortar along crack on brick wall
2. Hand clean all crumbling brick and mortar from the crack. Use oil free, dry compressed air to blow out the crack to remove all contaminants (eg. dust, oil, grease, etc.), debris, laitance, old coating, corrosion products or standing water ...
3. Inject "Selleys Mortar Works" or approved equivalent as deep as possible, ensuring that the opening is completely filled from base to surface. Where cracks are through cracks, inject from both side of wall.
4. Match the colour of the repair to the substrate by applying different colour range of the sealer.
5. Applying sealer in accordance to manufacturer's specification.

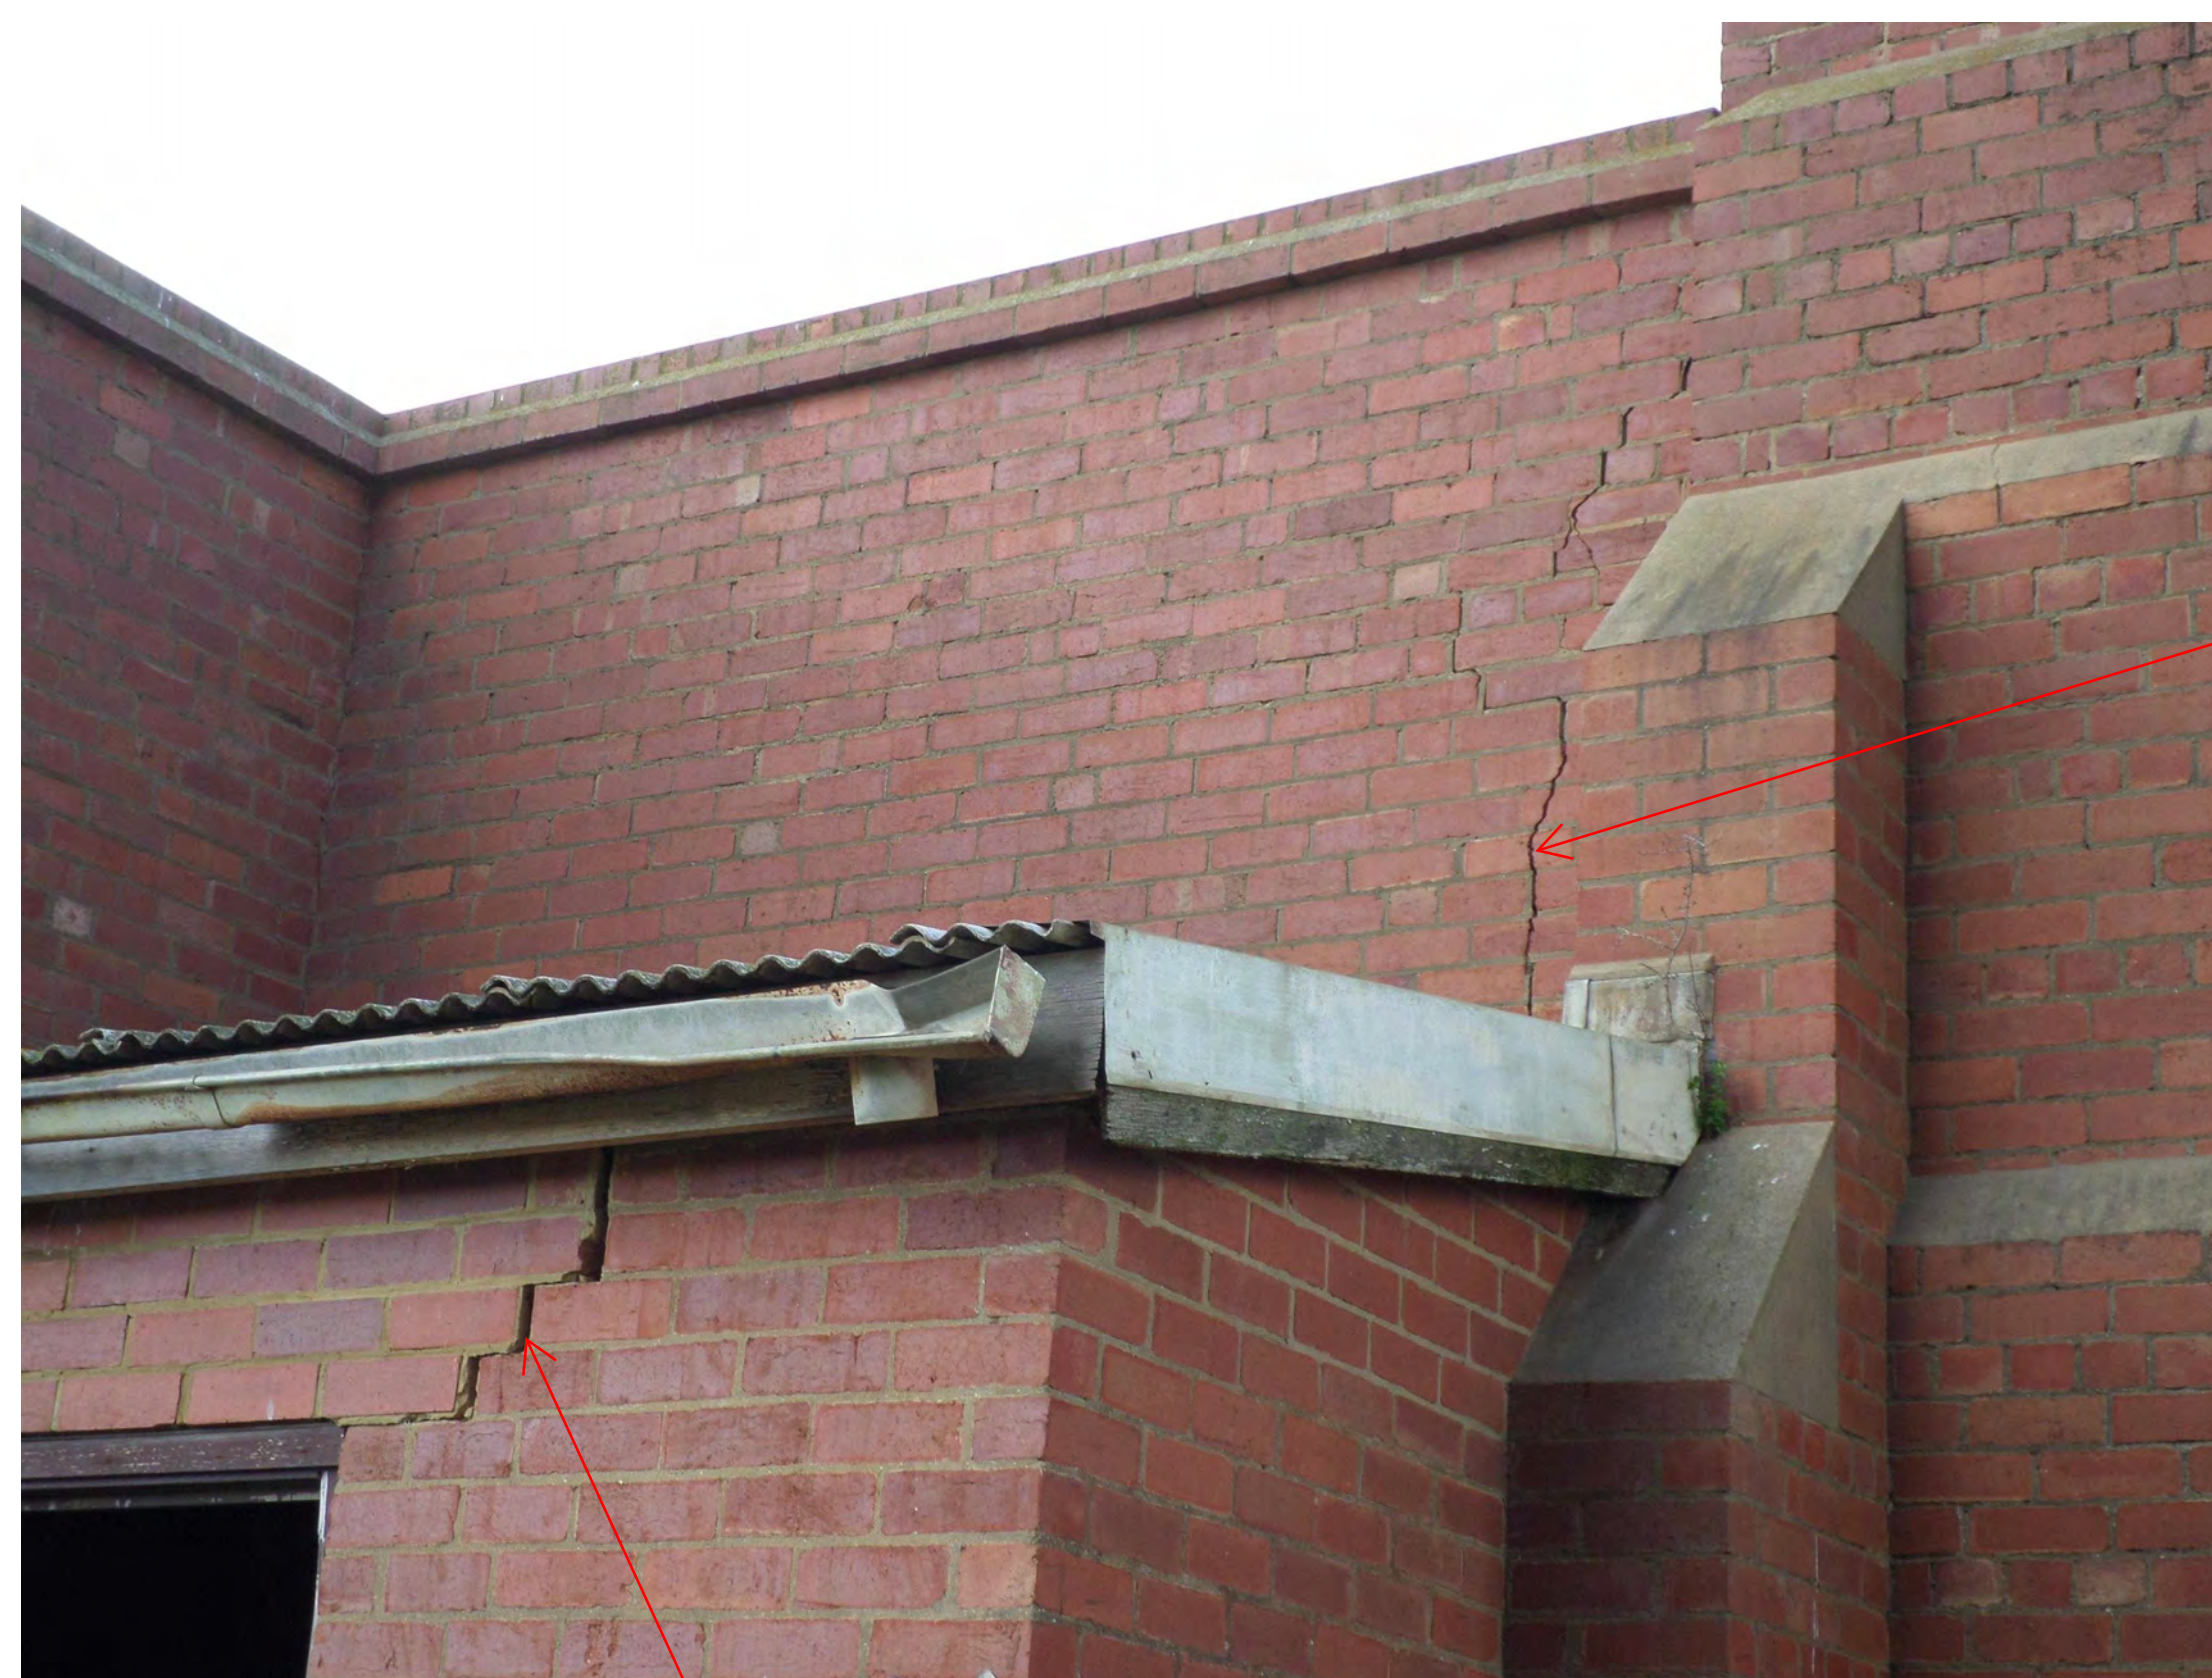
Exposed brickwork cracks

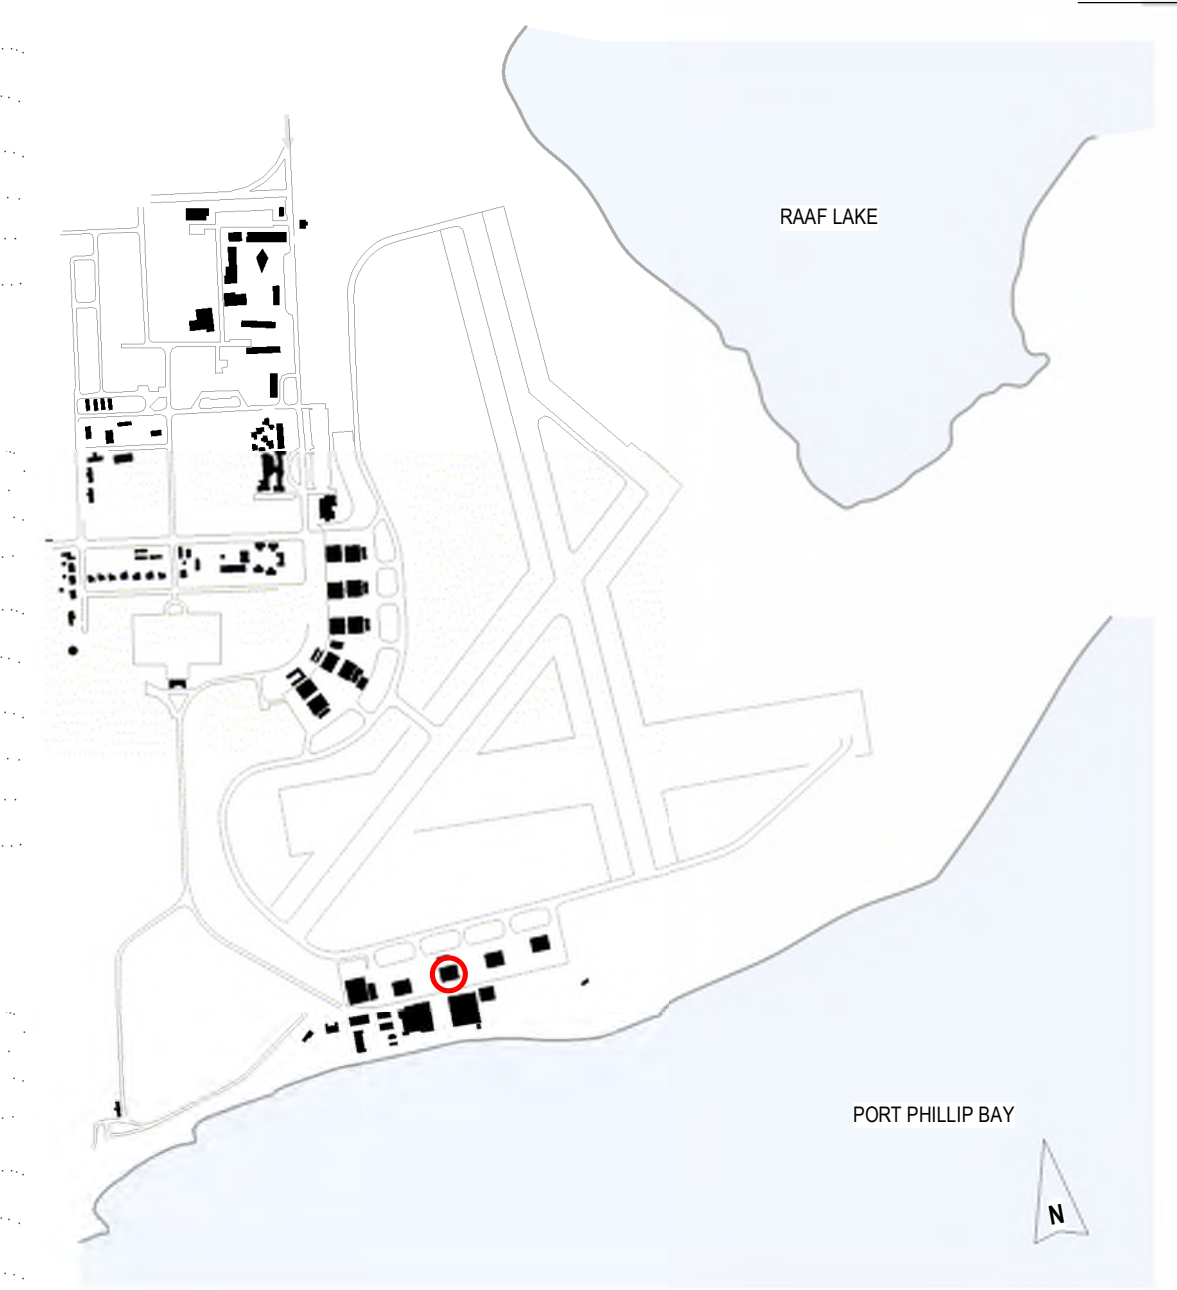
1 BUILDING A0212 - FLOOR PLAN
1:100

IMAGES OF TYPICAL DETERIORATION

THE CONTRACTORS SHOULD CONFER WITH ASBESTOS REGISTER FOR THIS BUILDING, TO ENSURE THAT ANY ASBESTOS PRESENT IS DISPOSED OF IN CORRECT MANNER AND IN COMPLIANCE WITH REGULATIONS.

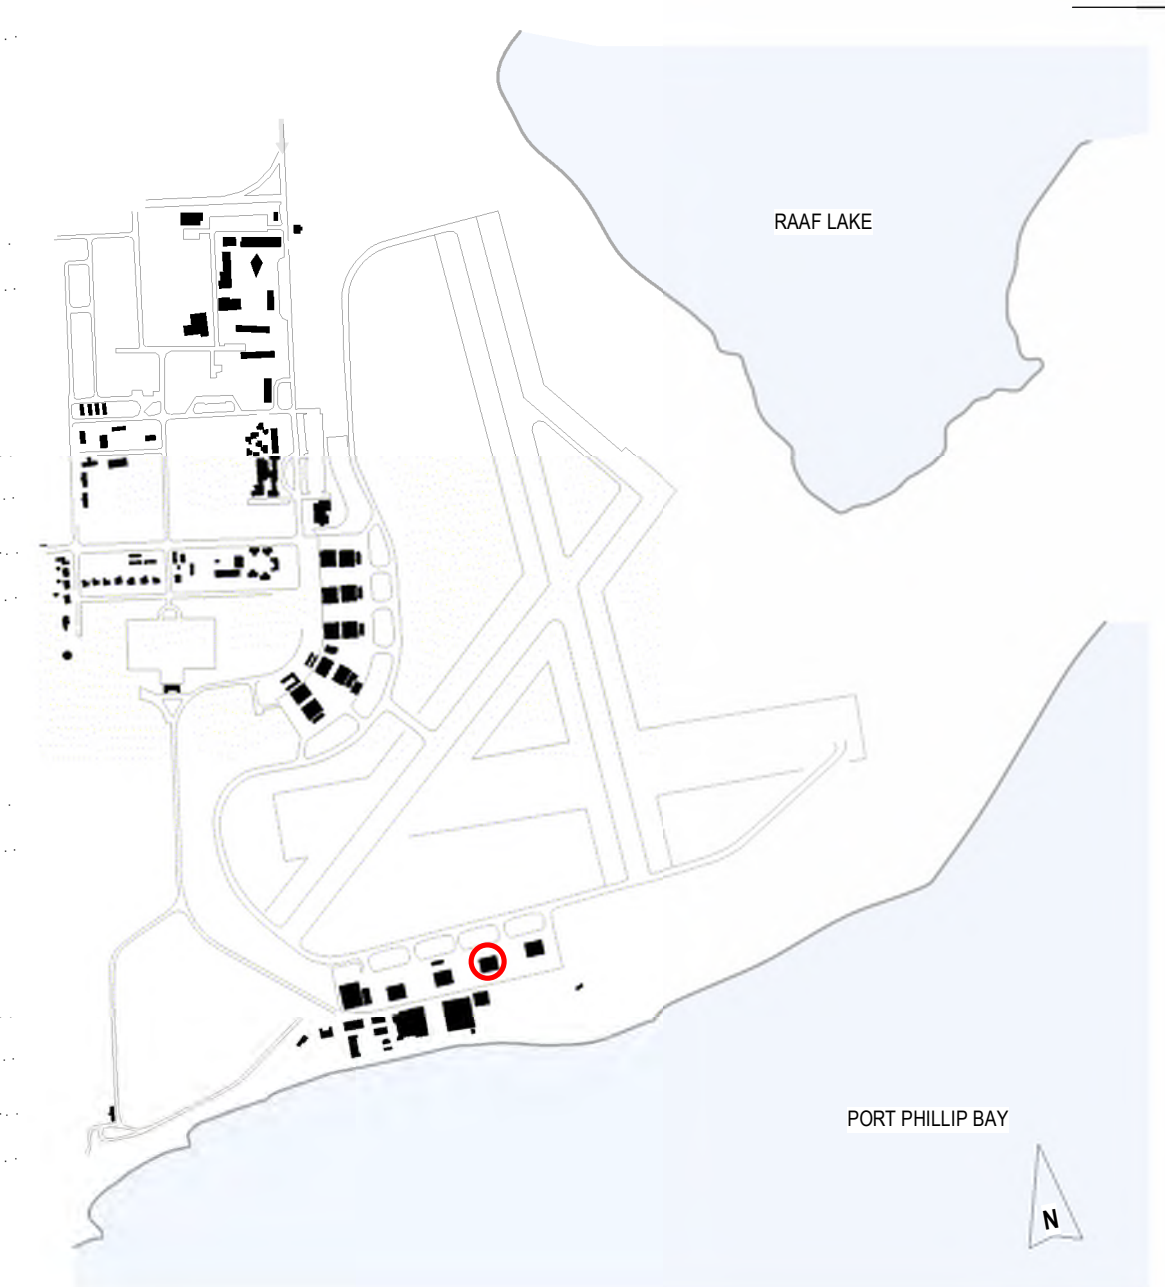
1 BUILDING A0213 - GROUND FLOOR PLAN
1:100

IMAGES OF TYPICAL DETERIORATION

- THE CONTRACTORS SHOULD CONFER WITH ASBESTOS REGISTER FOR THIS BUILDING. TO ENSURE THAT ANY ASBESTOS PRESENT IS DISPOSED OF IN CORRECT MANNER AND IN COMPLIANCE WITH REGULATIONS.

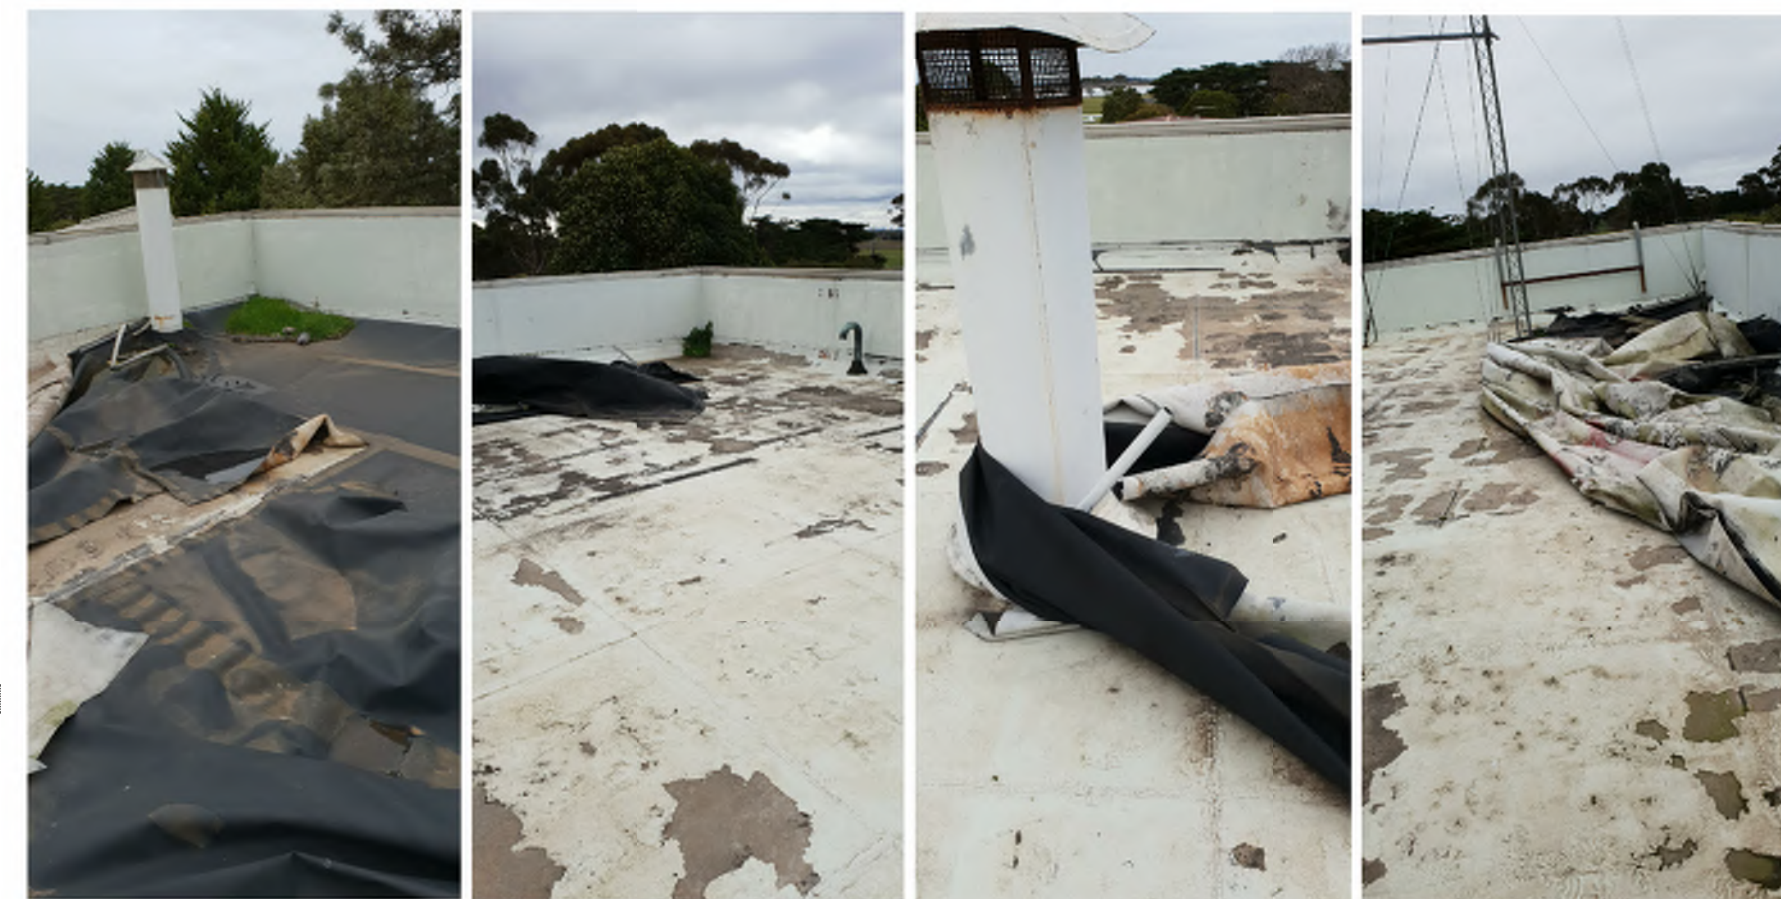
IMAGES OF DAMAGE TO WATERPROOF ROOF MEMBRANE

27. PRIOR TO ANY WORKS COMMENCING, THE CONTRACTOR IS TO CHECK WITH EXISTING ASBESTOS REGISTER FOR BUILDING AND CONFIRM IF ANY ASBESTOS IS PRESENT IN BUILDING. WHERE REQUIRED THE CONTRACTOR IS TO ALLOW TO REMOVE ASBESTOS FROM BUILDING AND DISPOSE OF DEBRIS IN CORRECT MANNER, IN ACCORDANCE WITH REGULATIONS.

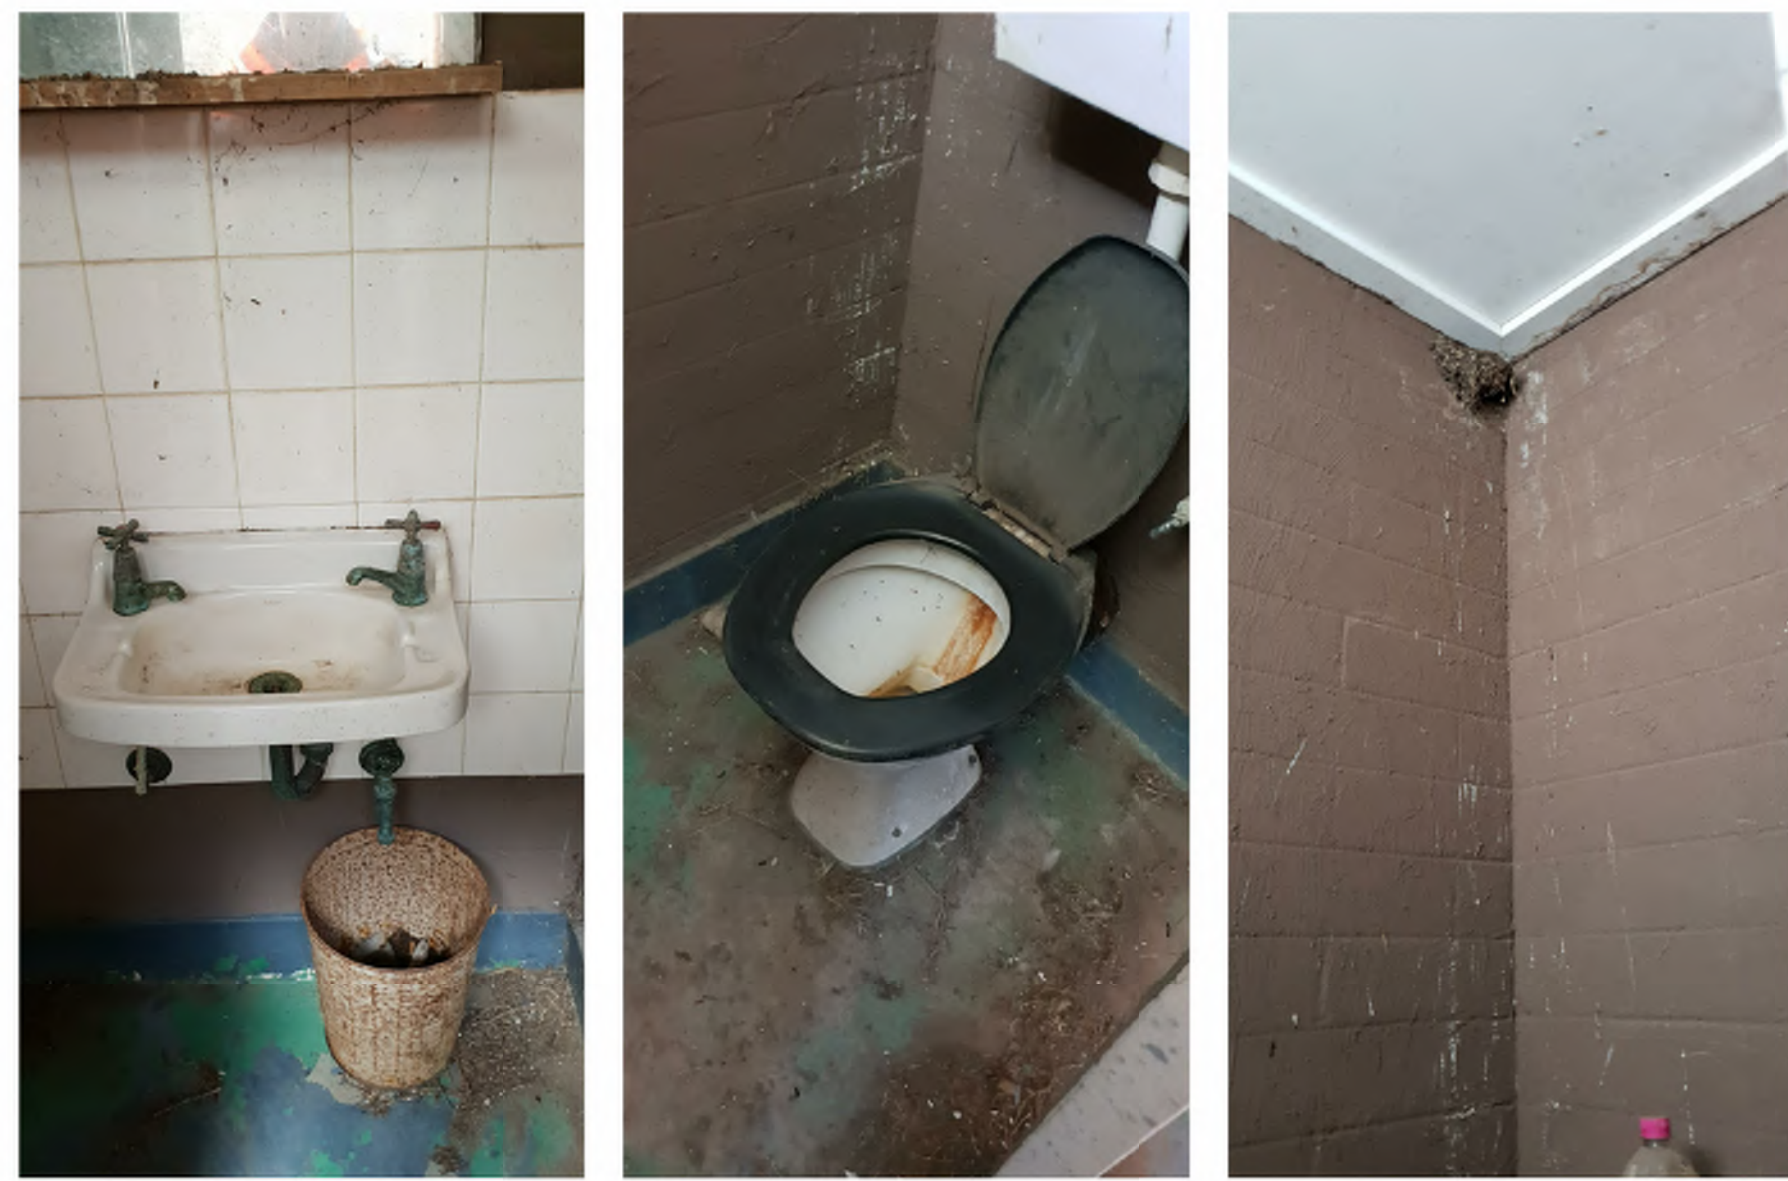
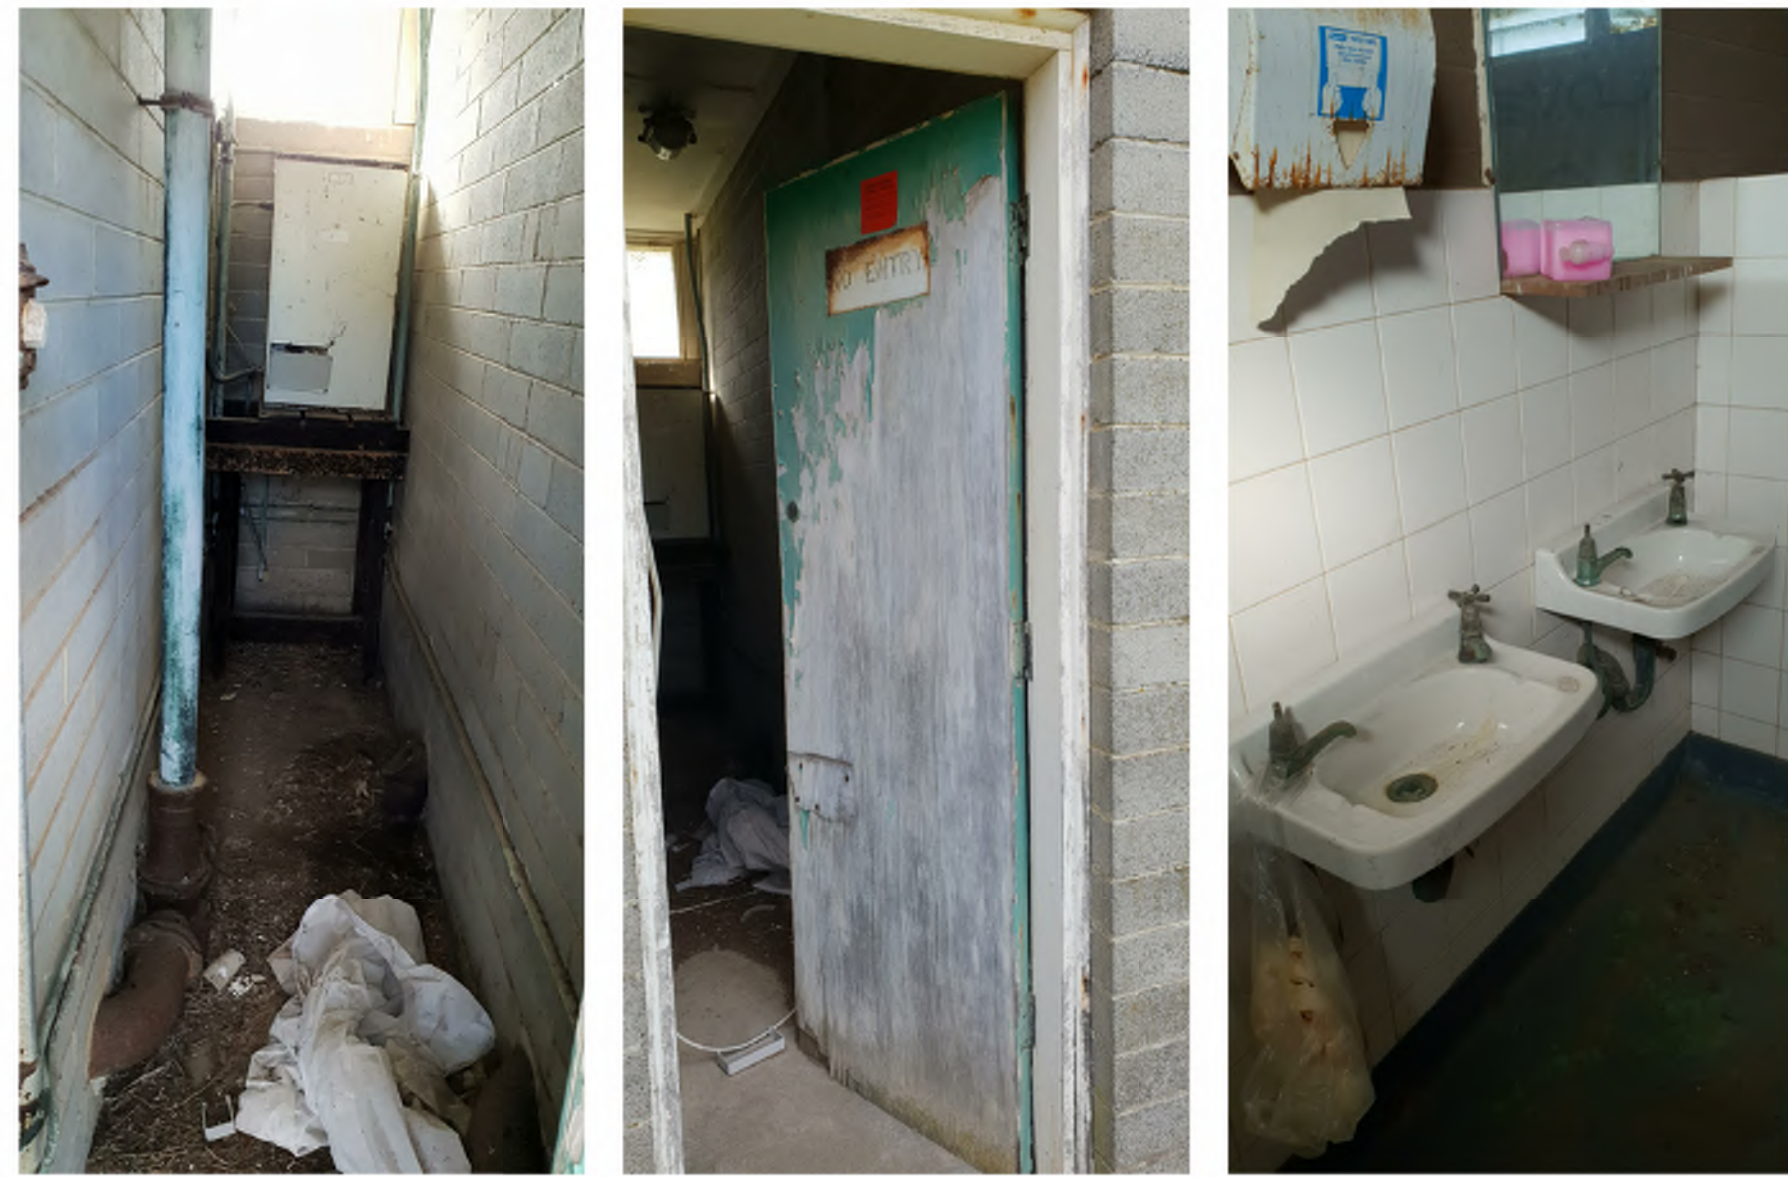
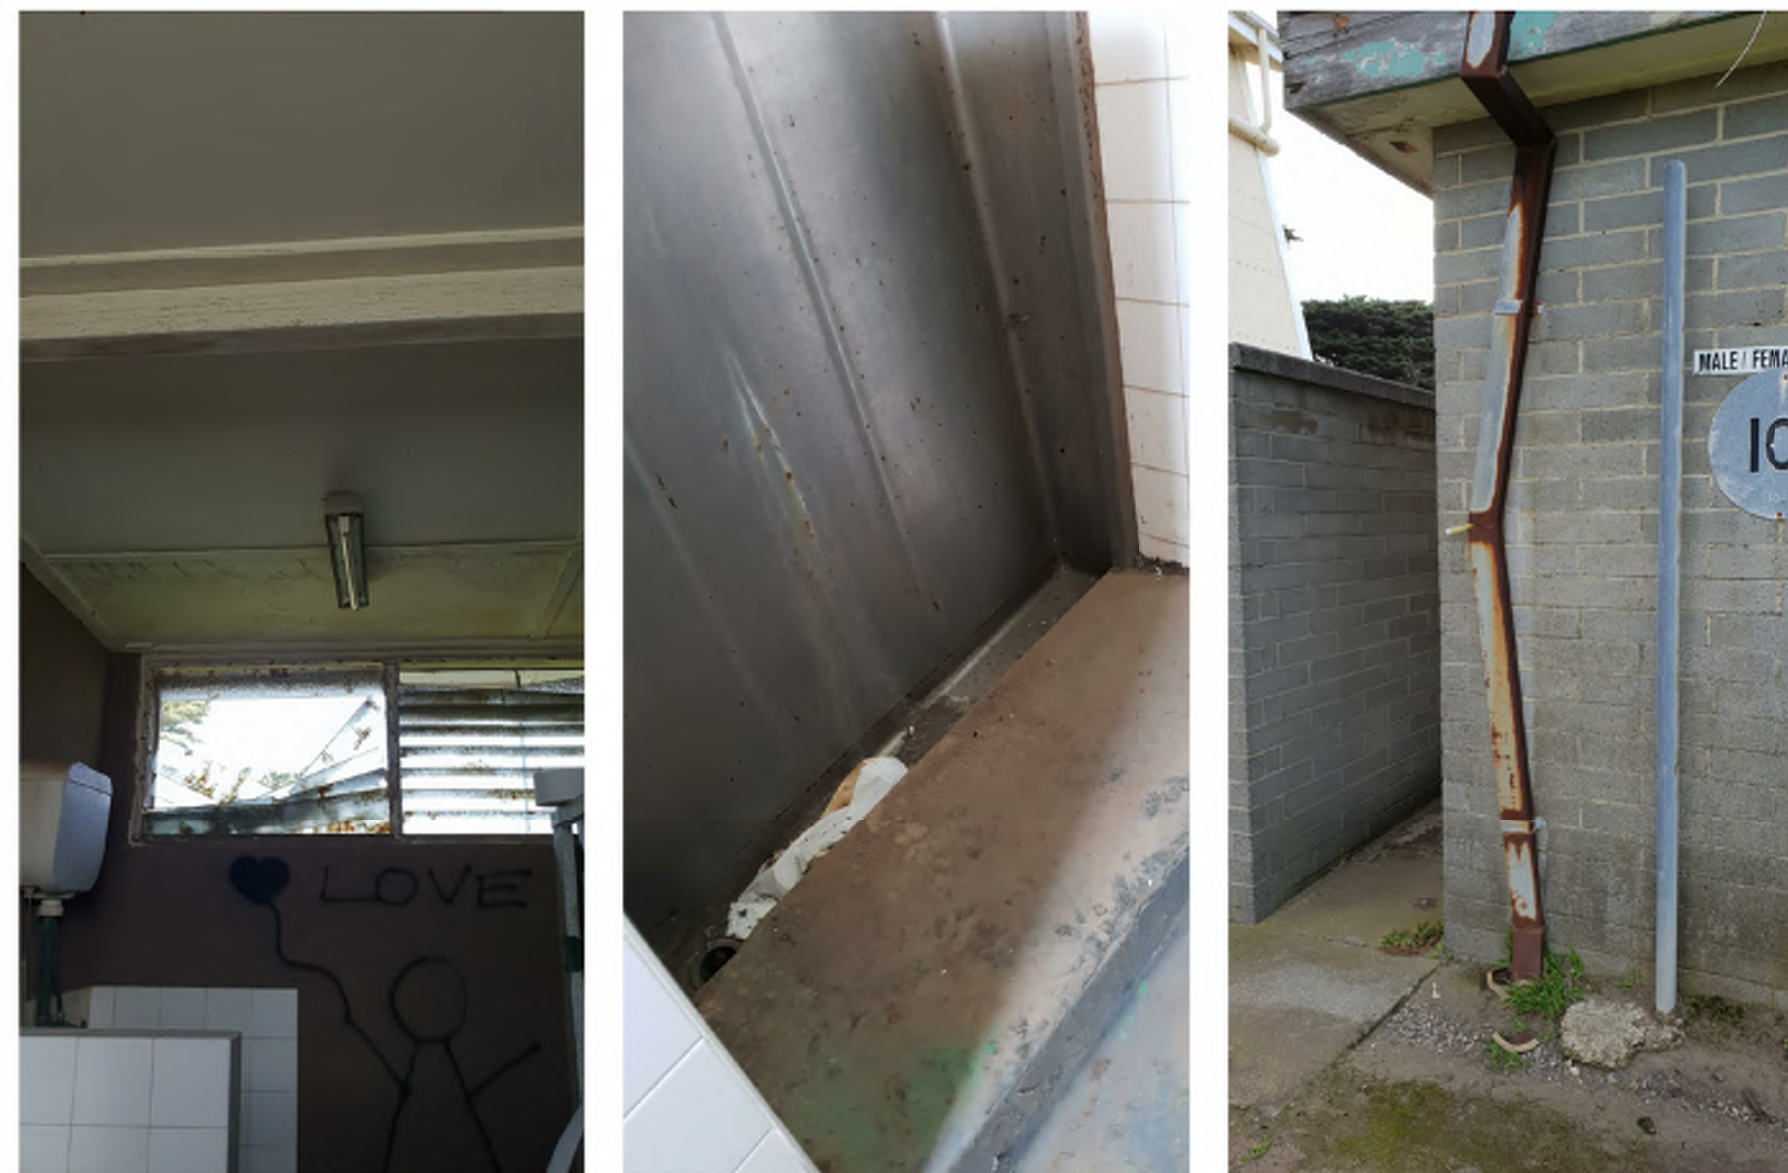
IMAGES OF TYPICAL DETERIORATION

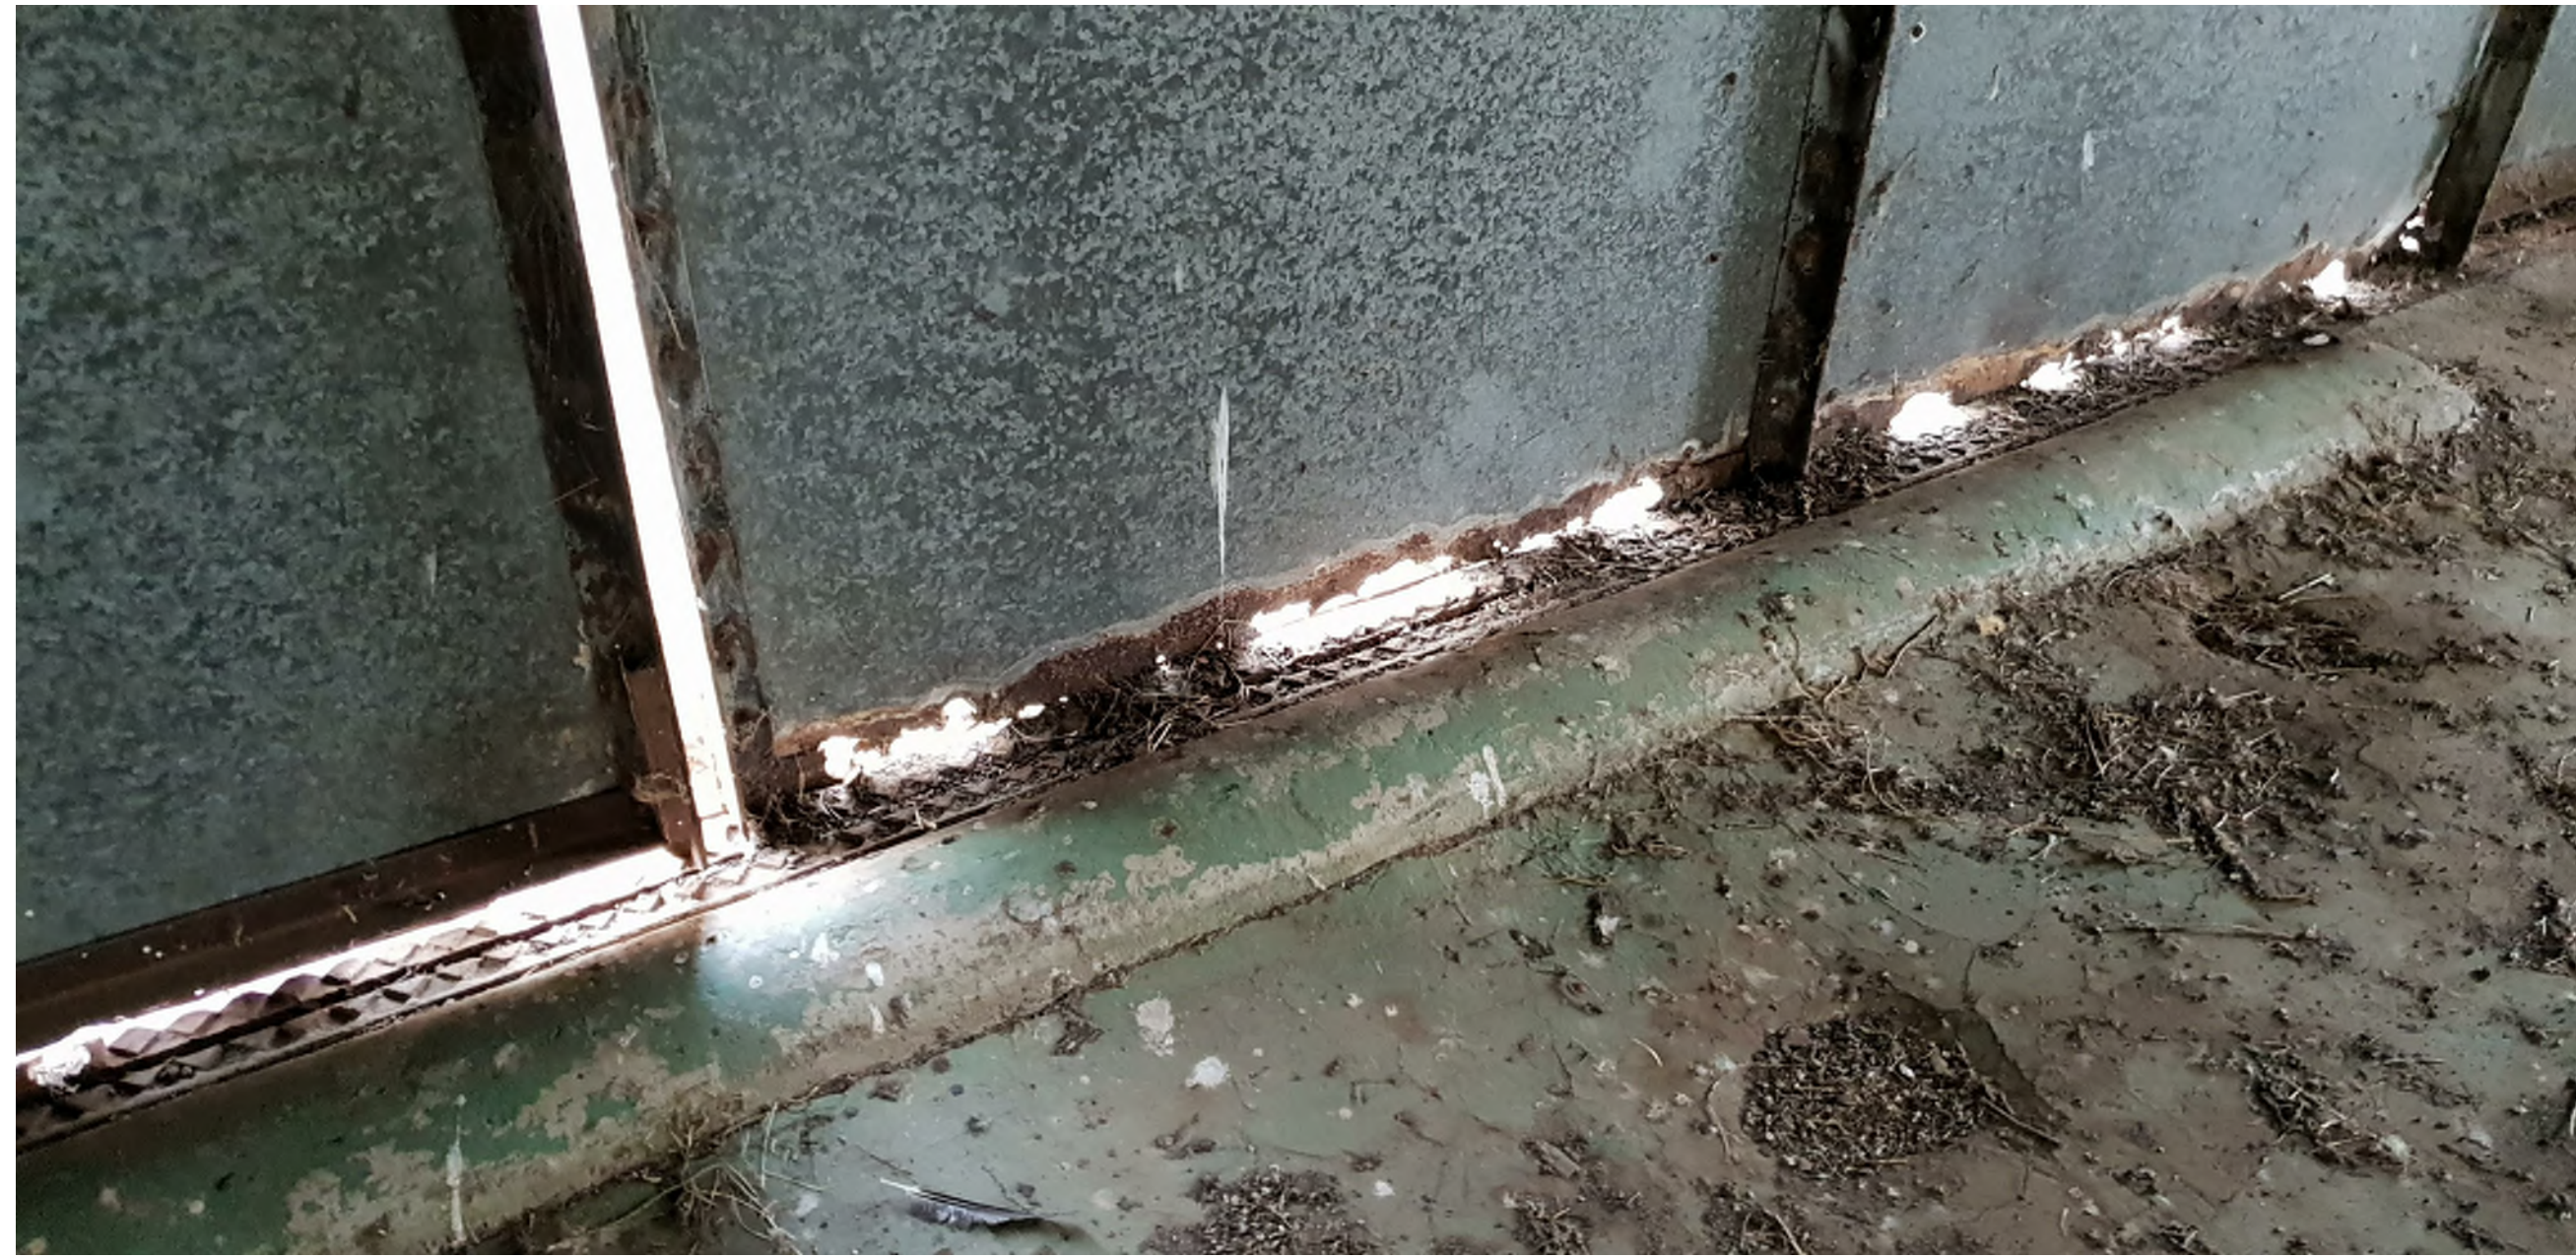
TYPICAL IMAGES - EXTERNAL

TYPICAL IMAGES - DAMAGE TO WALL LININGS
