PRELIMINARY DOCUMENTATION REPORT

Demolition of Structures at RAAF Williams – Point Cook, Victoria

(EPBC 2019/8514)

November 2023

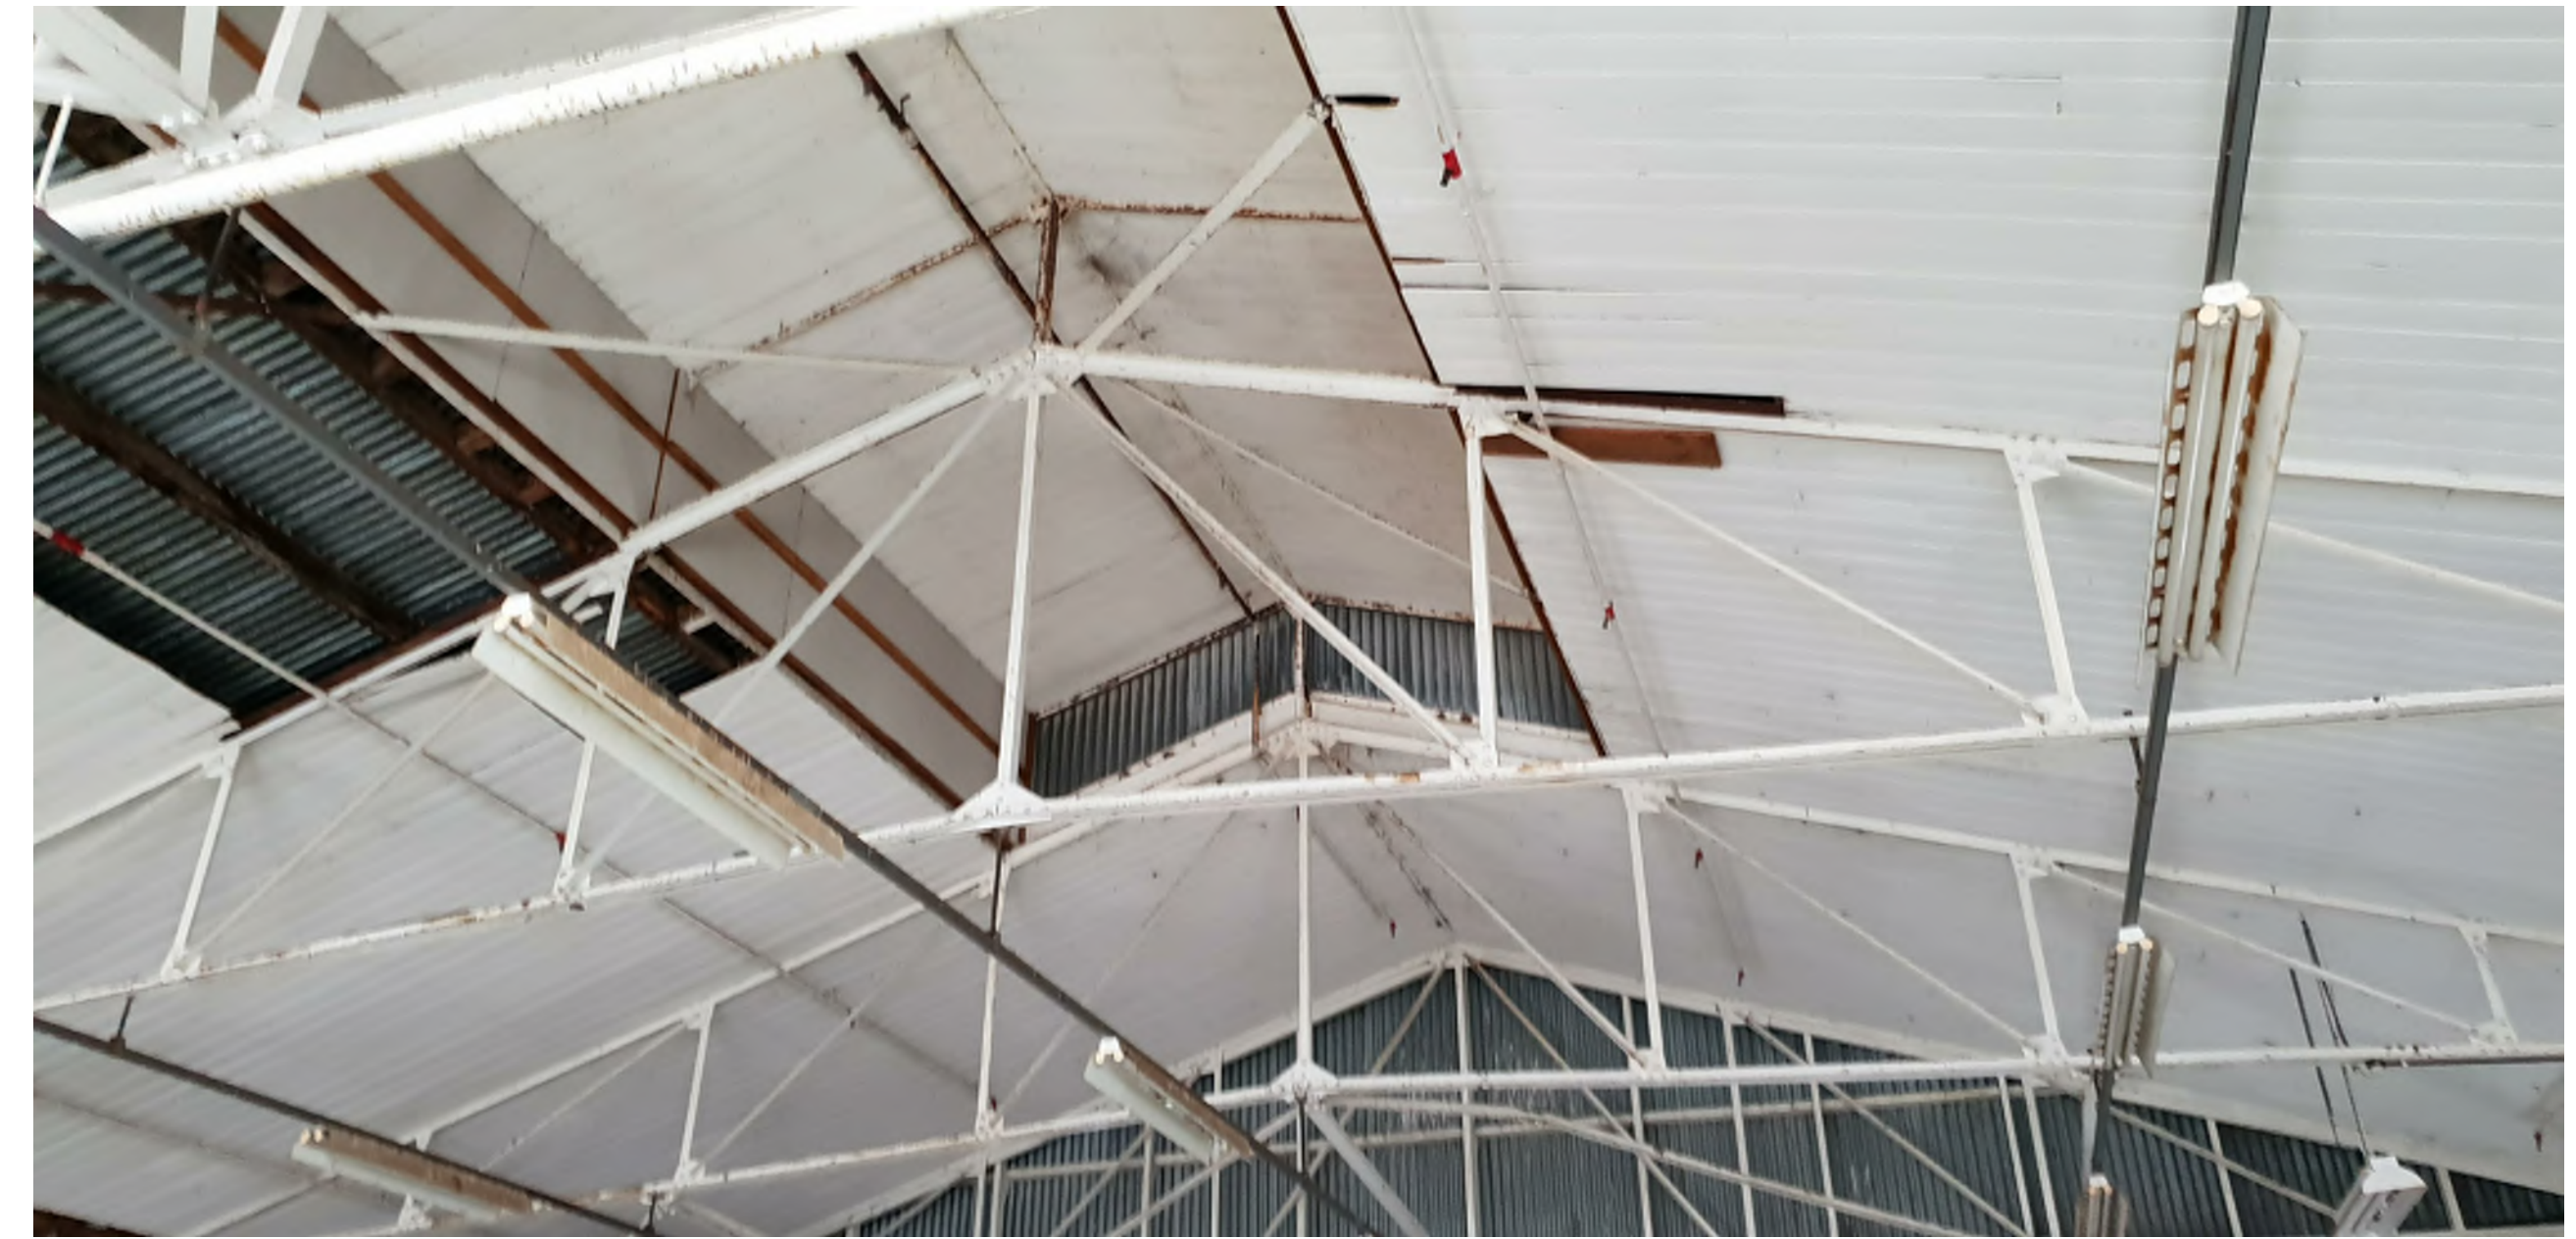
TYPICAL IMAGES - INTERNAL STEEL STRUCTURE / DUTCH GABLE

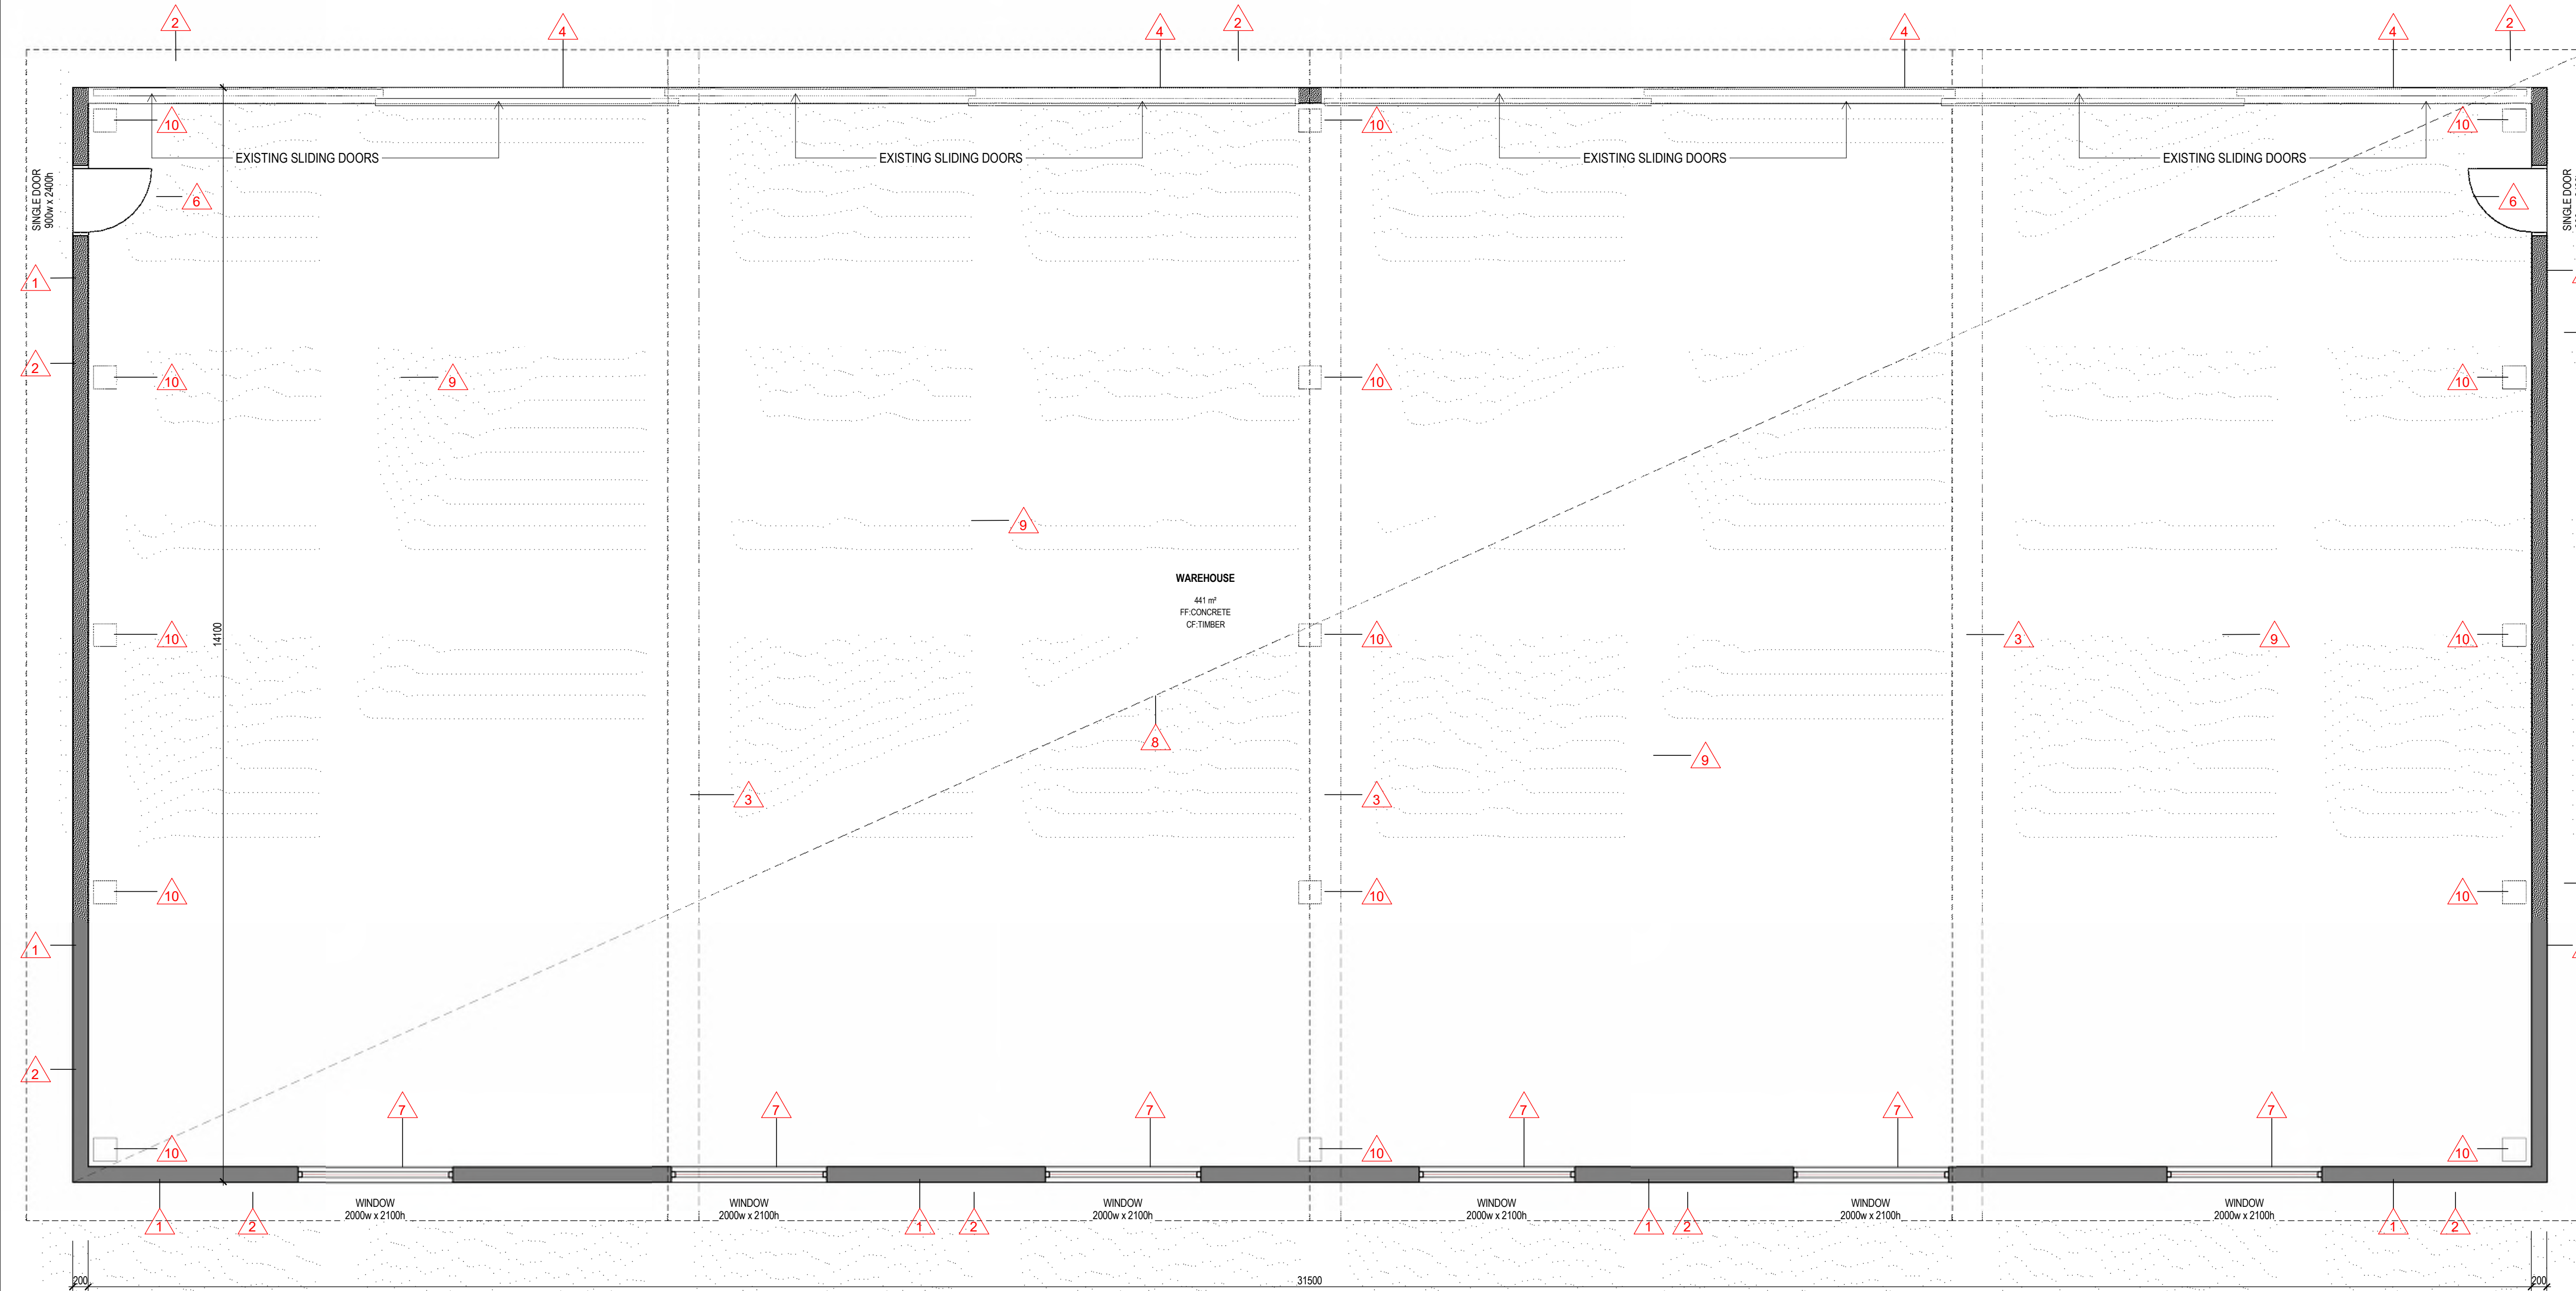
BUILDING 210

- EXTERNAL BUILDING SURFACES**
- EXISTING METAL WALL SHEETING IS SHOWING VISIBLE SIGNS OF CORROSION IN AREAS WHERE THE SHEETS HAVE BEEN PAINTED OVER. THE PAINT IS PEELING AND FLAKING. THE FIXINGS ARE ALL RUSTED AND IN SOME AREAS MISSING THE EXISTING SHEETING SHOULD BE REPLACED WITH NEW COLORBOND CORRUGATED WALL LININGS IN COLOURS TO MATCH EXISTING AND THE CONTRACTOR SHOULD ALLOW FOR MIN R2.5 RATED INSULATION TO ALL WALLS.

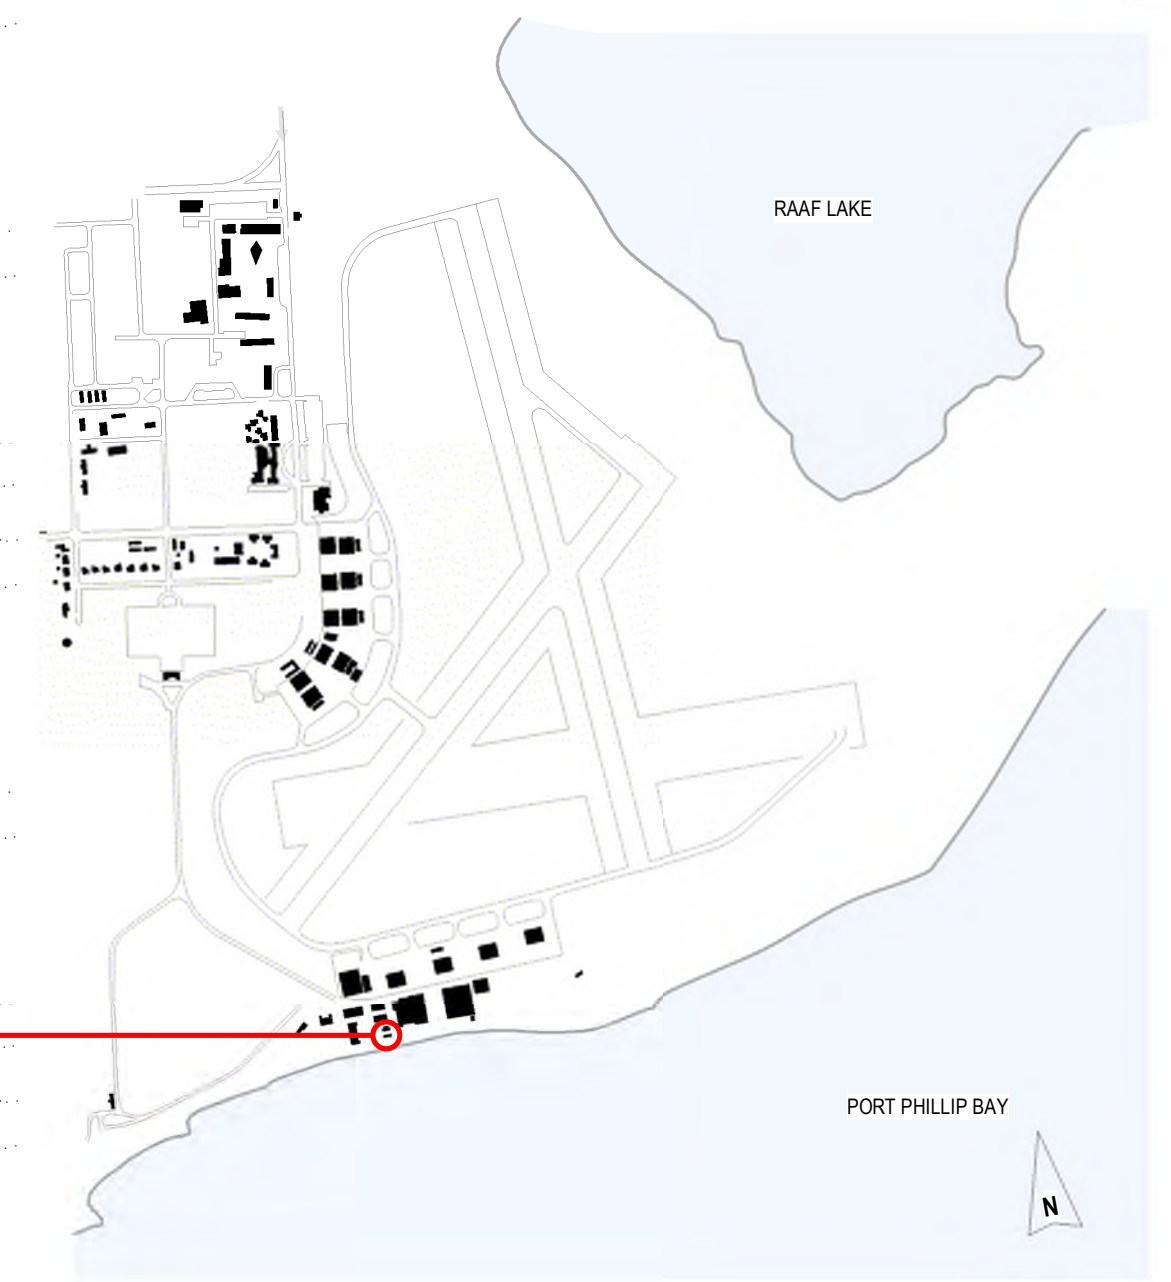
TOILET BLOCK SHOWING SIGNS OF DETERIORATION
