PRELIMINARY DOCUMENTATION REPORT

Demolition of Structures at RAAF Williams – Point Cook, Victoria

(EPBC 2019/8514)

November 2023

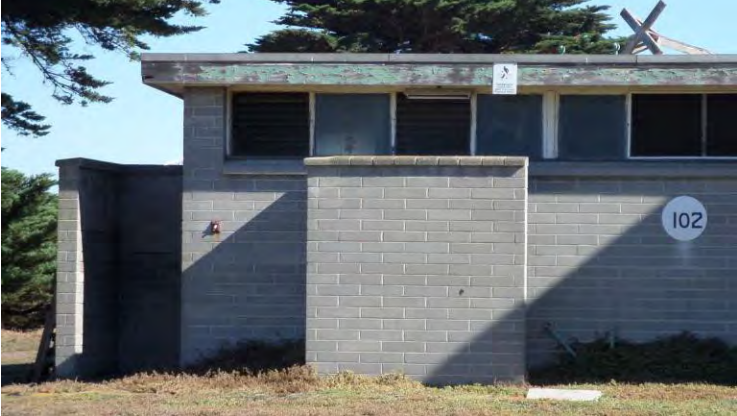
Asset name	Structural and Heritage Summary (from Aurecon, 2019)	Example image (from Aurecon, 2019)
Asset 102: Toilet block	<p>This is a small, timber-framed, grey brick block with a metal sheet-clad roof. The site HMP has concluded that the building is 'intrusive' to the heritage values of the Base. This building is structurally sound, however would require substantial works to bring the condition up to standard. Hazardous materials were also identified. The toilet block is considered beyond economic repair and is recommended to be demolished.</p>

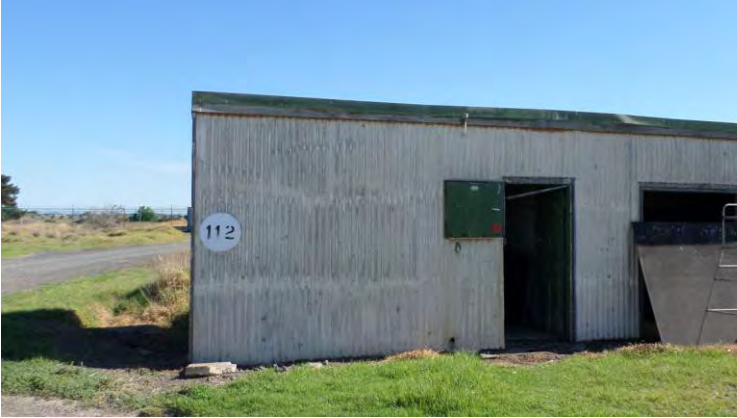
Asset 112: Store	<p>This is a timber-framed building with metal cladding. It is on a concrete slab, with timber decking in separate areas. The site HMP has concluded it does not contribute to the heritage values of the Base.</p> <p>The main structure of this building requires significant repair to both structural and condition related items. It is recommended to be demolished as it is considered beyond economic repair.</p>

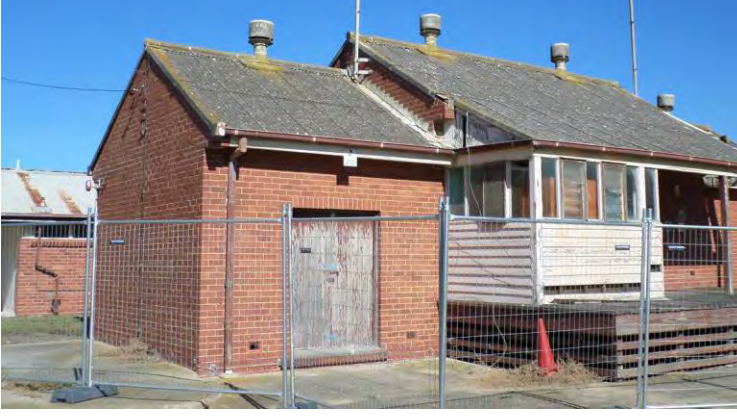
Asset 122: Hazardous store	<p>This is a brick walled building, with a timber-framed, metal-clad roof. It is on a bunded concrete slab, with an external timber-decked area. It is cited in the description of the NHL place, but not the CHL place.</p> <p>The main structure of this building is in good condition and can be either demolished or retained. Work would be required to improve the condition of the building and manage the identified hazardous materials. As there is no planned future use for this building, the repair and ongoing maintenance of this building is not considered effective use of funding.</p>

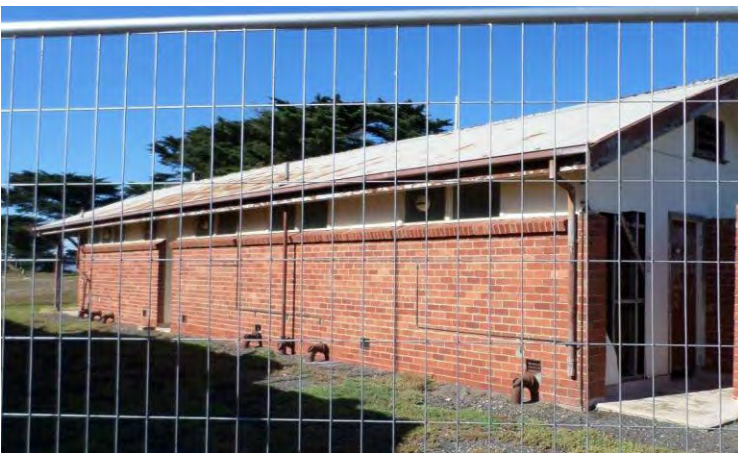
Asset name	Structural and Heritage Summary (from Aurecon, 2019)	Example image (from Aurecon, 2019)
Asset 218: Toilet block	<p>Asset 218 is a timber-framed, brick-walled structure with a metal-sheet roof. The site HMP has concluded that it is of no heritage value to the Base.</p> <p>The main structure of this building is beyond structural repair and is recommended to be demolished.</p>

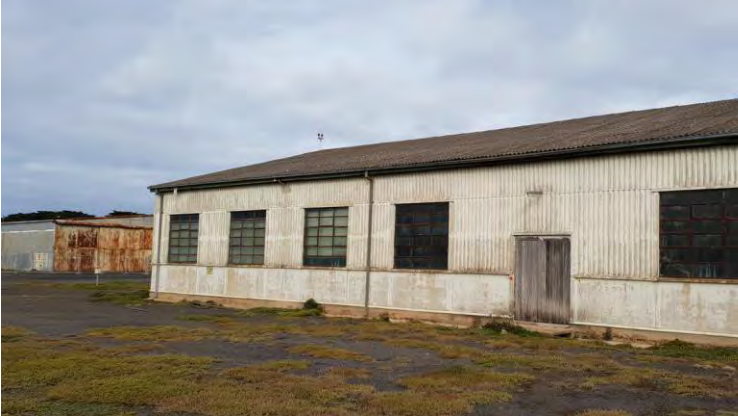
Asset 221: Store	<p>Building 221 is a large, steel-framed warehouse style building with profiled fibre cement sheet external walls, and metal roof sheeting. The site HMP has concluded that the building has medium importance to the heritage values of the Base.</p> <p>The main structure of this building is in good condition and can be either demolished or retained. Ongoing work would be required to improve the condition of the building and manage the identified hazardous materials. As there is no planned future use for this building, the repair and ongoing maintenance of this building is not considered effective use of funding.</p>

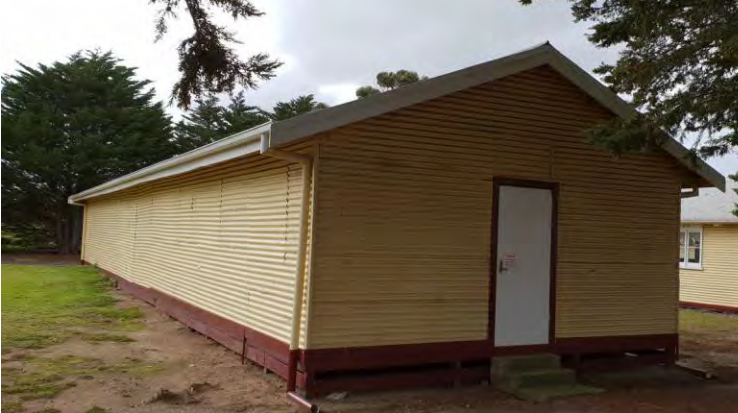
Asset 228: Trainee Sleeping Quarters College	<p>This building is also a RAAF Standard Hut (P1 Hut). It is of the same structure and form as Assets 125, 155, 156, 158, and 203. It is cited in the NHL and CHL place descriptions and is from the World War II era.</p> <p>The main structure of this building is in good condition and can be either demolished or retained. Ongoing work would be required to improve the condition of the building and manage the identified hazardous materials. As there is no planned future use for this building, the repair and ongoing maintenance of this building is not considered effective use of funding.</p>

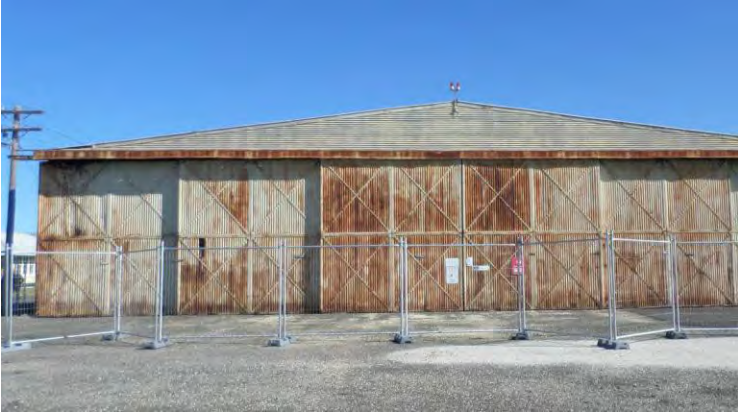
The remaining alternative of 'no action' would retain the assets in-situ and continue the current minimal maintenance regime. In its discussion on alternative actions to demolition, the Biosis (2019) HIA notes that unused assets quickly deteriorate and fall into disrepair, and it becomes difficult to justify any maintenance spending on a building that does not fit a future purpose. Safety risks over the longer term are likely to increase if structural issues are not addressed. Some of the Assets (e.g., the four Bellman Hangars, buildings 211 - 214) are currently causing safety incidents as

parts of the buildings (metal cladding) are regularly blown onto the airfield during high winds. While the 'no action' option maintains the buildings in their current form and context, therefore retaining their heritage value, this is not deemed to be a viable option due to the current and future safety risks posed by the condition of the Assets and lack of suitable use.

Asset name	Structural and Heritage Summary (from Aurecon, 2019)	Example image (from Aurecon, 2019)
Assets 211 – 214 Bellman Hangars	<p>These are steel-framed hangars with flat metal roofing and cladding, with large sliding doors for aeroplane access. They are located in the southern tarmac precinct. These buildings are cited in the NHL and CHL places.</p> <p>The main structures of these buildings are beyond structural repair due to the degree of metal corrosion that is present. They are recommended to be demolished.</p>

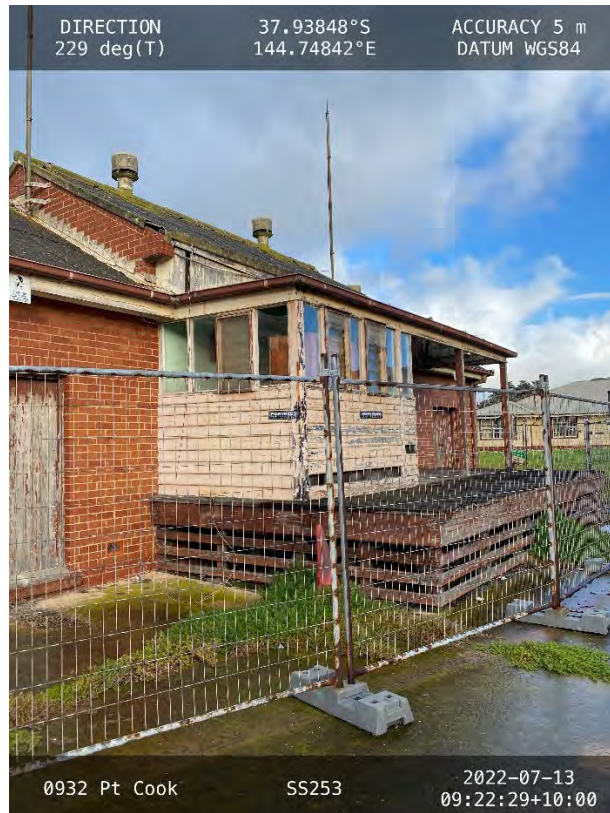
Photo 2

Building 122, majority of the building is on a concrete slab and an attached veranda is on wooden footings.

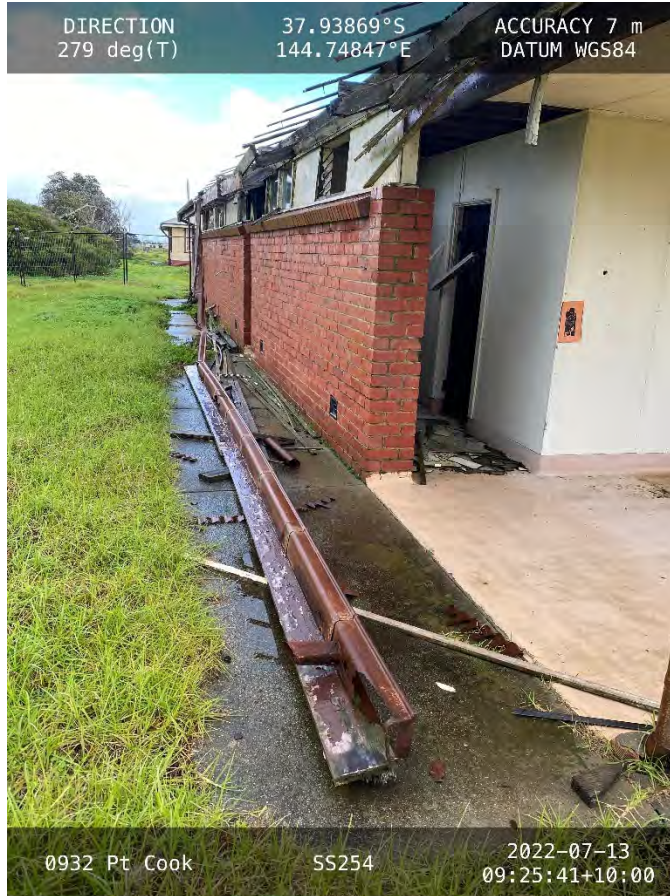
Photo 3

Building 122, building on concrete slab foundation.

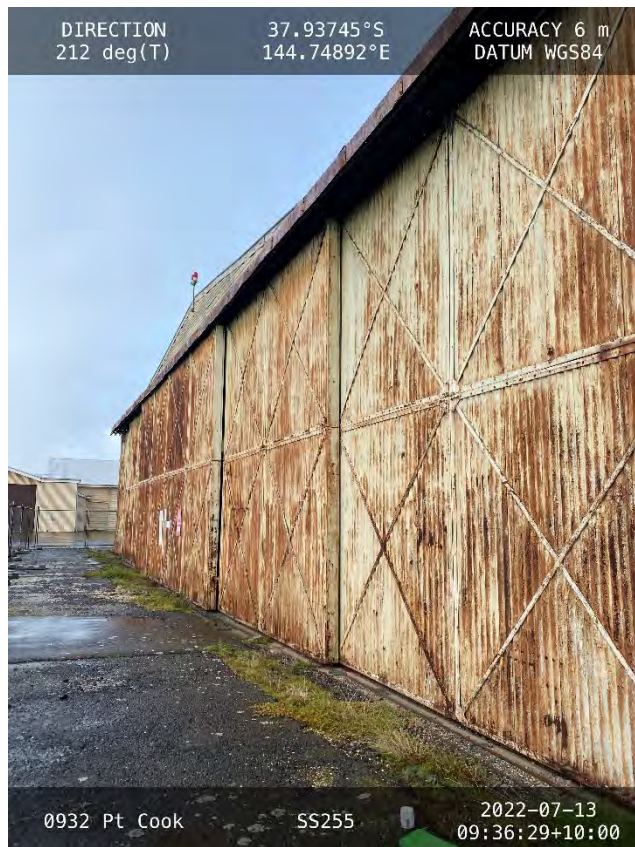
Photo 4

Building 221, World War II kit hanger on asphalt foundation.

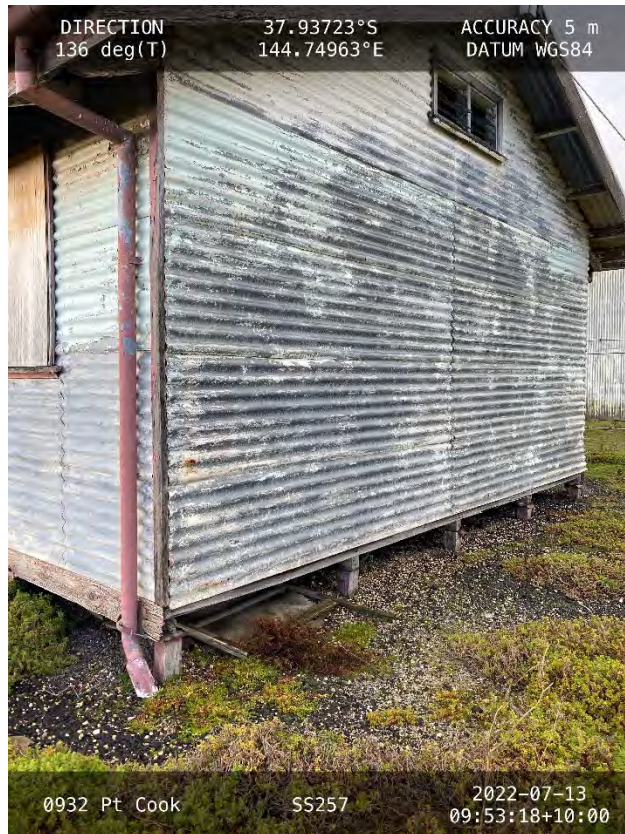
Photo 5

Building 203, building on wooden footings.

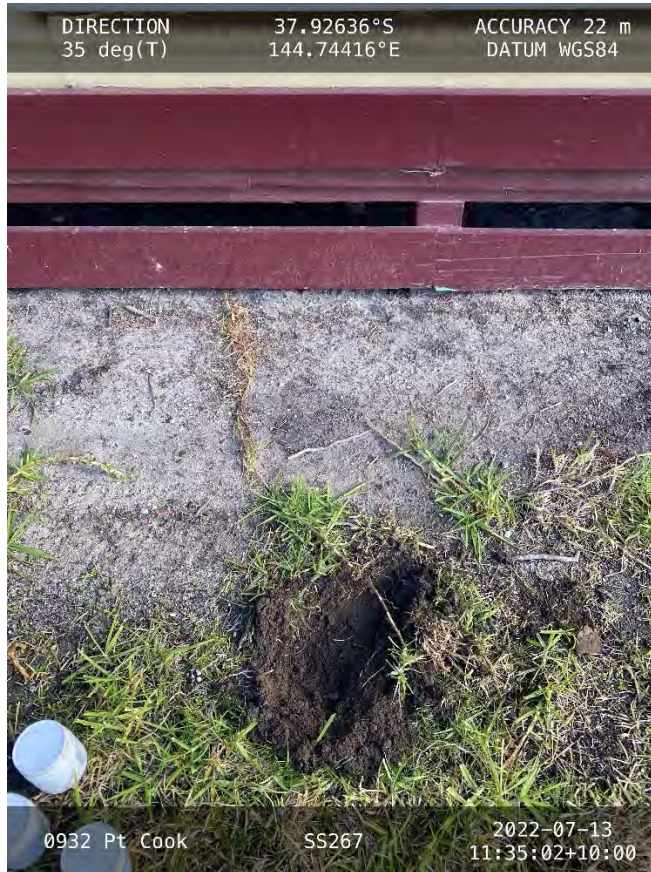
Photo 6

Example of soil characteristics, north of the tarmac. Building 228.

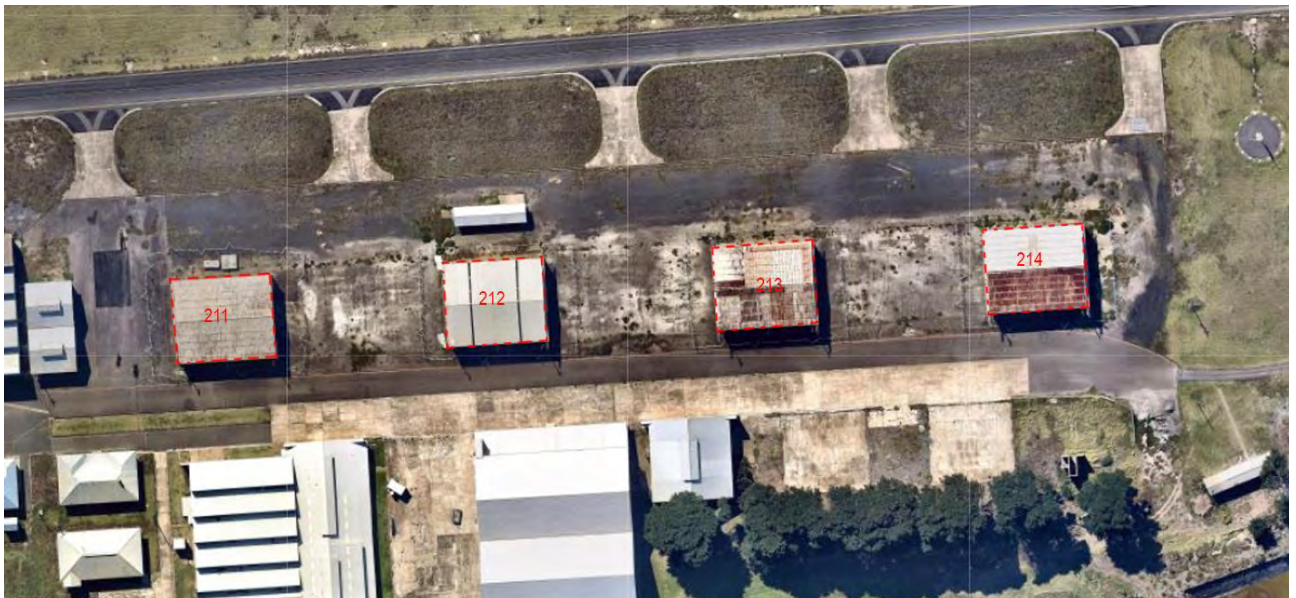
Figure 3 Plan view of hangars (image from Nearmap)

Only visual inspections of these buildings were conducted. This is from behind the secure fenced area, so internal inspection was unable to be undertaken. Externally, the building was in extensive need of works and damage can be seen in the deterioration of the building. The external structure of wall linings are both damaged, rusting, corroded and missing in numerous areas. The structure shows the large external doors and the sliding steel frames are badly damaged and missing in some parts. After visual inspection, the recommendation would be to demolish all the buildings.

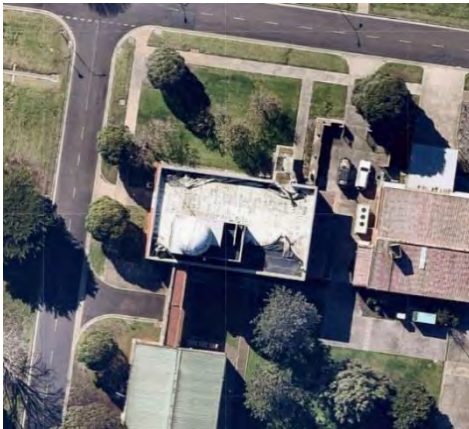
Figure 8 Plan view of Building 4 (image from Nearmap)

Upon inspection and due to the unoccupied status of the building, significant internal damage can be seen across floors, ceilings, windows, internal cabinetry and fixtures in toilets. There was also significant damage to the waterproof membrane on the roof. This has caused internal water damage to the building. Externally, the building is structurally intact and in reasonable good condition, however internally there is a need for major refurbishments to bring the building up to an acceptable standard to be able to work out of. The recommendation is to retain the building, provided major refurbishment works are to be completed.

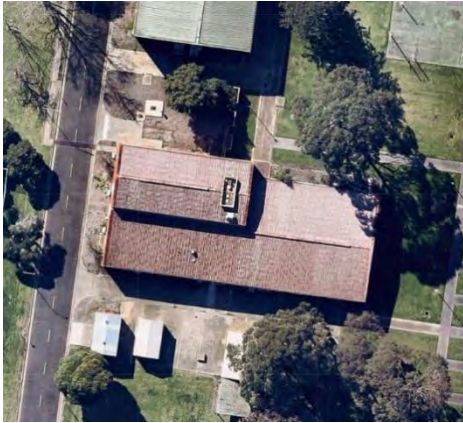
Figure 10 Plan view of Building 7 (Image from Nearthmap)

Upon inspection, due to the building been unoccupied, moderate internal damage can be seen across floors, walls, cabinetry and toilets. A lot of loose furniture, piles of discarded office supplies and rubbish have been left behind. Externally, the building is intact but will require some refurbishments and cleaning and external maintenance around the building.

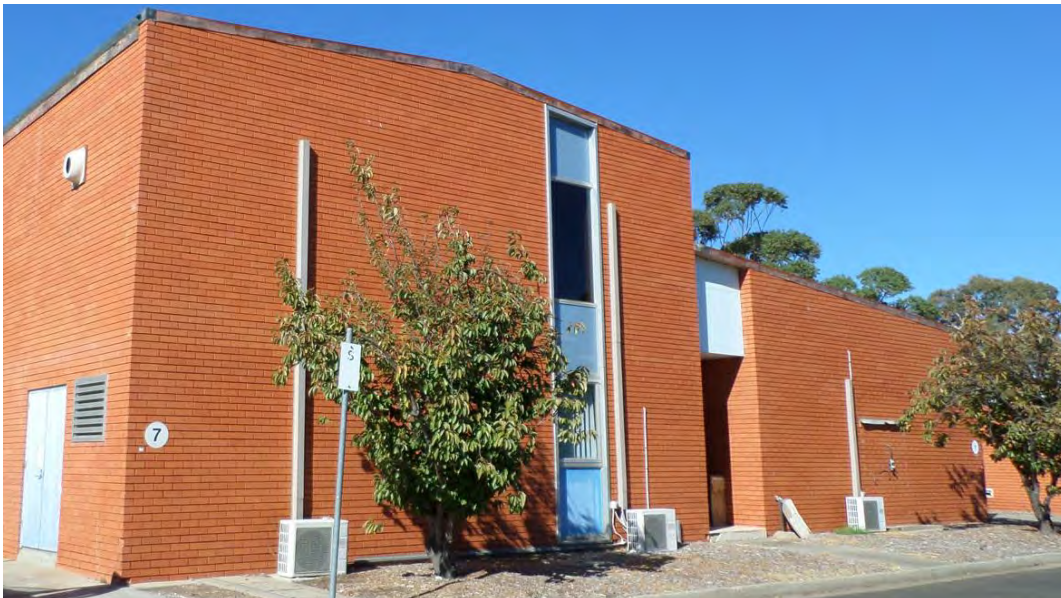
Figure 11 Building A0007

Despite the building being unoccupied and neglected, the condition of the building is considered fair. This building could be retained if moderate refurbishment works can be undertaken to the building to be acceptable for occupation.

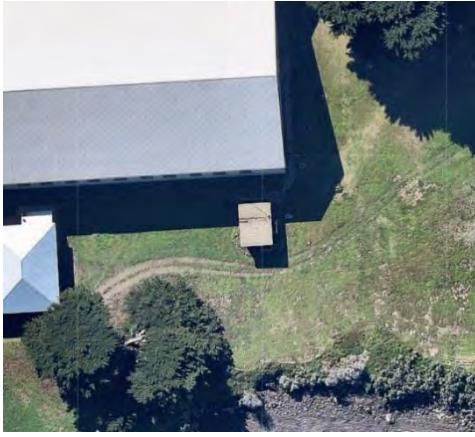
Figure 12 Plan view of A0102 (image from Nearmap)

Upon inspection, the state of disuse is heavily evident with all fixtures and fittings rusting and rotting. It is unfit for occupation with dust, cracks and mould. Externally, the building is showing decay with discolouring of masonry and rusting of the roof.

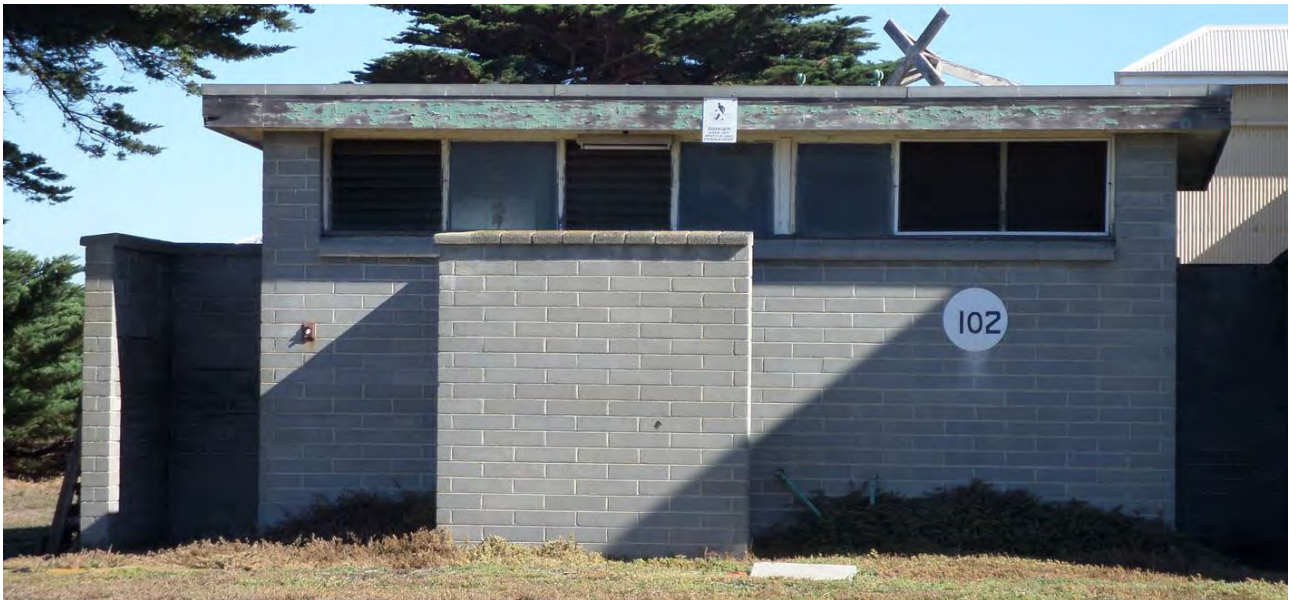
Figure 13 Building A0102

Given that this building is adjacent to a number of disused buildings, the toilet block is not used often and recommended to be demolished.

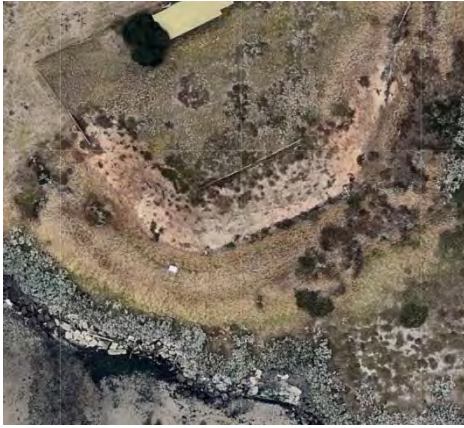
Figure 14 Plan View of A0103 (Image from Nearmap)

Upon inspection, this building does not exist based on the location from the Masterplan provided by the Department of Defence. The image below shows the large earthen mound, used as a stopping zone for bullets fired in its previous use as a firing range.

There is a small firing undercover building, which is dilapidated, and is no longer under use.

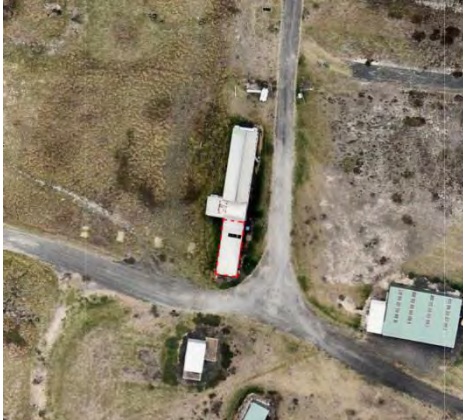
Figure 15 Plan view of A0132 (Image from Nearmap)

Upon inspection, the state of disuse and abandonment is evident with corroded gutters and flashing.

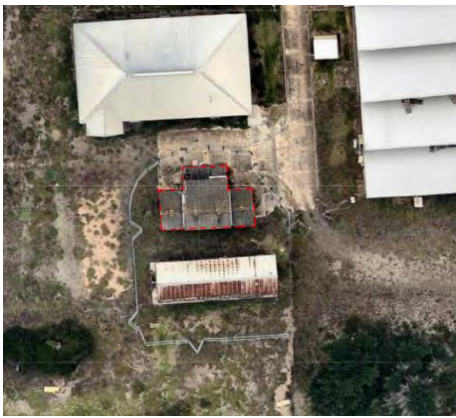
Figure 19 Plan view of A0122 (Image from Nearmap)

The main part of the building is in good condition and is structurally sound. The existing deck area and office should be demolished and replaced with new. The timber decking is damaged, rotting, uneven and the timber floor structure needs to be replaced.

The building can be retained with some refurbishment works.

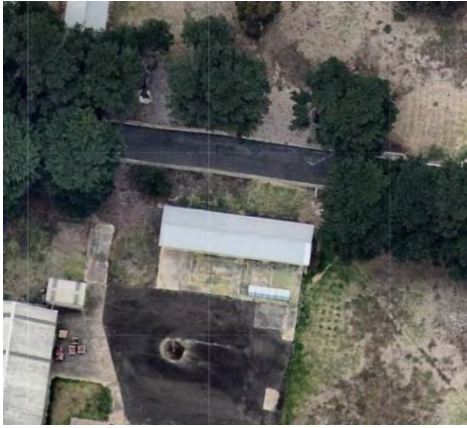
Figure 21 Plan view of Building A0125 (image from Nearmap)

The flooring is uneven and would need re-stumping and the walls jacked back up to be level and straight. The building services would need a complete upgrade.

There is no heating or cooling, or amenities to the building, and there is no insulation to walls or ceilings. The existing doors, would need to be replaced with new doors and compliant door hardware.

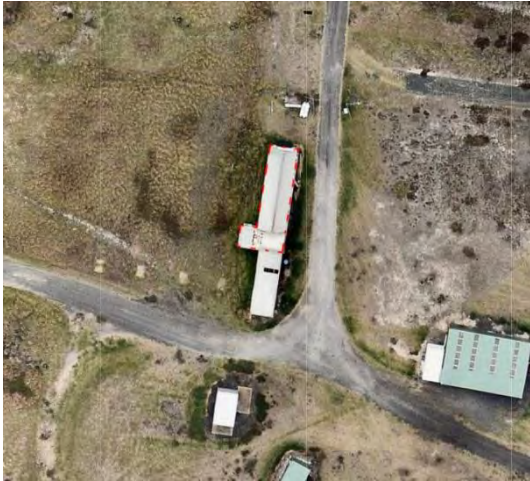
Figure 23 Plan view of Building A0132 (image from Nearmap)

Upon inspection, the state of disuse and abandonment is evident with corroded gutters and flashings.

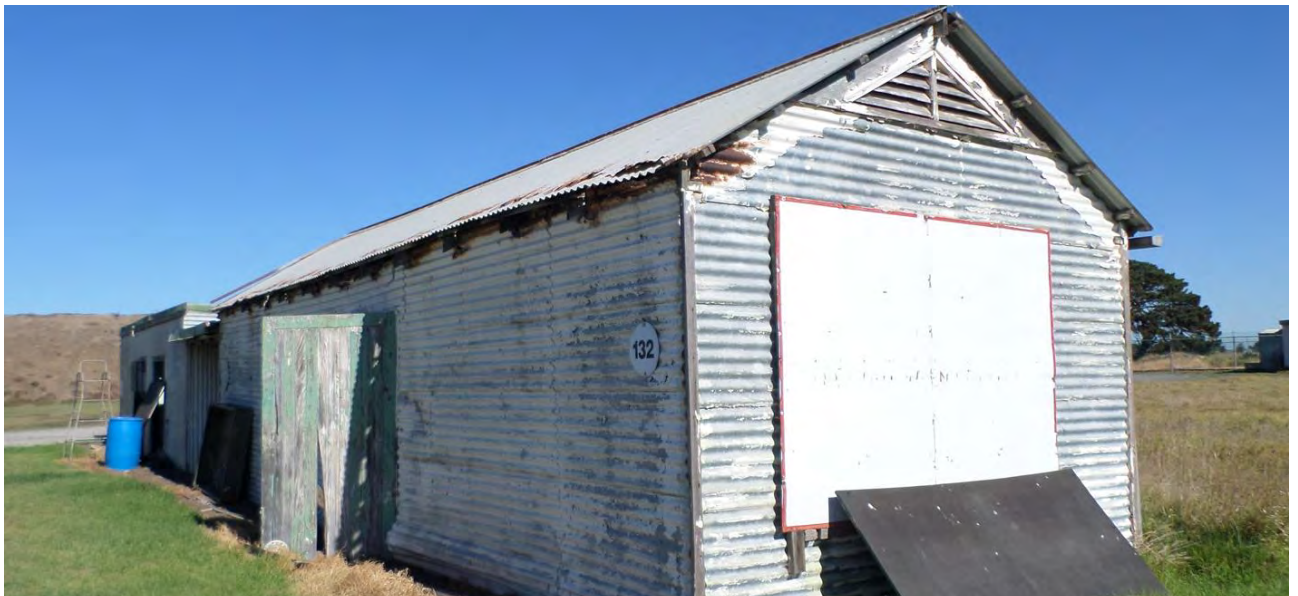
Figure 24 Building A0132

External metal sheeting is in poor condition as the corrugated metal sheeting are worn and torn. There is significant rust in the connection between timber frame and the metal cladding sheets. The timber frame on the roof is deteriorating, with peeling paint and rotting timber. Metal flashings have corroded with the metal roof sheeting rusted.

Internal wall linings and partitions are non-existent with structural frames requiring secondary timber support. The timber is rotting. There is also significant rust in the connection between timber frame and the metal cladding sheet. The internal concrete flooring has cracked and is discolouring.

The existing concrete slab to the west side of the building should be broken up and be disposed of. After removal of all debris, surface levels should be filled with clean soil and seeding to provide a level surface around where the building footprint once was.

The main structure of this building is in an acceptable state requiring possible minor structural repairs however there is a significantly large number of architectural repairs to be undertaken such that it would be considered beyond economic repair. It is recommended to be **demolished**.

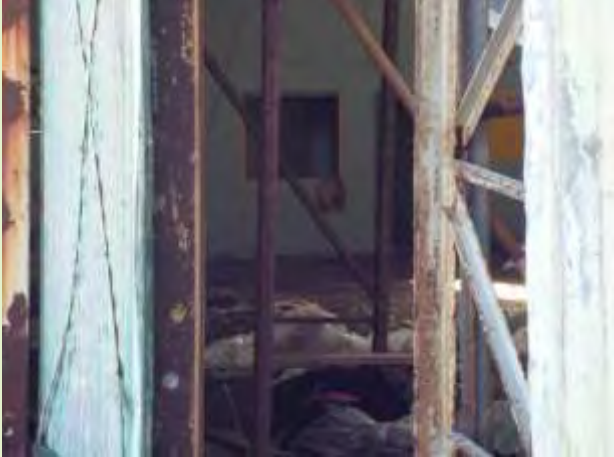
<p>Building A0212. Zoomed in image to show surface corrosion on the columns trusses and sliding door frames.</p>
5

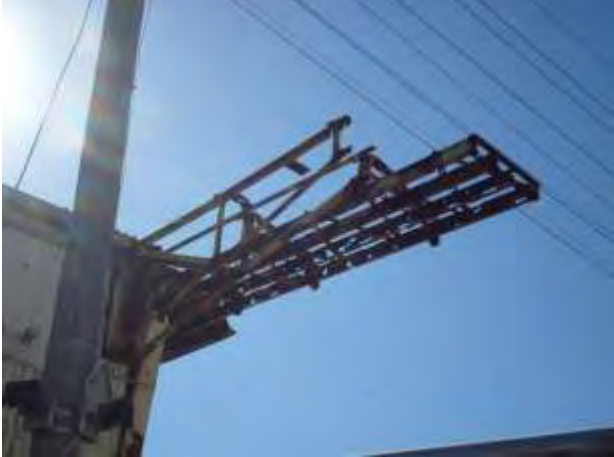
<p>Building A0212. Severe corrosion shown on the steel sliding door guides, leaving the doors inoperable.</p>
6	 	<p>Building A0213. Corrosion and paint deterioration present across the doors and wall metal sheet cladding. Corrosion present on the door framing and cross bracing. Corrosion present on the sliding door guides.</p>
7

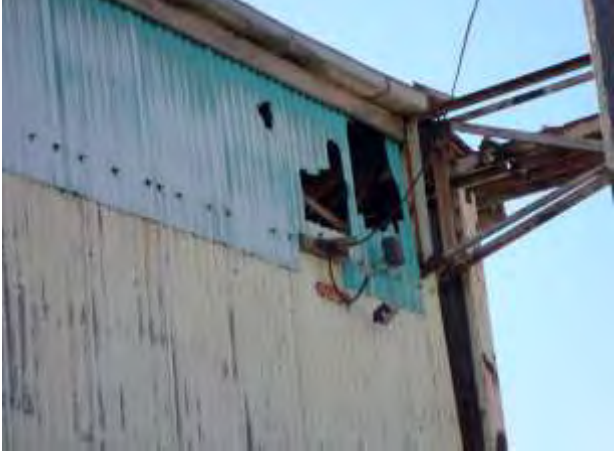
<p>Building A0213. Damage to existing metal wall cladding. Corrosion present on sliding door guides.</p>

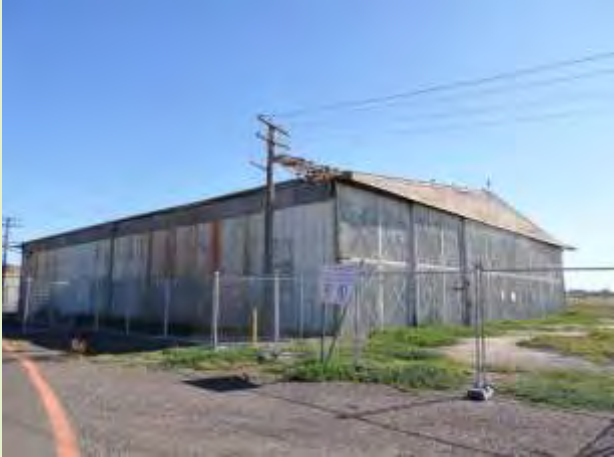
<p>Building A0214. Corrosion and paint deterioration present across the wall metal sheet cladding.</p>
9

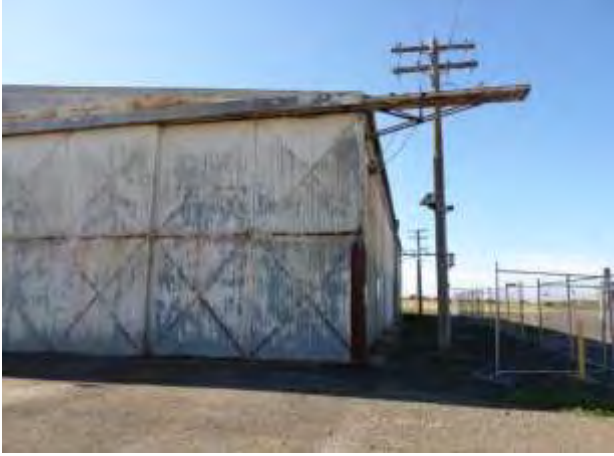
<p>Building A0214. Corrosion and paint deterioration present across the door and wall metal sheet cladding. Corrosion present along the door frames, bracing and guides.</p>

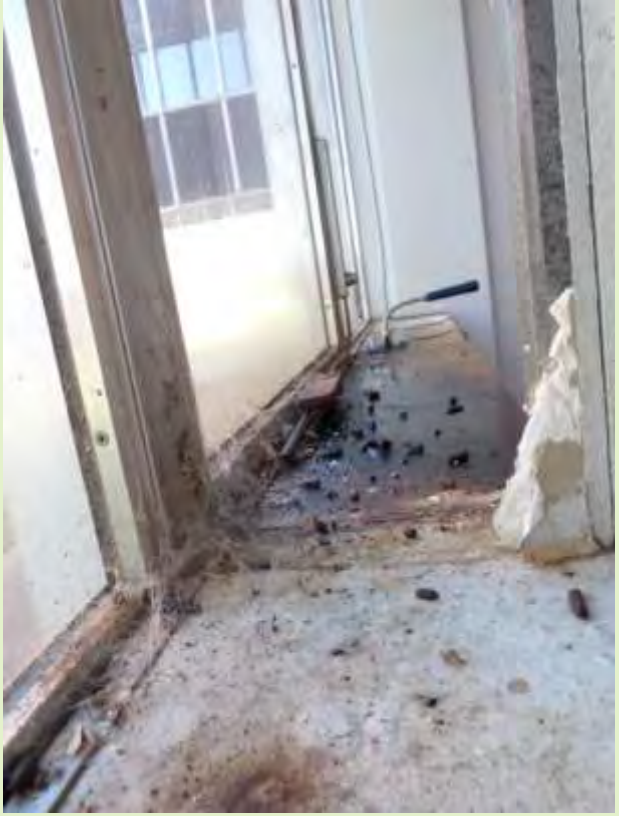
<p>Water leaking from roof slab to ground floor along the south-east side of building. There was no evidence of water leaking through window or external walls.</p>

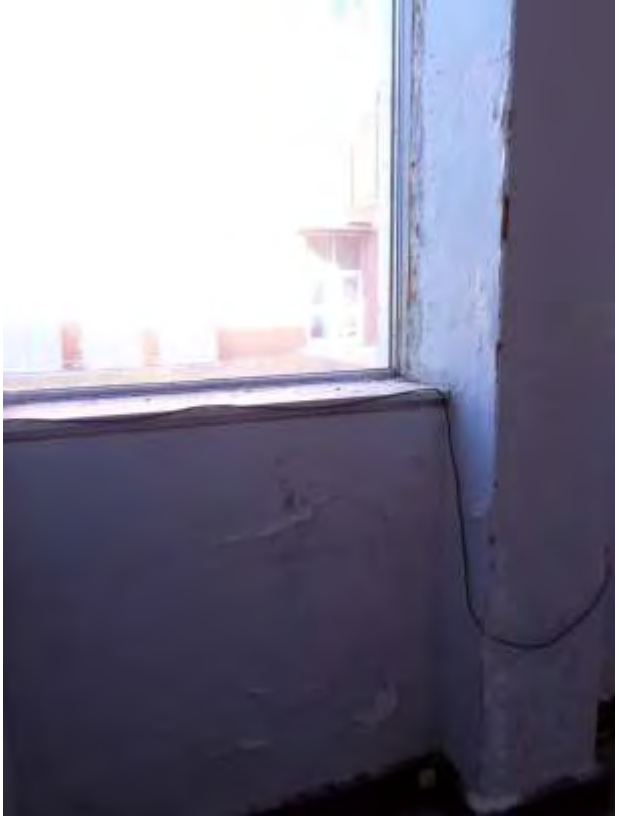
<p>High level of moisture in brick wall that caused the paint peeling and window frames corroded. This occurred to external walls along the south-east of building.</p>
6

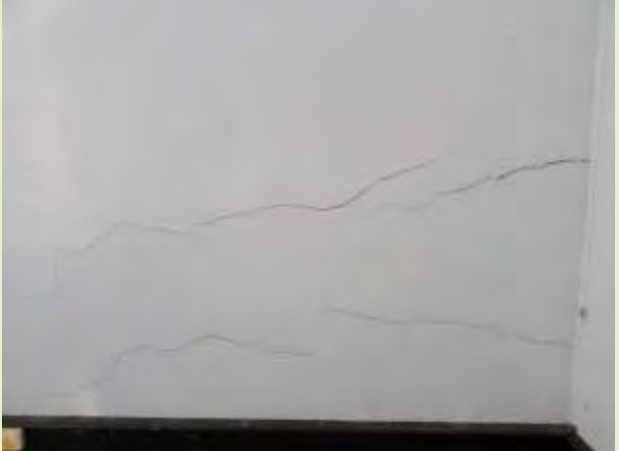
<p>Horizontal cracks evidence on brick wall. Does not indicate typical stepped type cracking of brickwork under hence likely thermal / shrinkage movement. This occurred to most of external wall along the north-west side of building.</p>
7

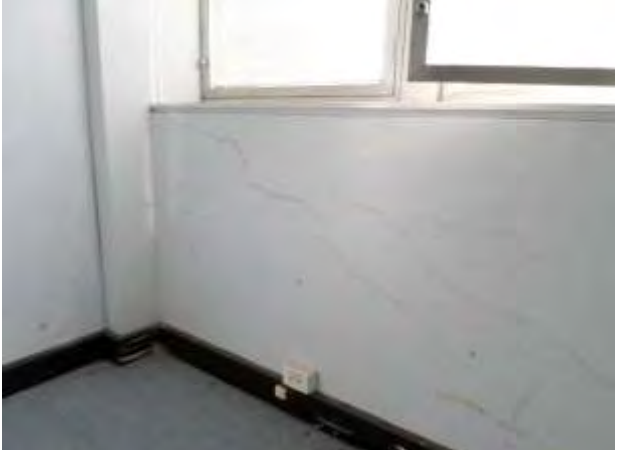
<p>Long horizontal cracks evidence on brick wall. Does not indicate typical stepped type cracking of brickwork under hence likely thermal / shrinkage movement</p>

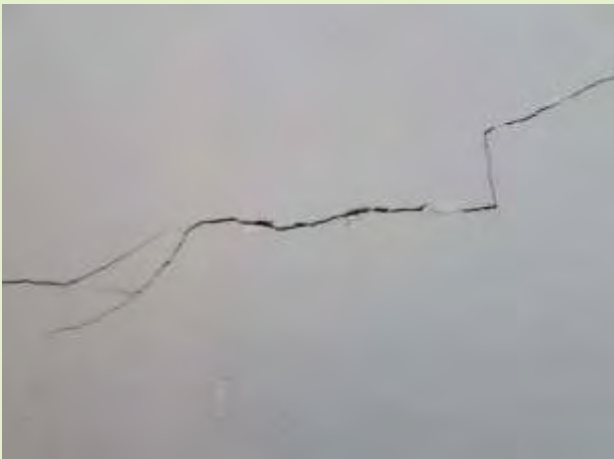
A photograph showing a horizontal crack on a light-colored brick wall. The crack is jagged and runs across the frame, with a width that varies slightly. The background is a plain, light-colored wall.	<p>Horizontal cracks evidence on brick wall, crack width varies up to 2mm wide.</p>
9

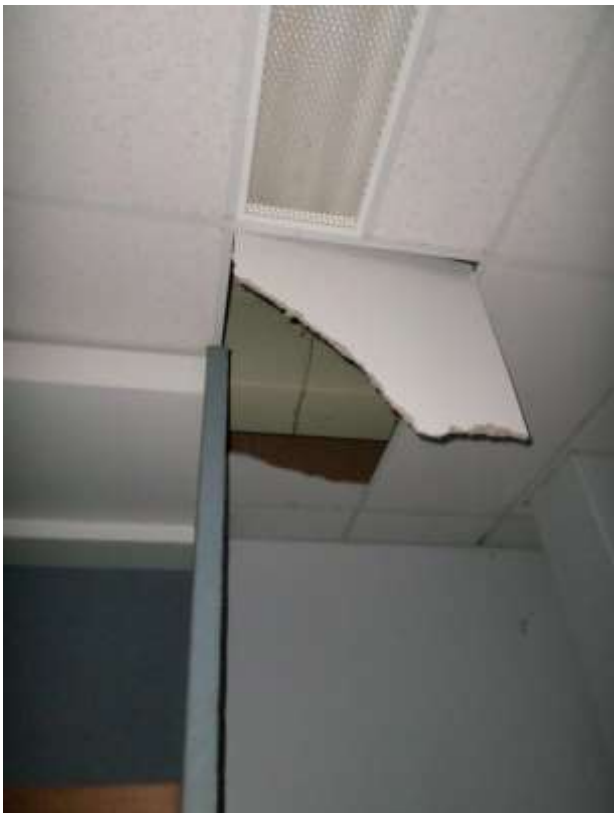
A photograph of a suspended ceiling in a room. One of the white, rectangular ceiling panels is missing or severely damaged, revealing the dark structure underneath. A blue vertical support beam is visible in the foreground, and other ceiling panels are visible in the background.	<p>The failure of the majority of suspended ceiling panels in the building and falling that caused significant safety issue.</p>

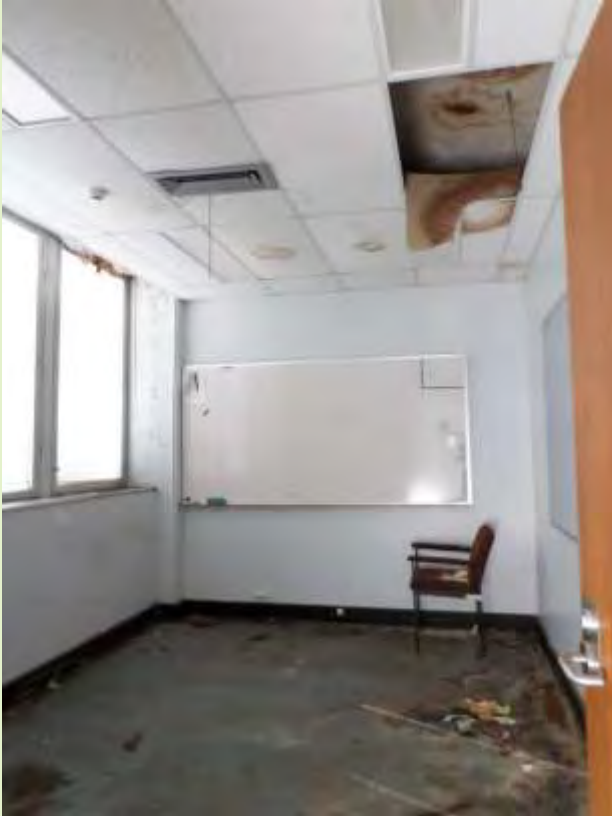
<p>Example of suspended ceiling panel failure due to water leaking from roof slab. This occurred to the majority of suspended ceiling at level 1.</p>
11

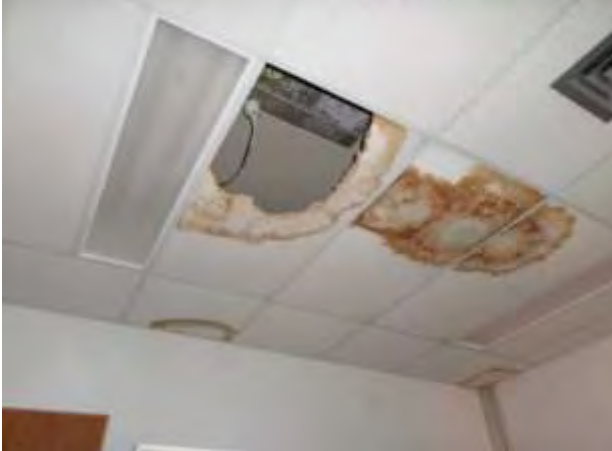
<p>Another example of suspended ceiling panel failure due to water leaking from roof slab.</p>
12	 	<p>High level of moisture in roof slab that damaged the paintwork.</p>

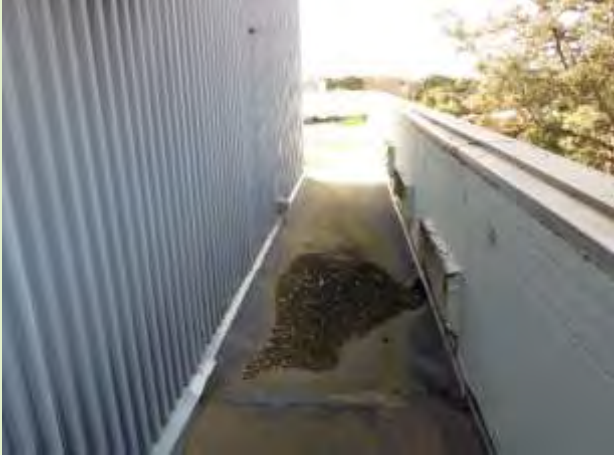
The precast slab failed and deflected that content the garbage and blocked the roof drain.
29

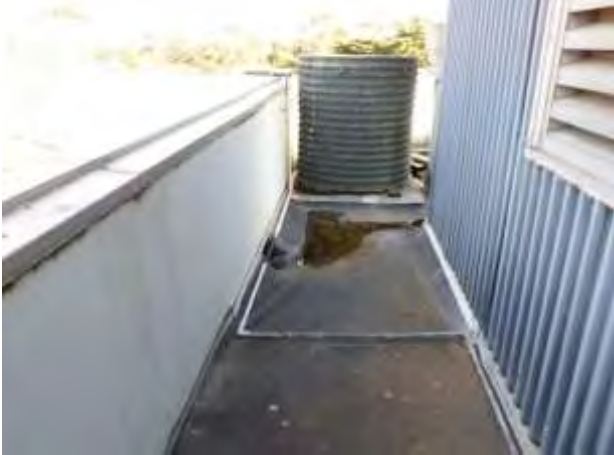
The precast slab failed and deflected that content the garbage and blocked the roof drain.

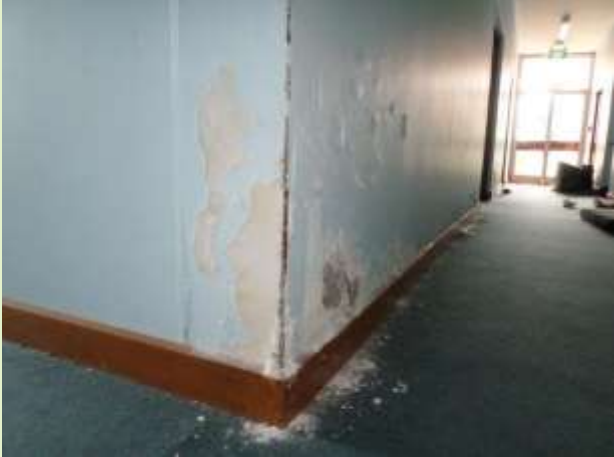
<p>Typical example of paint peeling and bubbling on the walls throughout the ground floor. Minor corrosion present on the wall framing.</p>
5

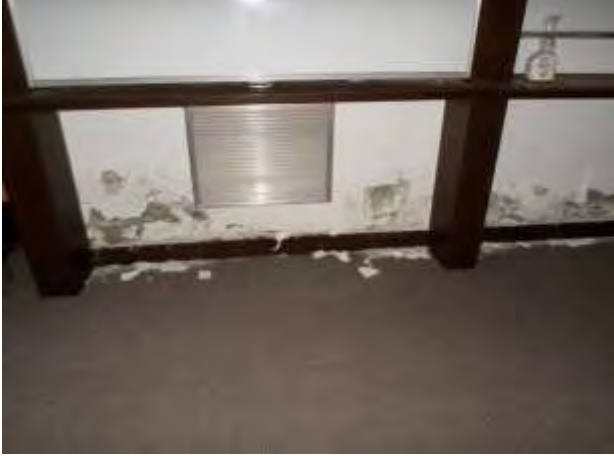
<p>Typical peeling and flaking paint on concrete walls.</p>
6

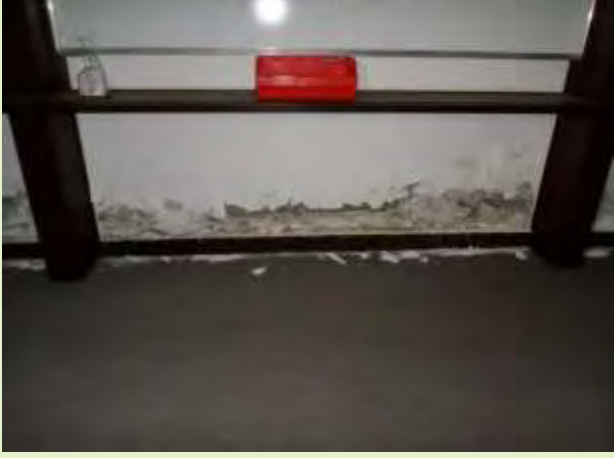
<p>More typical paint peeling and flaking on concrete walls.</p>
7

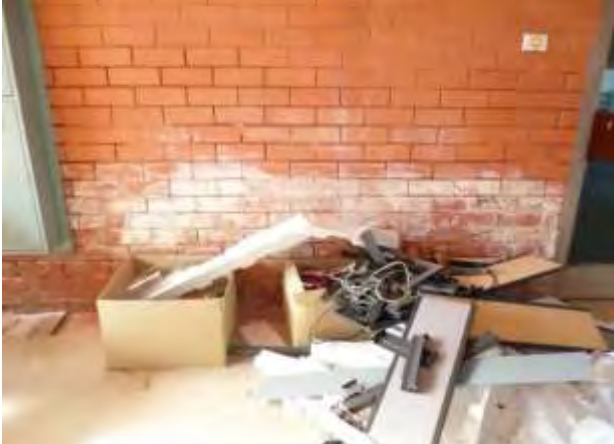
<p>Evidence of white coloured mineral build up at the bottom of a red brick wall on ground floor.</p>

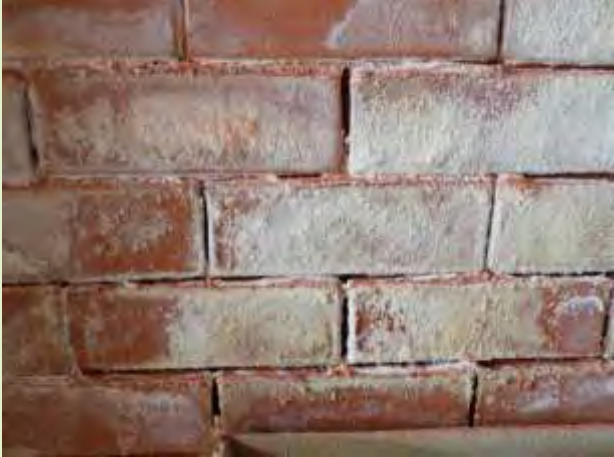
Item Ref.	Item Photo	Item Description
8

A close-up photograph of a red brick wall. The bricks are arranged in a standard pattern. A white, crystalline mineral substance is coating the surface of the bricks and filling the mortar joints. The coating is uneven and appears to be thicker in some areas, particularly along the joints.	<p>Close-up of white mineral substance on red brick wall. Note that in some areas the coating becomes increasingly thick.</p>
9

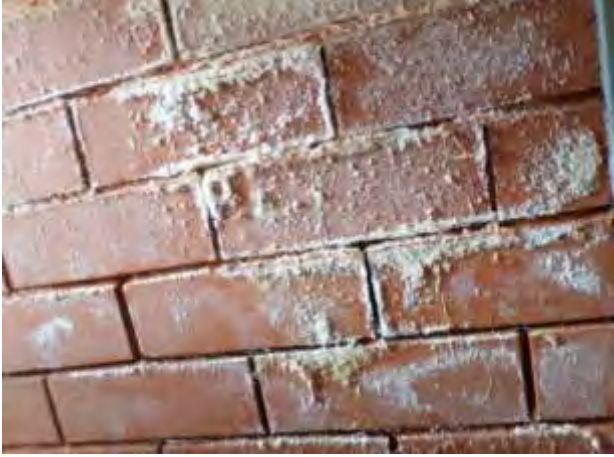
A close-up photograph of a red brick wall, similar to item 8. The white mineral coating is more prominent and thicker, especially along the mortar joints between the bricks. The coating has a crystalline, flake-like appearance.	<p>Another close-up example of the white mineral substance on the red brick wall. Note the thicker build-up primarily along at the joint between the bricks.</p>
10

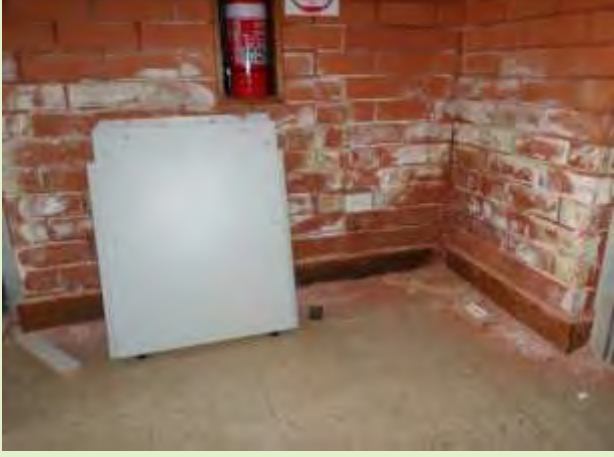
A photograph of a room corner with brick walls. The walls are covered in a significant amount of white mineral build-up, particularly in the lower half of the wall. A white board is leaning against the wall on the left, and a red fire extinguisher is mounted on the wall above it. The floor is a light-colored concrete or stone.	<p>Another example of a brick wall with a large amount of white mineral build up. Note the height that the substance increases is typical across the entire ground floor of the building.</p>

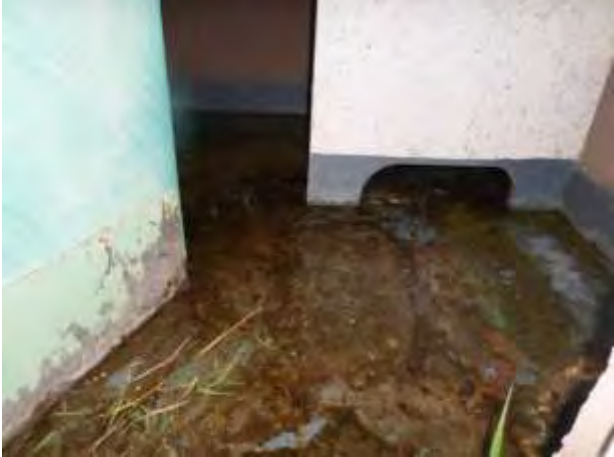
Item Ref.	Item Photo	Item Description
9

Pooling of water in toilet area which indicates a lack of drainage or blockage of the drainage. Surface deterioration to door.
10

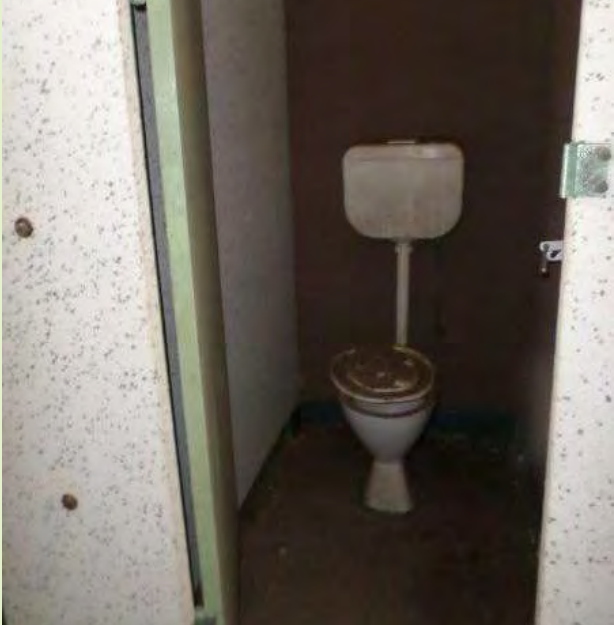
Damage and poor condition of toilet.

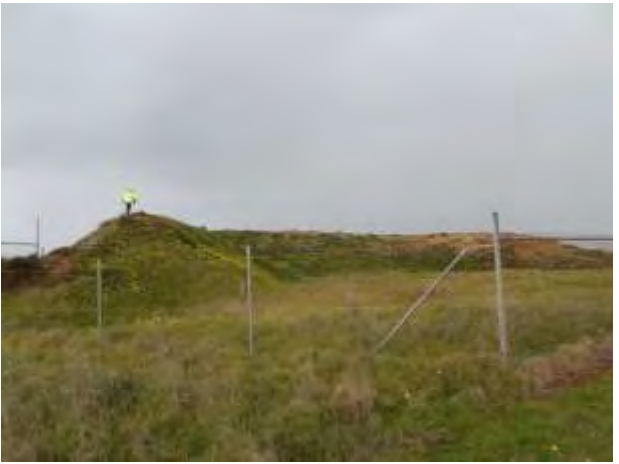
Item Ref.	Item Photo	Item Description
1

A photograph showing a large earthen mound or ridge. In the foreground, there is a fence made of wooden posts and wire. A person is visible on the top of the mound, providing a sense of scale. The sky is overcast and grey.	<p>Photo depicts the size of the large mound and the fence containing the area. There is also a set of steps on the left hand side of the photo that the person has used to climb to the ridge of the mound. These steps may be considered unstable.</p>

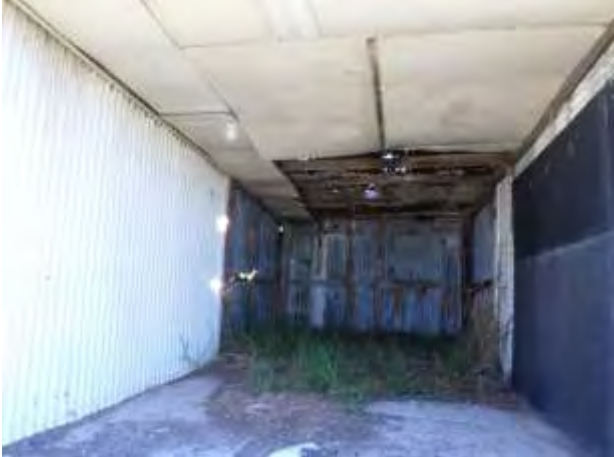
<p>A few ceiling panels have become dislodged from their fixings and are falling down. Ceiling panels are missing and the roof is exposed. Corrosion occurring on the metal wall sheeting on the back wall. Severe corrosion occurring on the roof metal sheet panels where the roof is exposed. Overgrown vegetation present. Concrete shows signs of cracking and settlement.</p>

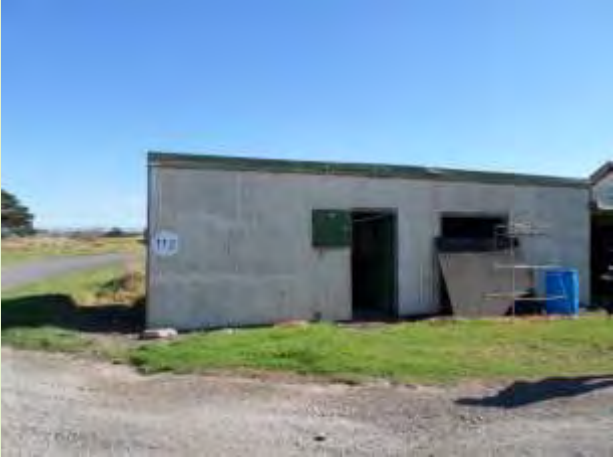
Item Ref.	Item Photo	Item Description
8

<p>Corrosion present on the metal wall cladding at the top of the wall and joint to roof.</p>
