PRELIMINARY DOCUMENTATION REPORT

Demolition of Structures at RAAF Williams – Point Cook, Victoria

(EPBC 2019/8514)

November 2023

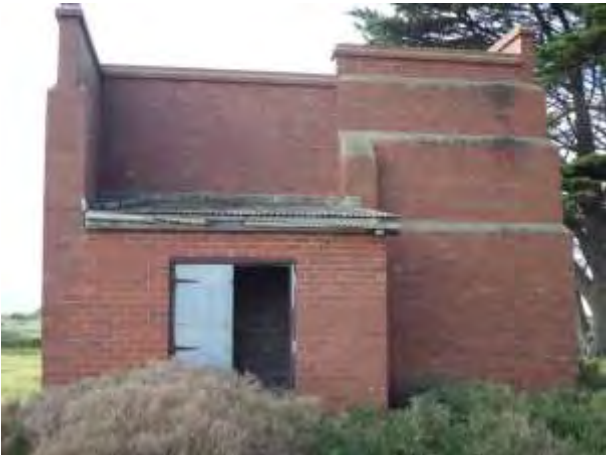
Item Ref.	Item Photo	Item Description
1

A photograph showing the exterior of a brick building. A dark door is visible on the left side. The roof is made of corrugated metal. There are some plants in the foreground.	<p>Cracks in the brickwork can be seen at the top right corner of the door frame and on the wall above. Door and door frame have surface deterioration. Roof sheeting shows signs of corrosion. Gutter damaged and has corrosion.</p>
2

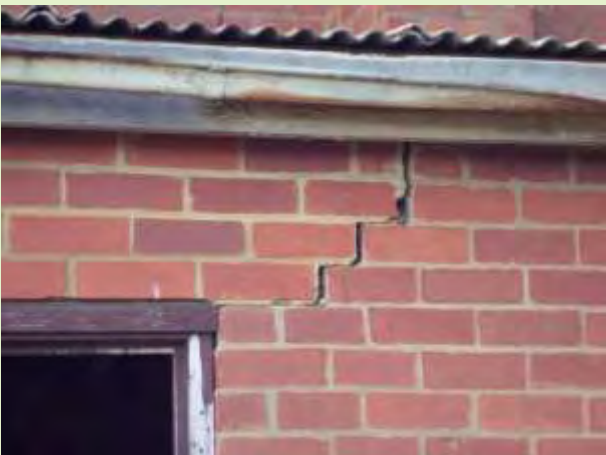
A close-up photograph of a brick wall. A large, jagged crack runs vertically through the bricks, starting from the top edge of a door frame and extending upwards.	<p>Large crack in the brickwork above the door frame, likely due to shrinkage or expansion of the building.</p>
3

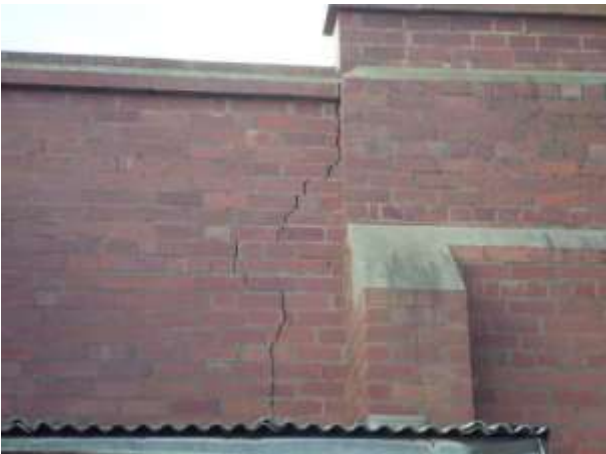
A close-up photograph of a brick wall. A large, jagged crack runs vertically through the bricks, starting from the top edge of a door frame and extending upwards.	<p>Large crack in the brickwork on the upper half of the building, likely due to shrinkage or expansion of the building.</p>

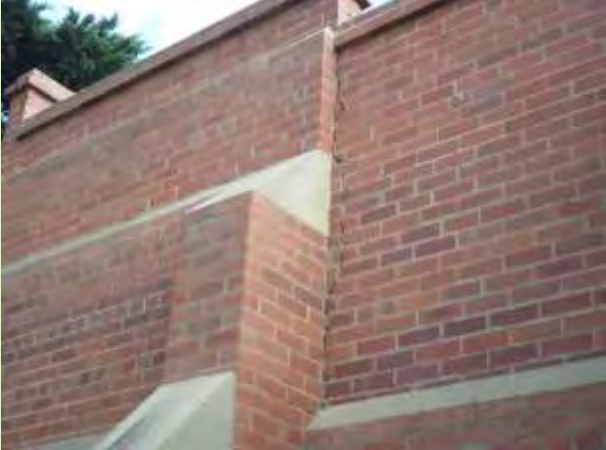
Item Ref.	Item Photo	Item Description
4

<p>Large crack in the brickwork on the upper half of the building, likely due to shrinkage or expansion of the building.</p>
5

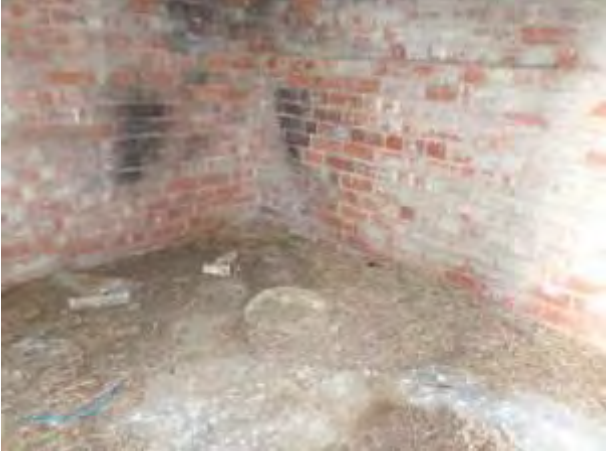
<p>Minor cracks in the concrete slab. Surface damage to the brickwork.</p>
6

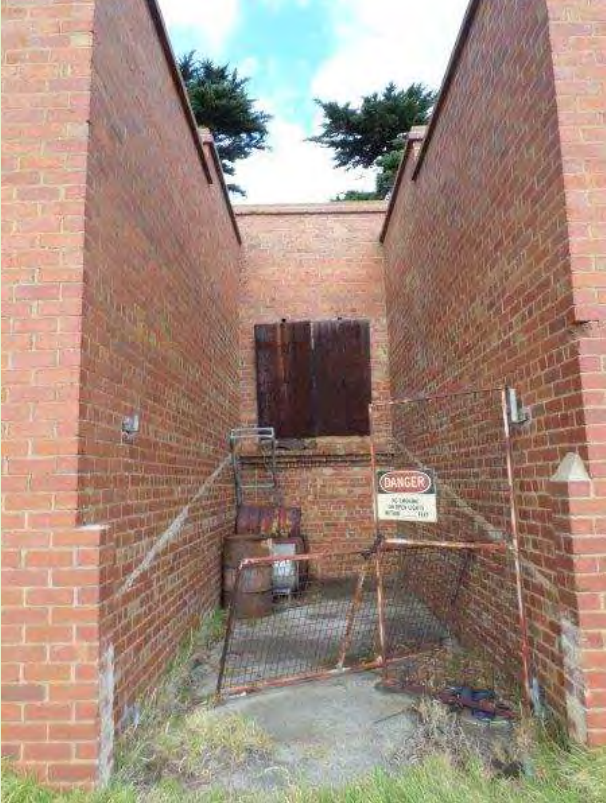
<p>Corrosion of the metal window shade/panel. Damage and corrosion to existing gate.</p>

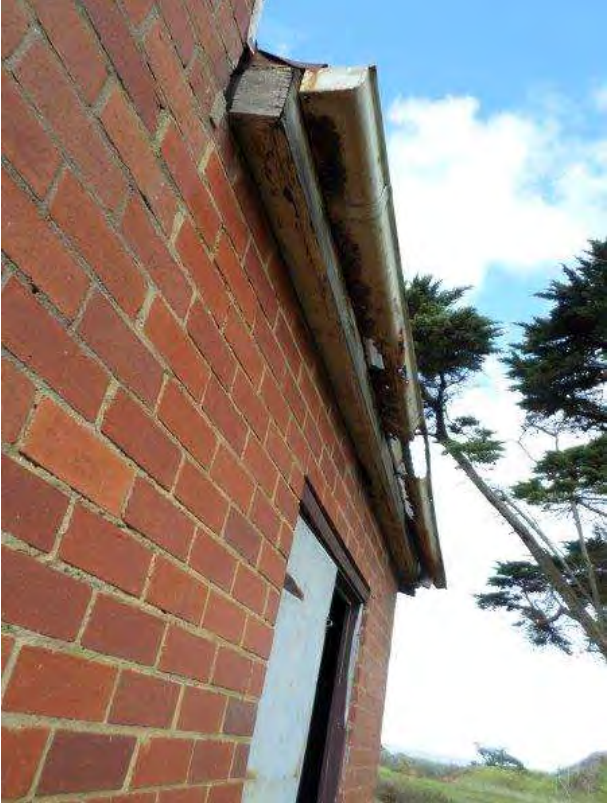
Item Ref.	Item Photo	Item Description
7

Severe corrosion on gutter.

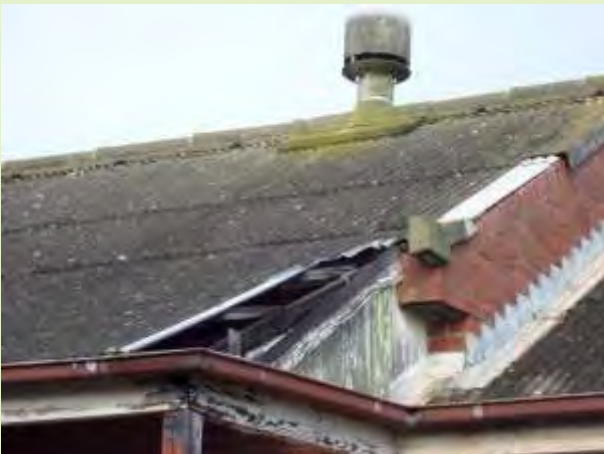
Item Ref.	Item Photo	Item Description
8

<p>Section of metal sheet roof cladding is missing and is required to be replaced. Physical deterioration and minor corrosion of metal sheet roof cladding. Missing section of metal corner roof clashing. Organic accumulation (moss) at the ridge of the roof. Painting required on timber fascia.</p>
9

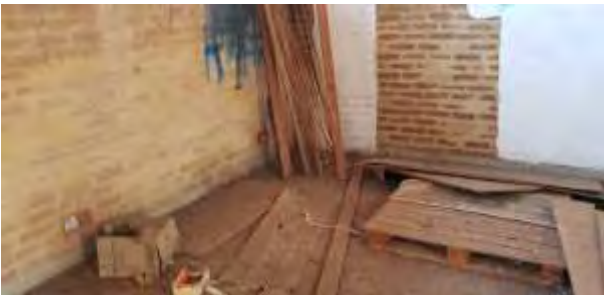
<p>Notable graffiti on the walls and paint missing in locations.</p>
10

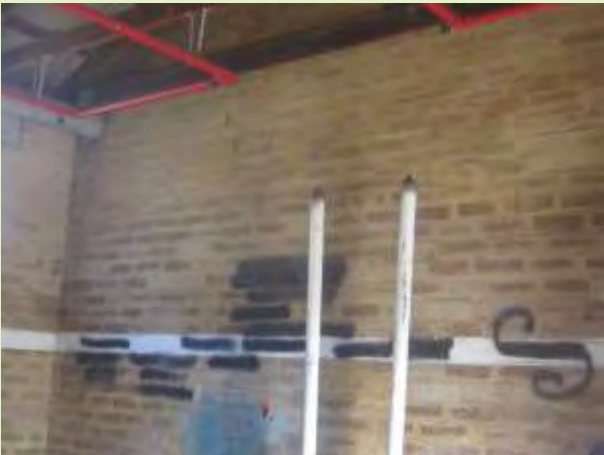
<p>Graffiti on the walls requiring painting.</p>

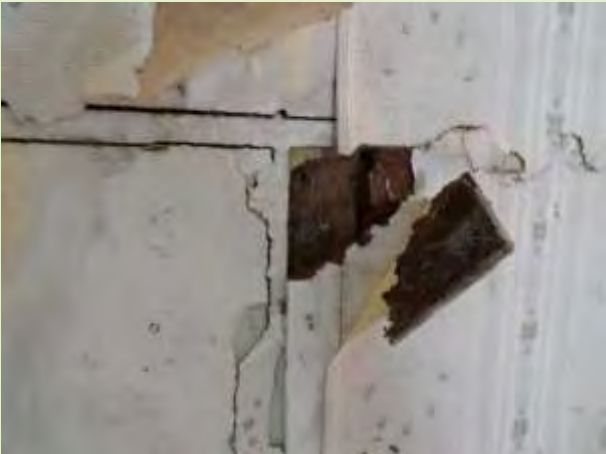
Item Ref.	Item Photo	Item Description
8

Damage to wall, and cracking of wall and wall framing.
9

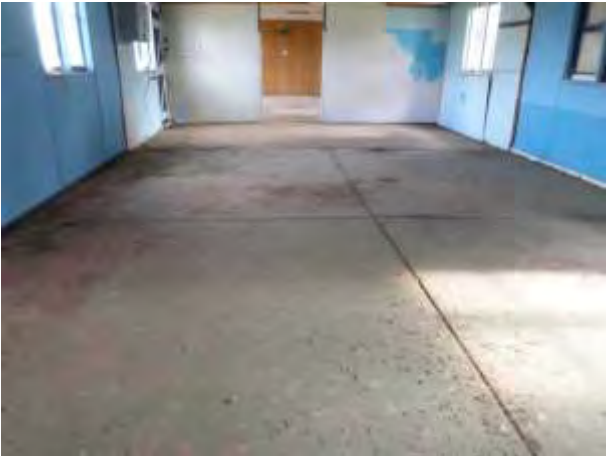
Surface deterioration of paint on the concrete slab floor.

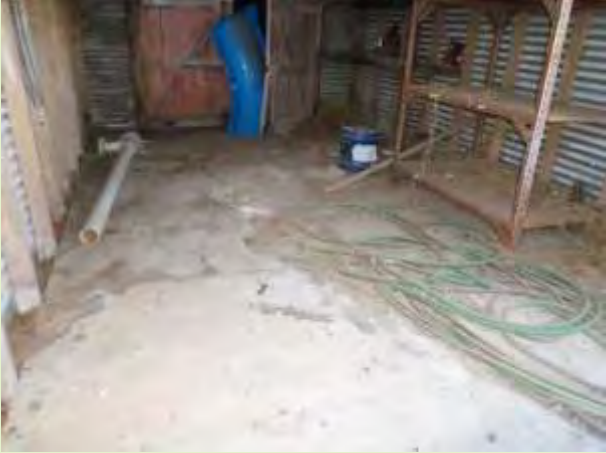
<p>Concrete slab on ground has significant cracks, settlement and potential spalling. Double doors show surface deterioration and potential physical damage.</p>

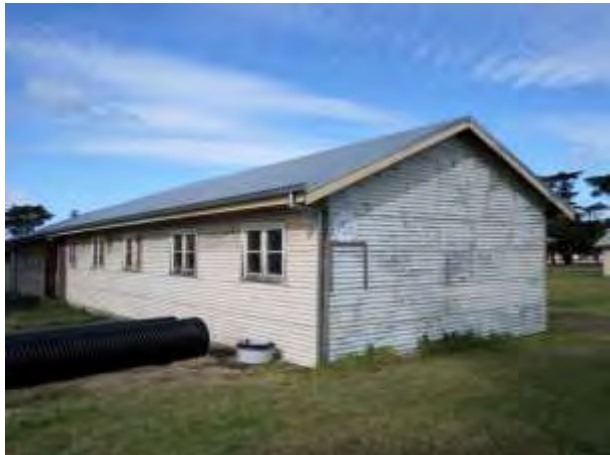
Item Ref.	Item Photo	Item Description
1

<p>Surface deterioration and peeling paint on the metal wall cladding. Surface deterioration of the corner timber wall flashing.</p>
2

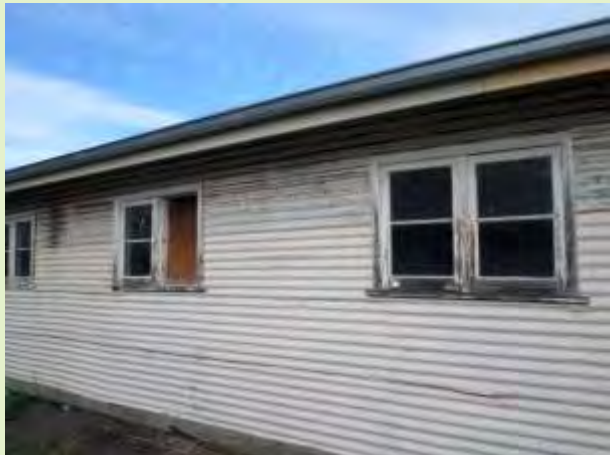
<p>Surface deterioration and faded/peeling paint on the metal wall cladding and window frames.</p>
3

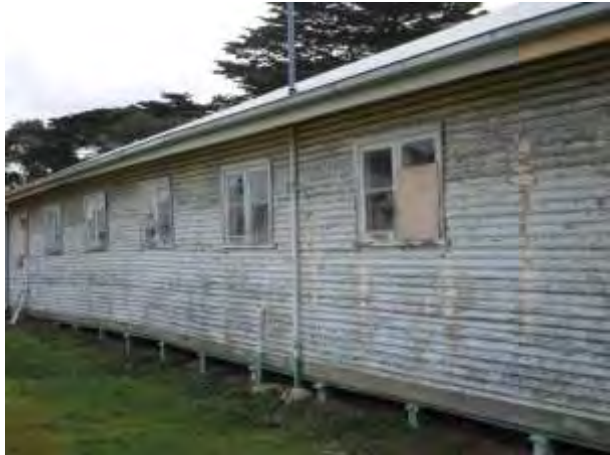
<p>Severe surface deterioration and peeling of the paint on the metal wall cladding. Surface deterioration and peeling paint on the window frame.</p>

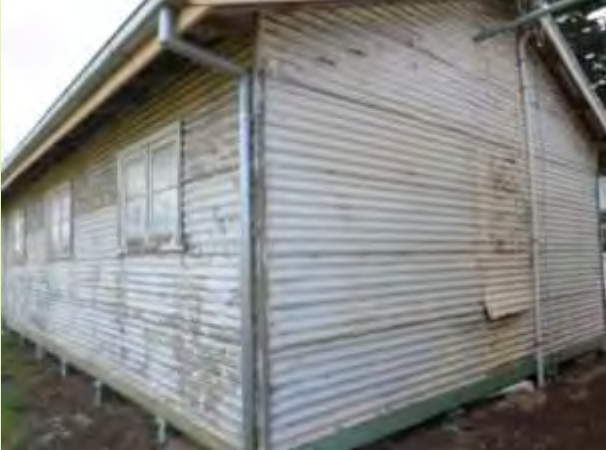
Item Ref.	Item Photo	Item Description
4

<p>Damage to metal sheet cladding. Surface deterioration and peeling paint of the metal sheet cladding, window frame, floor bearer.</p>
5

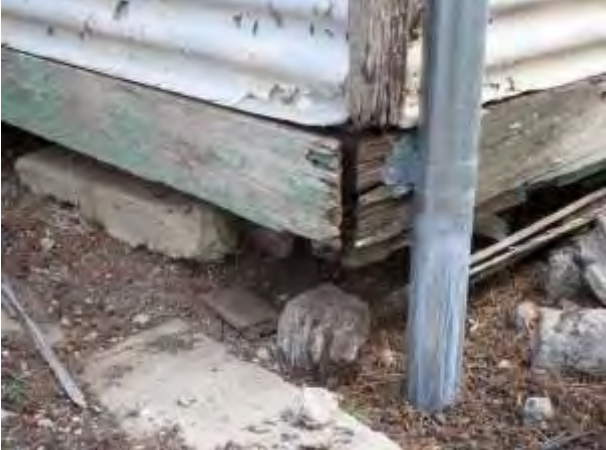
<p>Timber stub column has been removed which presents a significant structural issue as it no longer supports the building at this location. Timber bearer has physical deterioration and surface deterioration.</p>
6

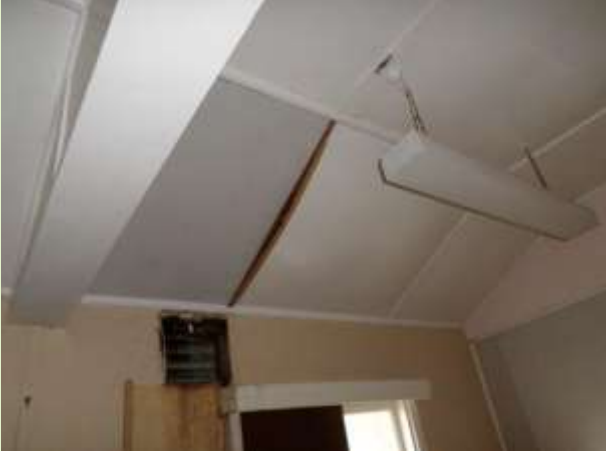
<p>Ceiling panel has become loose which indicates potential damage to fixings which is a safety hazard. An area on the wall has been damaged with a section being removed.</p>
7

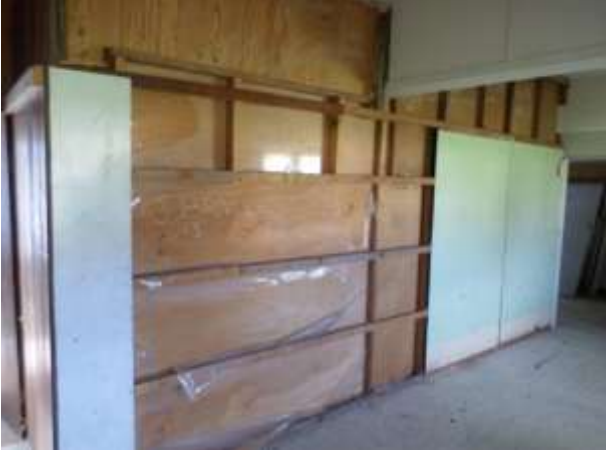
<p>Numerous areas of the wall and wall panels either damaged or missing.</p>

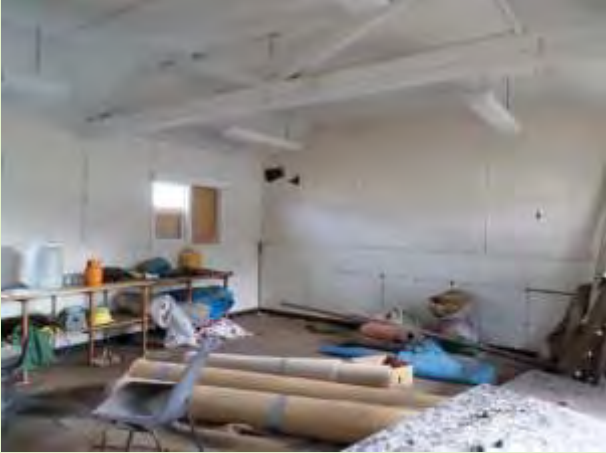
Item Ref.	Item Photo	Item Description
8

<p>Damage and two large holes in the back-wall panel. Surface deterioration of the timber truss.</p>

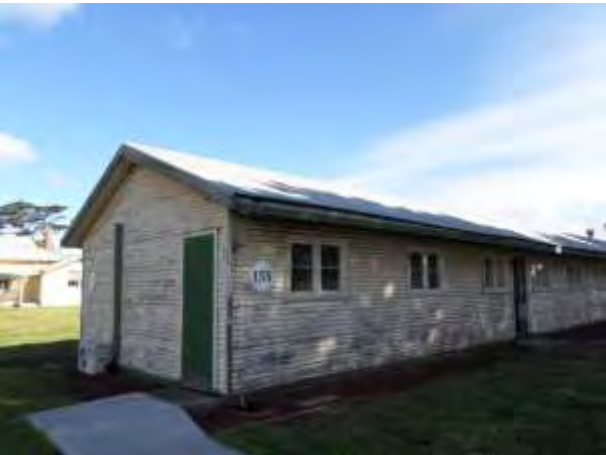
Item Ref.	Item Photo	Item Description
1

<p>Surface deterioration to metal wall cladding, timber fascia, timber bearer, window frame and door.</p>
2

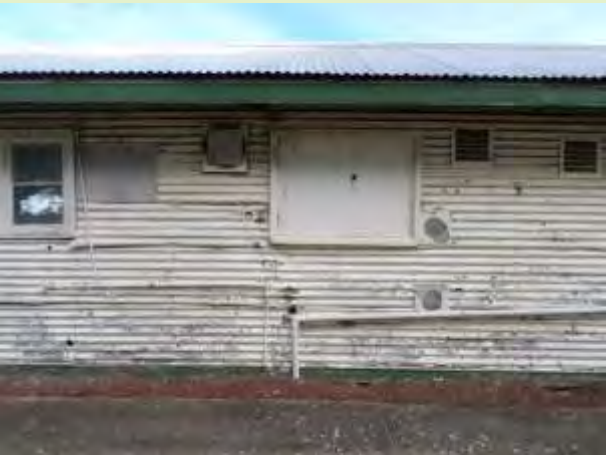
<p>Physical damage and holes in the metal wall cladding. Surface deterioration to metal wall cladding, timber fascia, timber bearer and window frame.</p>

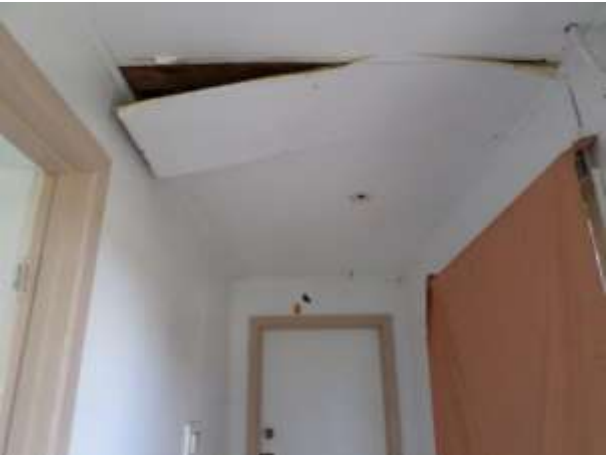
<p>Large ceiling panel has become loose and is falling from the ceiling fixings. Safety hazard.</p>

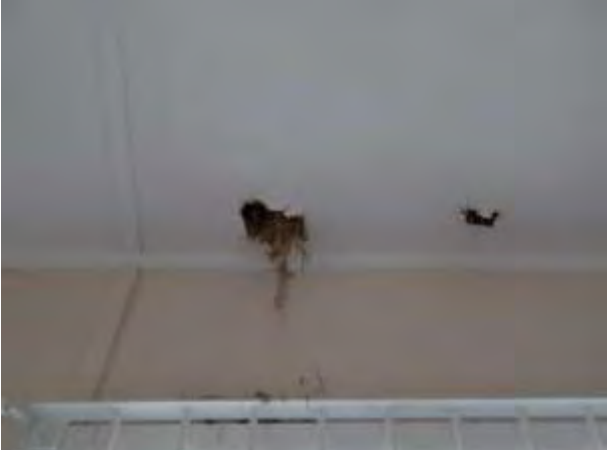
<p>Damage and holes in ceiling panel.</p>

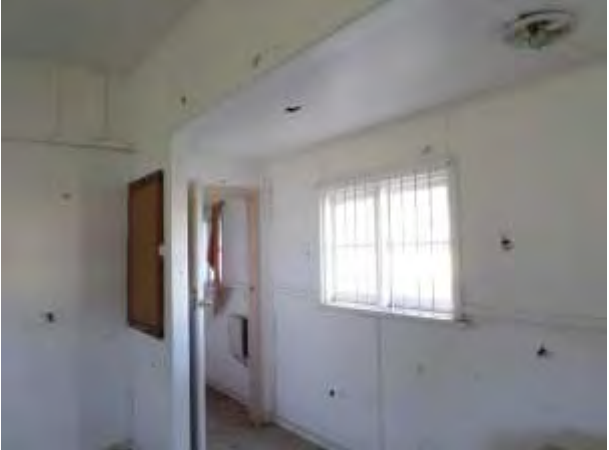
<p>Damage to wall and ceiling panels as seen by a number of holes throughout.</p>

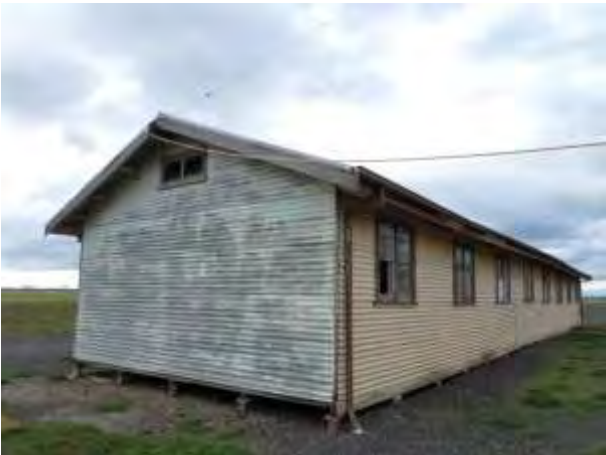
Item Ref.	Item Photo	Item Description
1

<p>Surface deterioration of metal wall cladding, window frames, timber fascia and timber bearers.</p>
2

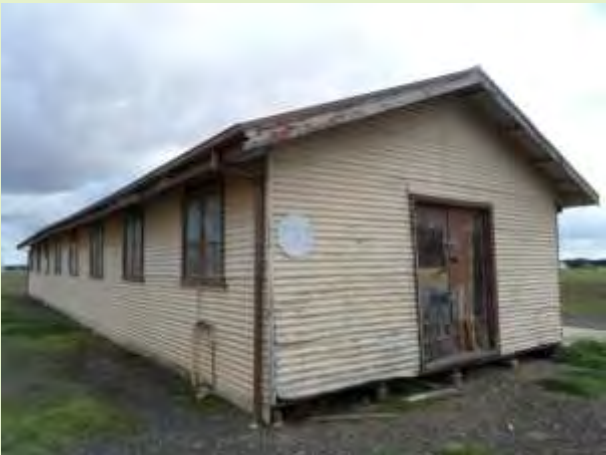
<p>Surface deterioration of metal wall cladding, window frames, timber fascia and timber bearers. Physical damage to the metal wall cladding and the door.</p>
3

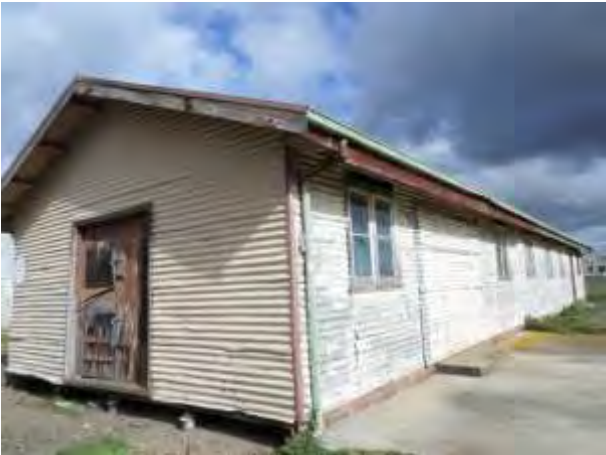
<p>Surface deterioration of metal wall cladding, window frames, timber fascia and timber bearers. Physical damage to the metal wall cladding and the door.</p>

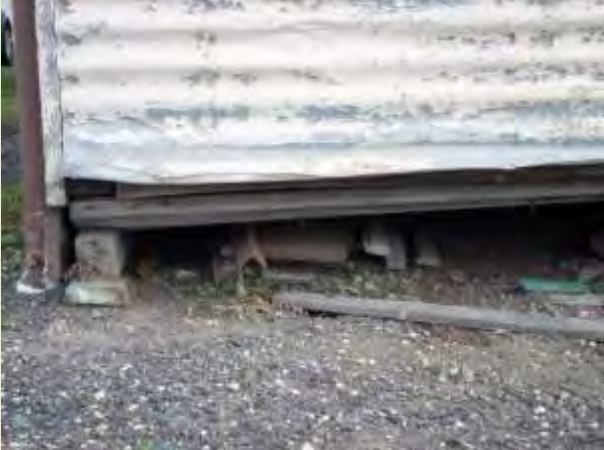
Item Ref.	Item Photo	Item Description
4

A photograph showing the underside of a building. A wooden beam is visible, supported by a concrete block. The metal cladding above shows significant surface deterioration and rust. The ground below is gravel.	<p>Evidence of the timber flooring failing and falling as seen by the timber members below the building. Timber bearer appears to be have physical deterioration. Metal wall cladding has significant surface deterioration.</p>
5

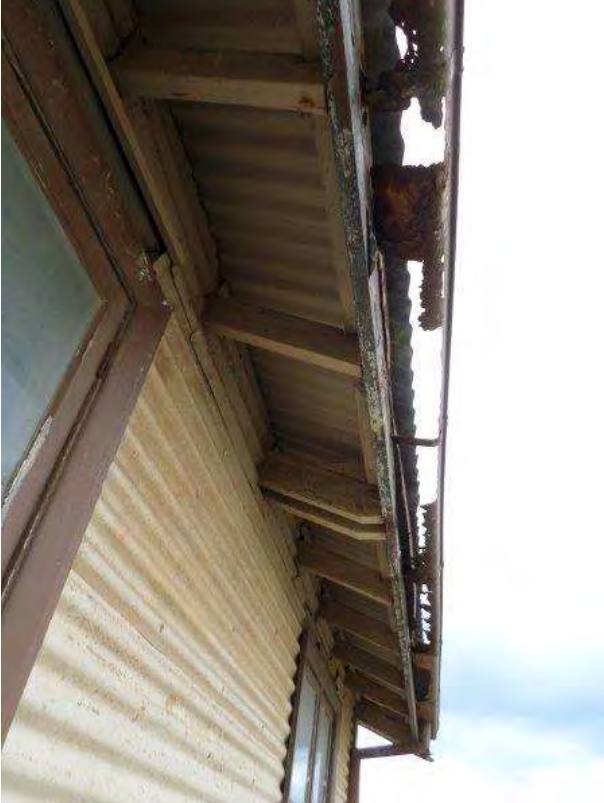
A close-up photograph of a gutter on a building. The gutter is severely corroded, with large sections missing, revealing the underlying metal structure. The surrounding wall is made of corrugated metal.	<p>Severe corrosion of gutter.</p>
6

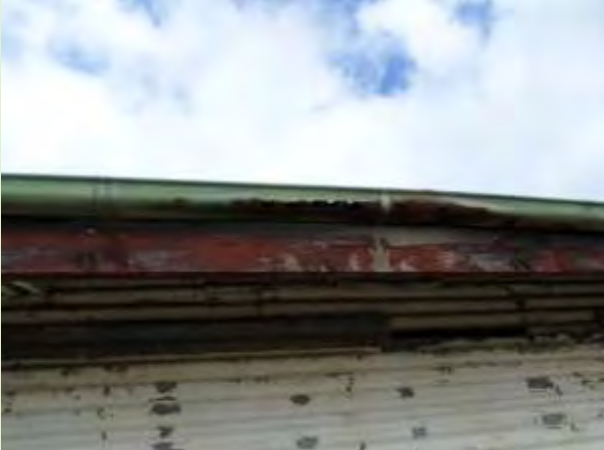
A photograph of a building facade. The gutter is severely corroded and missing. The timber fascia and metal wall cladding show significant surface deterioration and rust. The sky is visible in the background.	<p>Severe corrosion of gutter. Surface deterioration of timber fascia and metal wall cladding.</p>

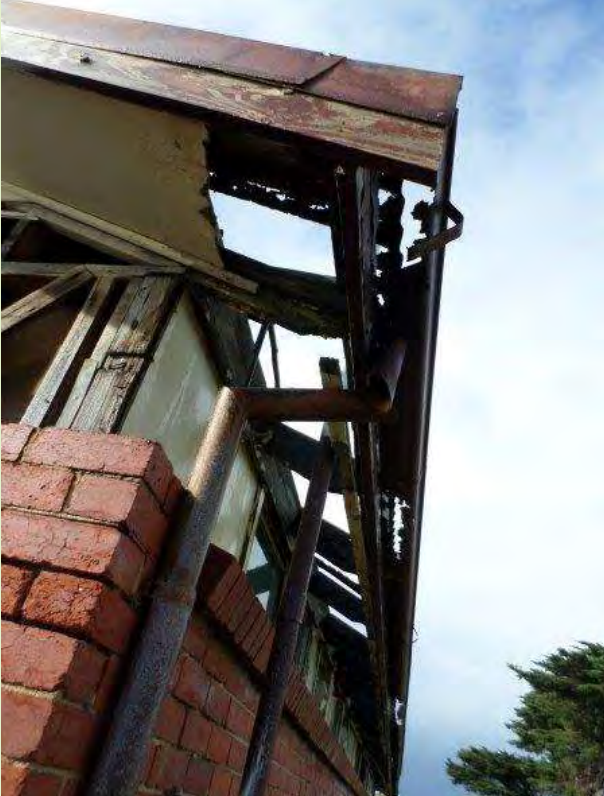
A photograph showing the exterior of a building's roof. The roof is made of metal sheet cladding and has a gutter. The metal cladding is severely corroded, with large holes visible. The gutter is also heavily corroded. The roof is supported by a timber frame. A brick wall is visible on the left side of the image. The sky is blue with some clouds.	<p>Severe corrosion present on the metal roof sheet cladding and holes visible from underneath the roof eaves. Severe corrosion to gutter. Significant corrosion to downpipe.</p>

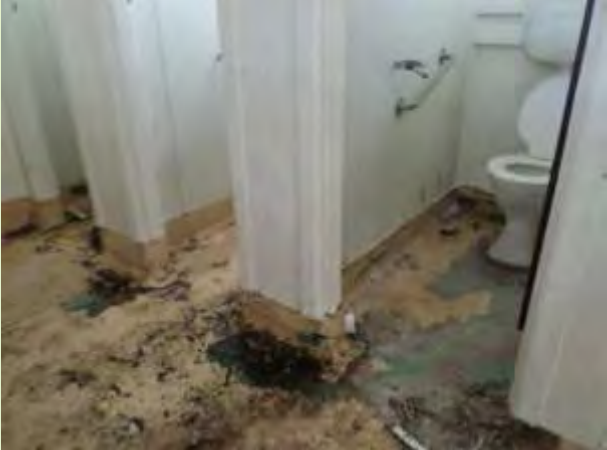
A photograph showing a bathroom floor with significant deterioration and debris accumulation. The floor is covered in a thick layer of brown and black material, likely mold or debris. A white toilet is visible in the background, and a white shower curtain is partially visible on the left. A black vertical pole or pipe is on the right side of the frame.	Significant deterioration to the floor and accumulation of debris.

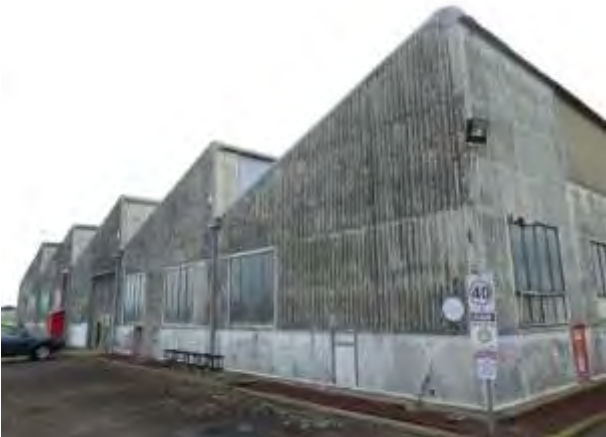
<p>Building 221. Material accumulation and surface deterioration can be seen on external corrugated fibre cement sheet walls.</p>
2

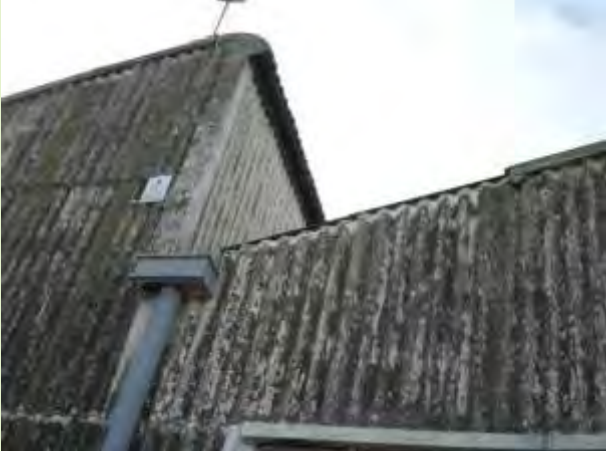
<p>Zoomed in perspective of material accumulation and surface deterioration on external corrugated fibre cement sheet walls.</p>
3

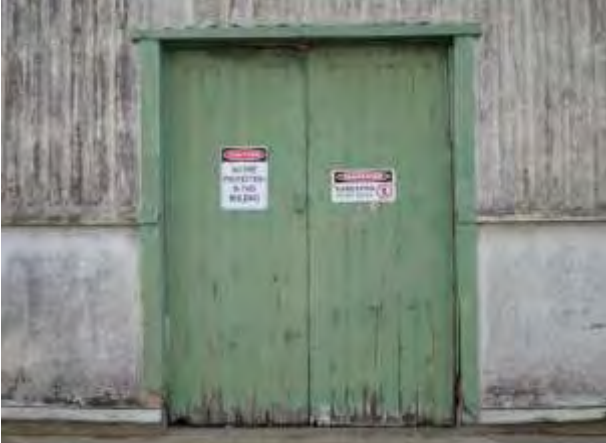
<p>Physical damage and deterioration of door. Asbestos present within the building as per warning on the right door.</p>

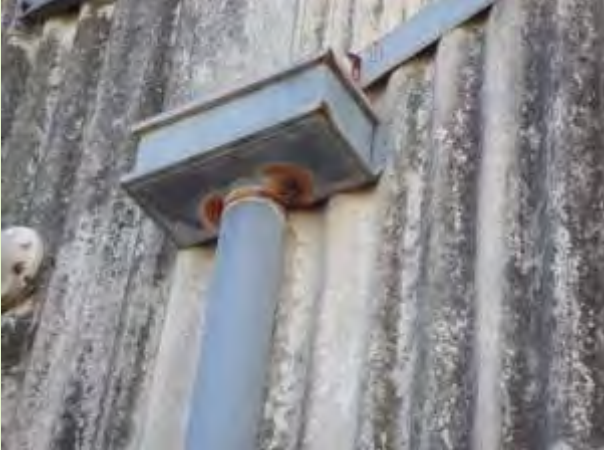
<p>Corrosion to metal downpipe and fixings.</p>
5

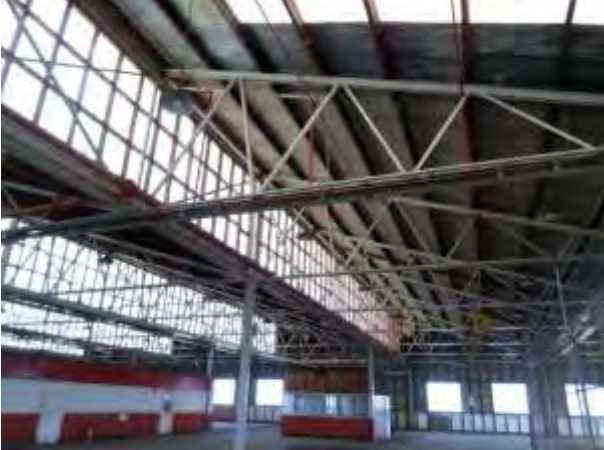
<p>Internal perspective of the roof framing for building 221. Minor corrosion present on the steel trusses and roof framing.</p>
6

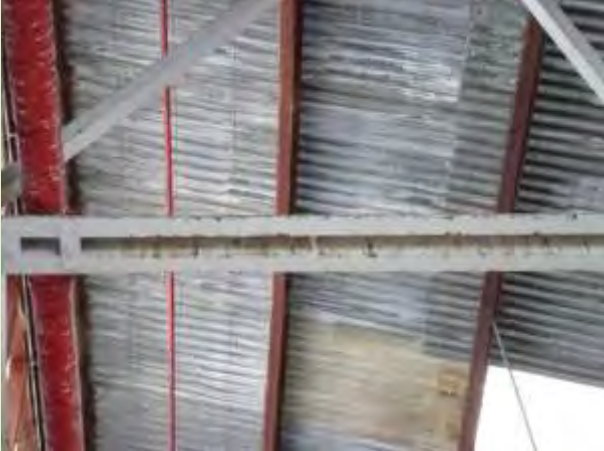
<p>Example of minor corrosion and pitting on steel roof truss.</p>
7

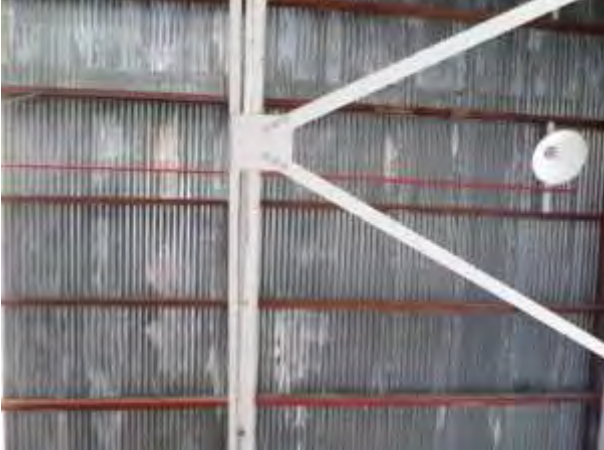
<p>Example of minor corrosion and pitting on steel roof truss and bracing.</p>

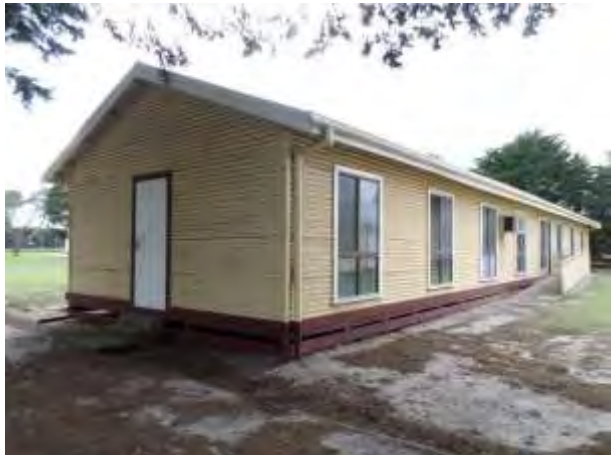
Building 228. External wall cladding minor damage.
2

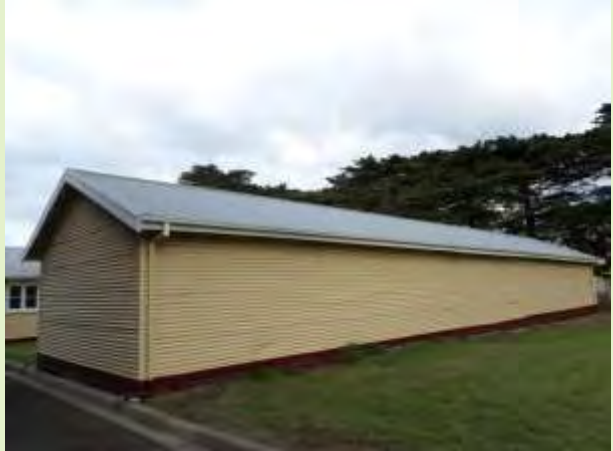
External wall cladding minor damage. This face of the building has had the windows and door removed and metal wall cladding placed over the top.
3

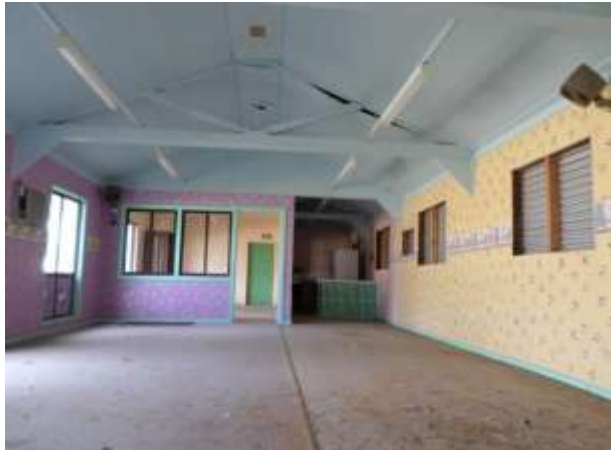
Ceiling panel falling down from its fixings. Wall panels missing where windows once were, leaving the timber frame exposed.

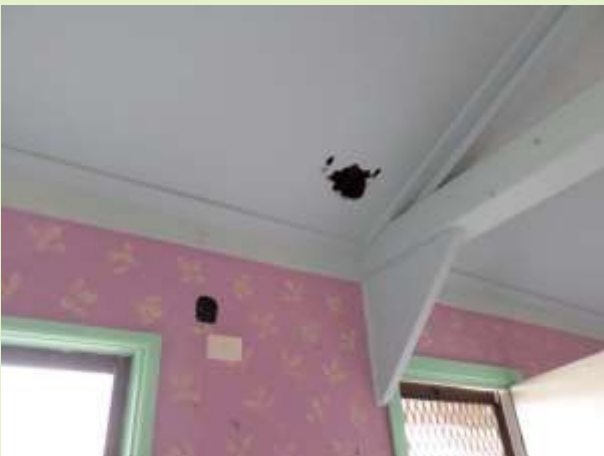
<p>Damage and holes in both walls and ceiling panels.</p>
7	 	<p>Internal timber ceiling fixing has become loose.</p>

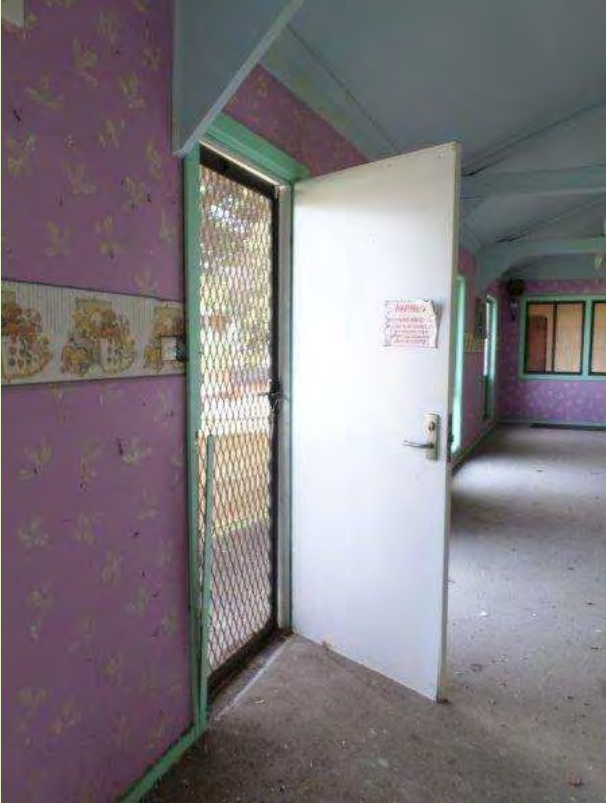
Timber door frame damaged and lifting from support.
9

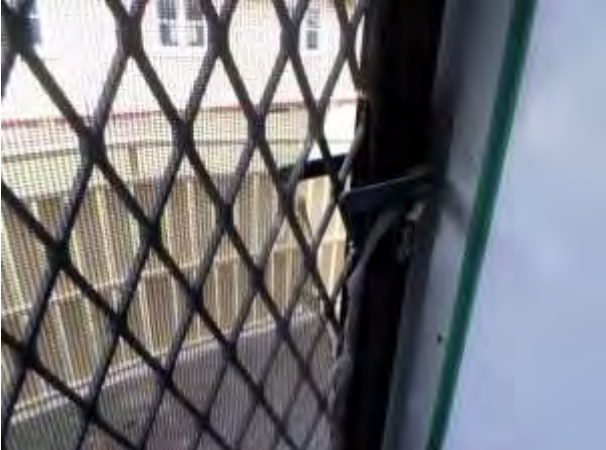
Metal security/fly screen damaged and to be replaced.

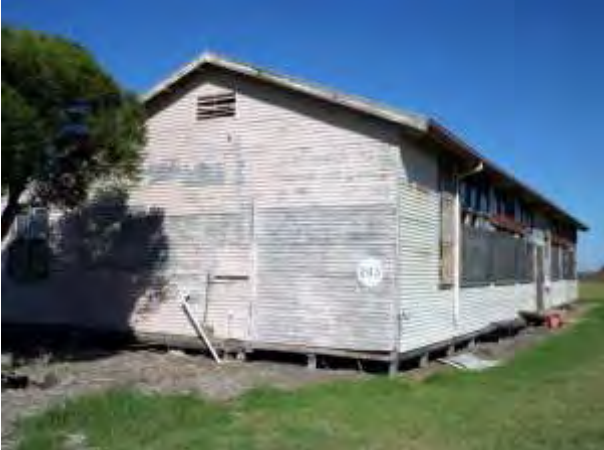
<p>Building 243. Metal wall cladding has physical damage and surface deterioration. Fascia has surface deterioration.</p>
2

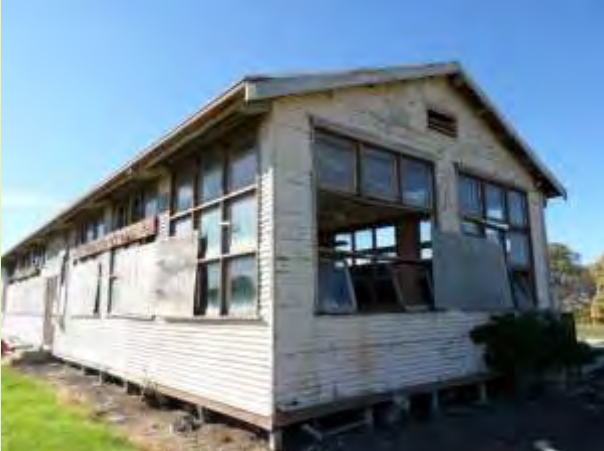
<p>Metal wall cladding has physical damage and surface deterioration. Fascia has surface deterioration. Window frames and glass are damaged and broken. Timber bearer and stub columns shows signs of physical damage and deterioration.</p>

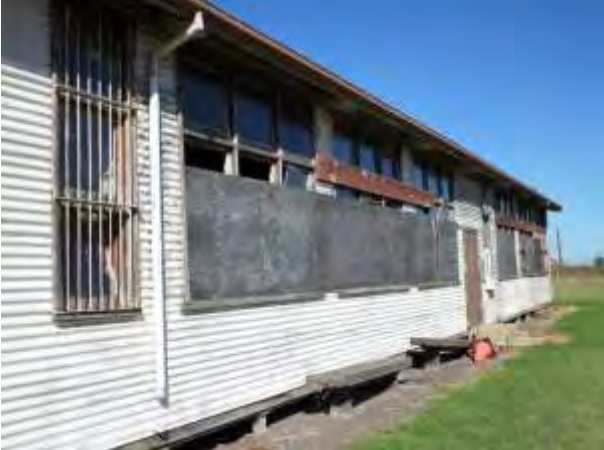
<p>Metal wall cladding has surface deterioration. Window frames and glass are damaged and broken. Downpipe is damaged and missing bottom section. Gutter shows signs of damage and potential corrosion. Timber bearer has signs of physical deterioration.</p>

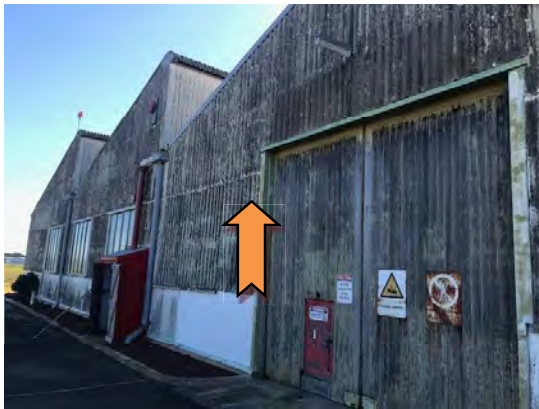
Photo 1. Asbestos-containing corrugated cement to walls.

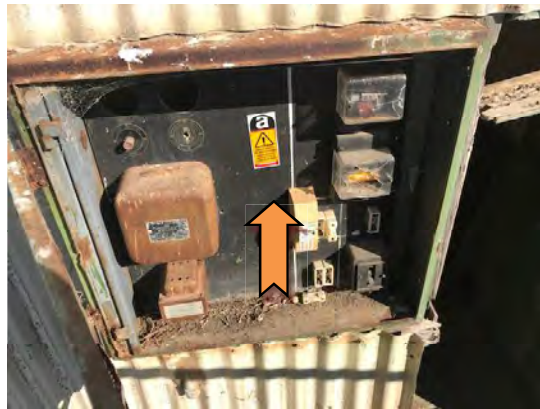
Photo 2. Asbestos-containing bituminous electrical board.

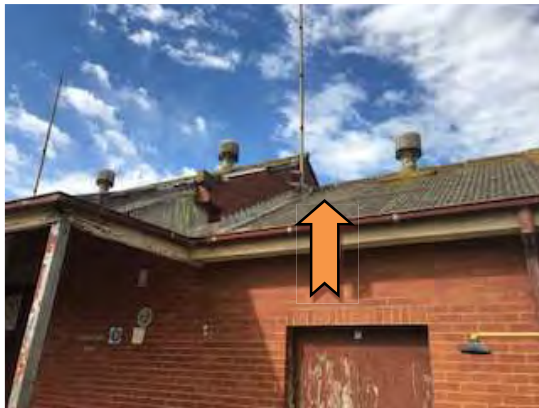
Photo 3. Asbestos-containing corrugated cement roof sheeting.

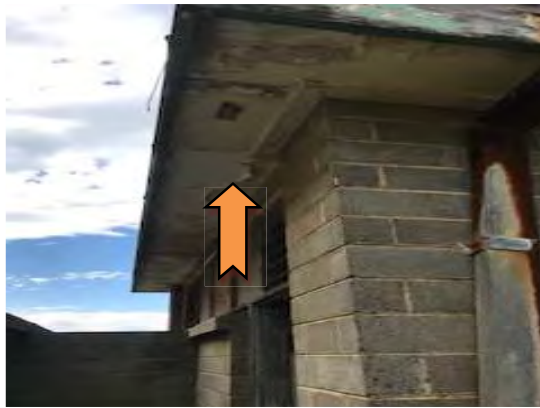
Photo 4. Asbestos-containing fibre cement sheet eaves.

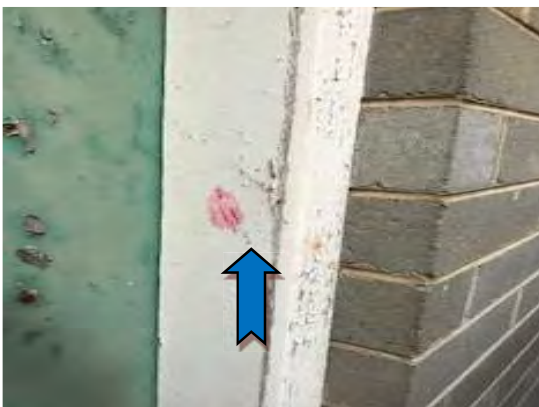
Photo 5. Lead-containing paints throughout the Site.

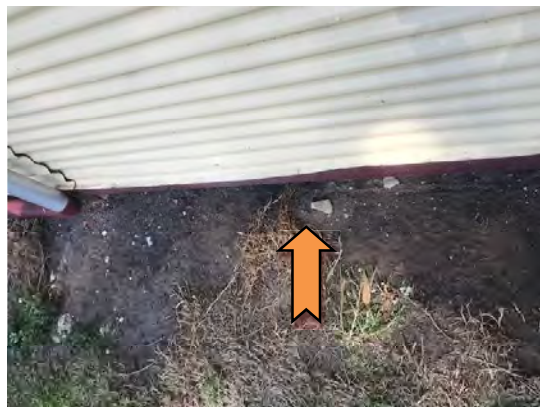
Photo 6. Asbestos containing fibre cement sheet debris to the external surface areas.
