PRELIMINARY DOCUMENTATION REPORT

Demolition of Structures at RAAF Williams – Point Cook, Victoria

(EPBC 2019/8514)

November 2023

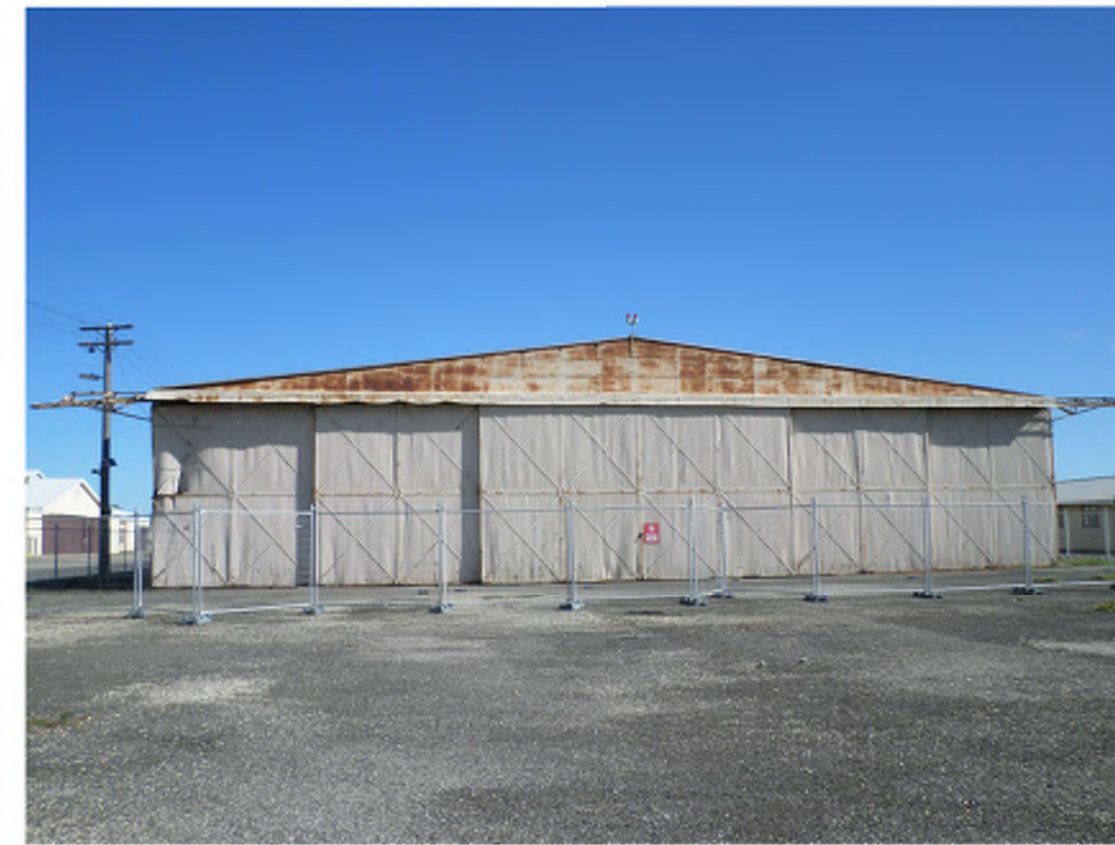
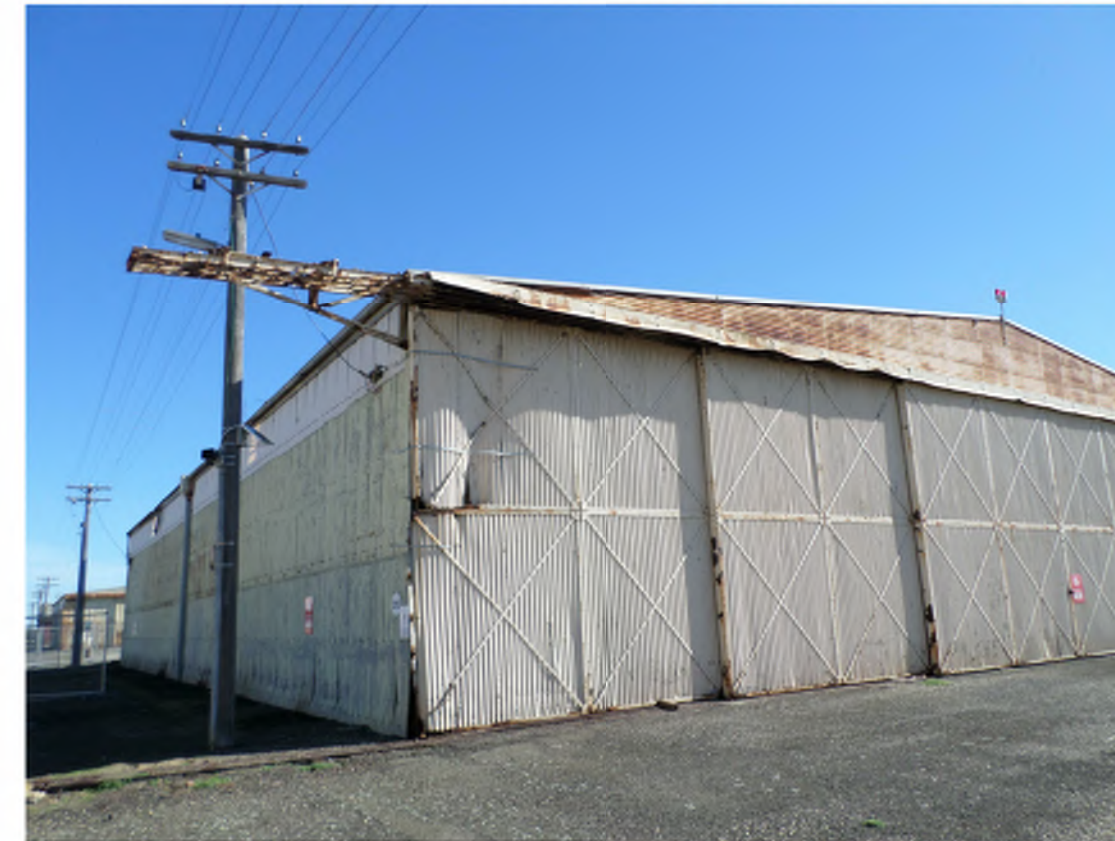
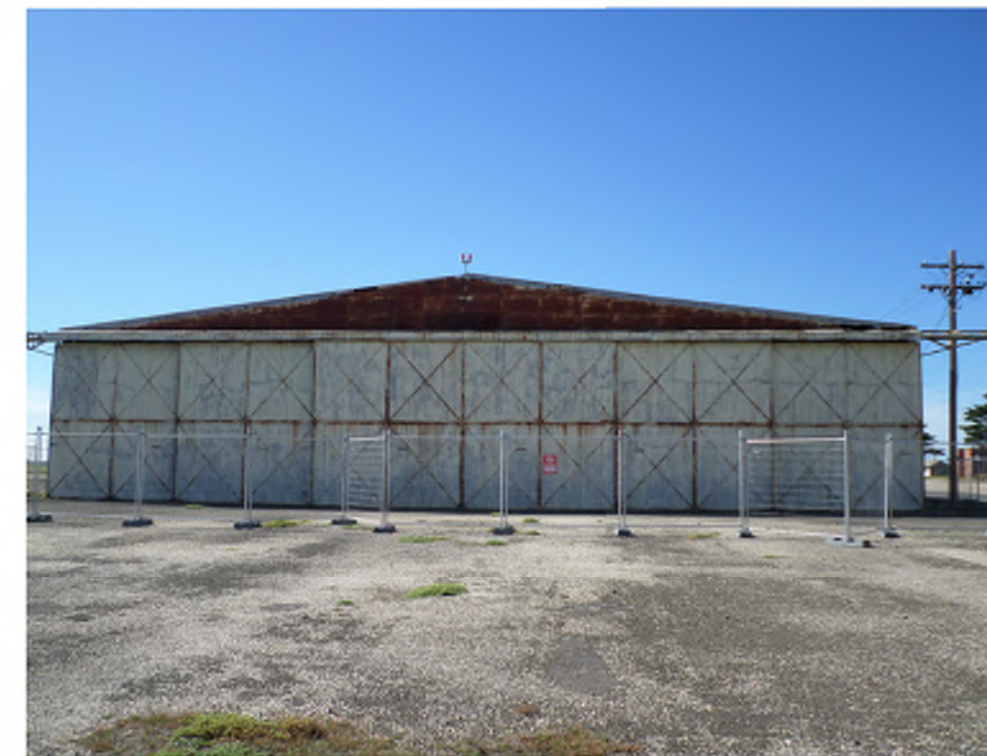
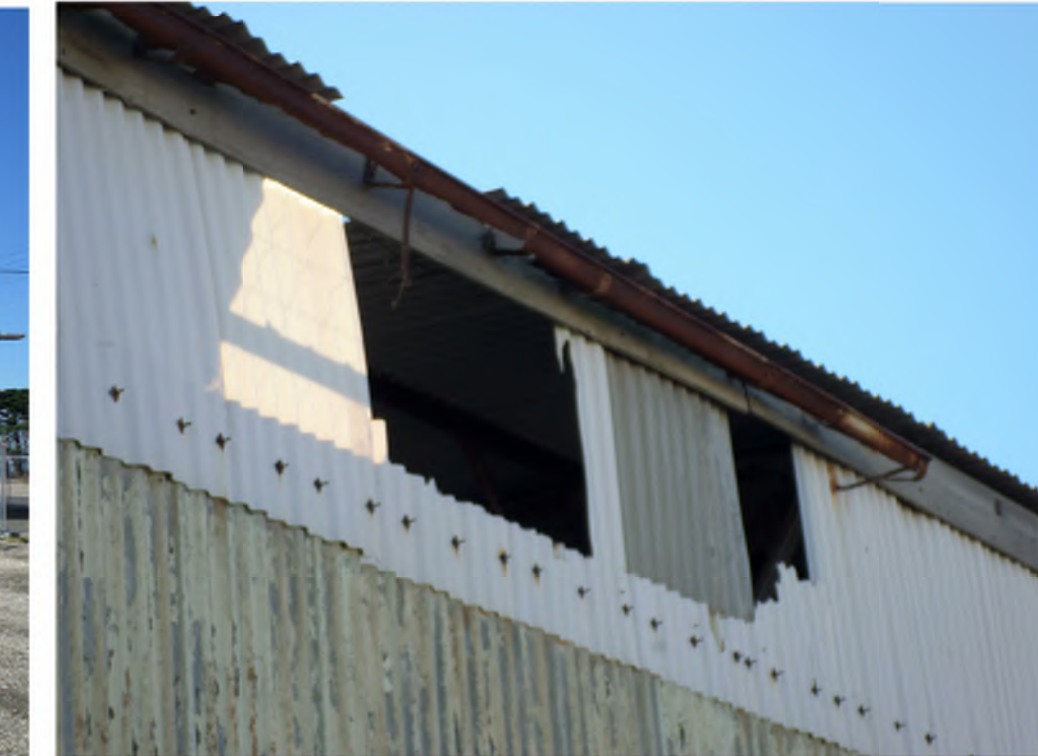
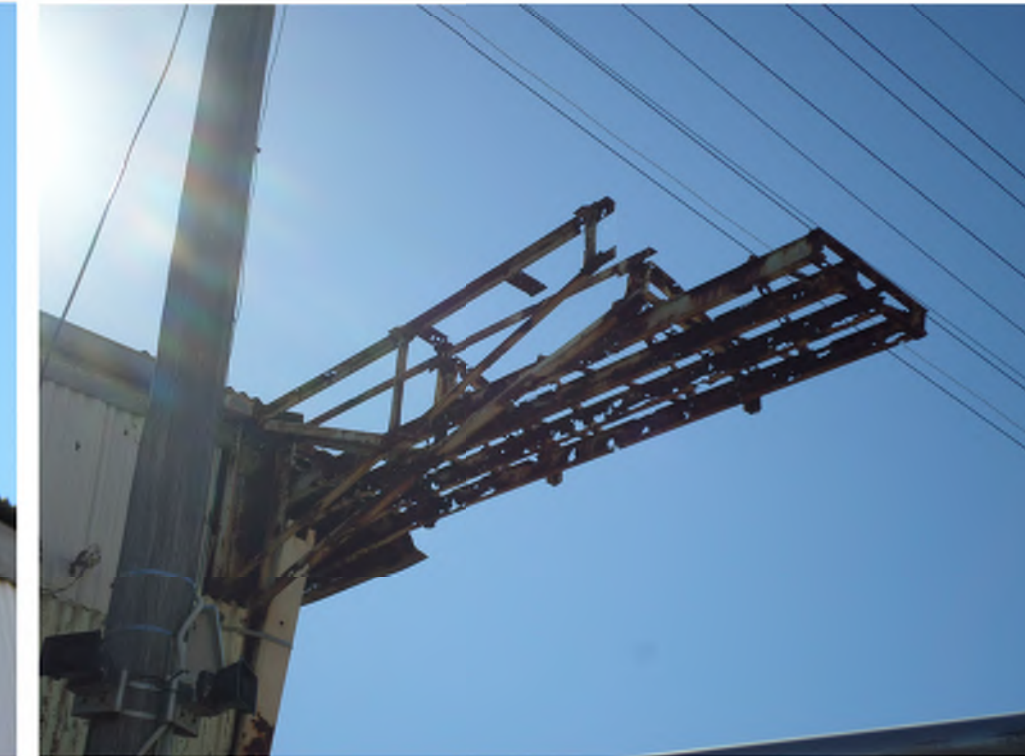
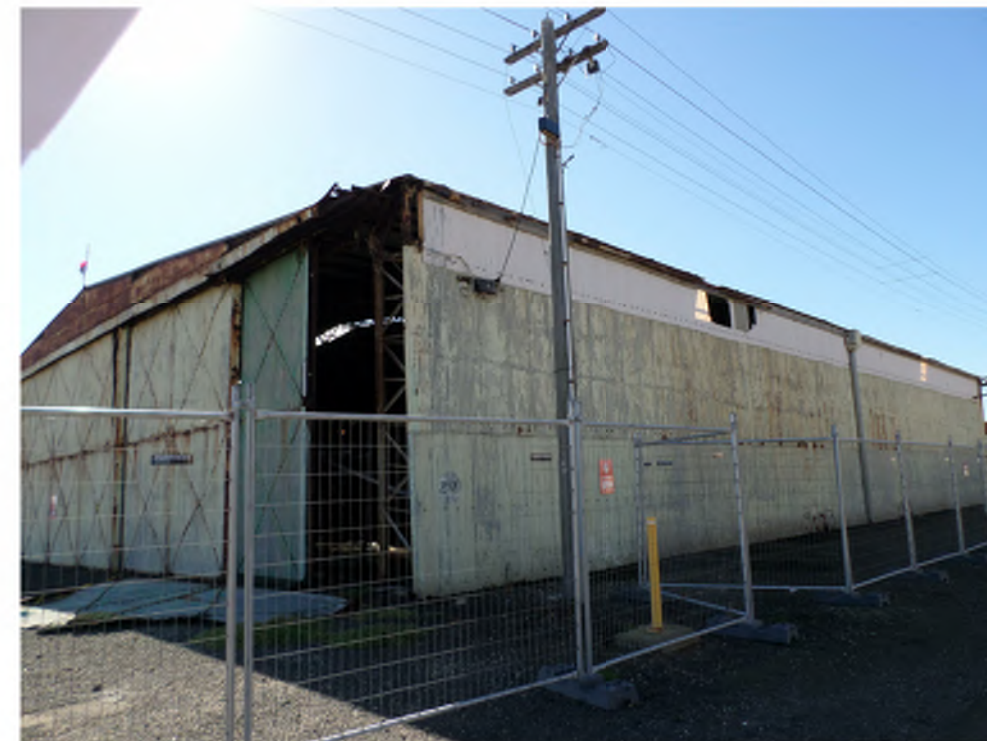
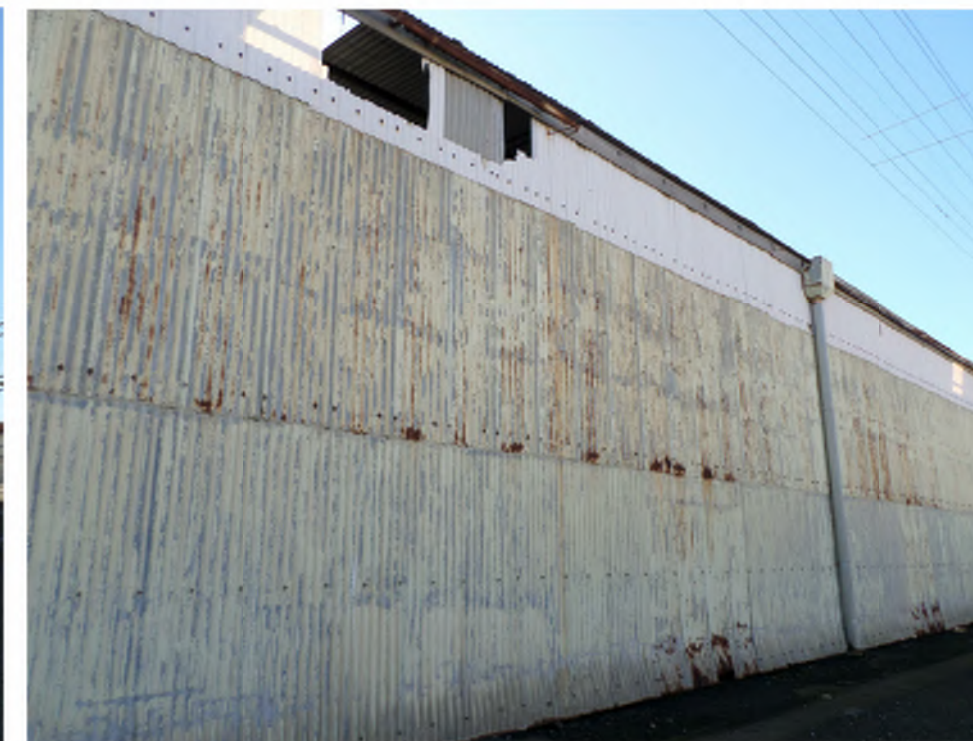
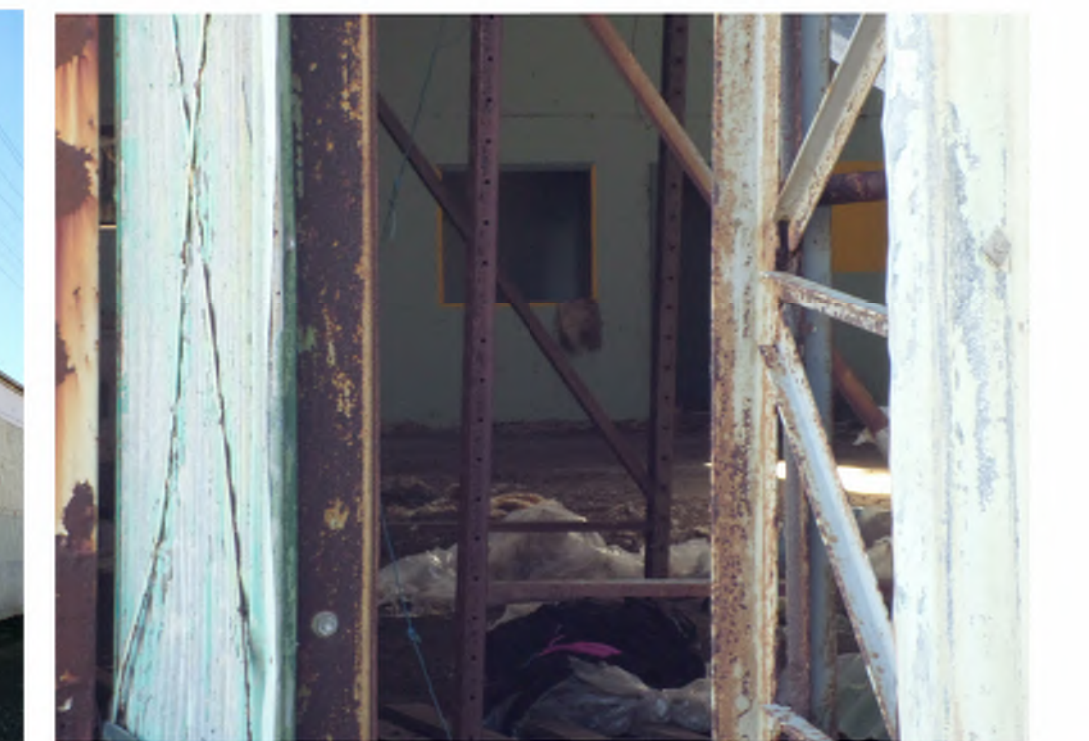
IMAGES OF TYPICAL DETERIORATION

- EXTERNAL METAL WALL CLADDING SHOWS SIGNIFICANT SIGNS OF CORROSION AND DAMAGE WITH SOME PANELS MISSING AND OPEN TO THE ELEMENTS. THIS HAS LED TO FURTHER DETERIORATION TO THE BUILDING INTERNALLY. CORNER WALL FLASHINGS, OVERHEAD DOOR FLASHING ARE MISSING OR BADLY CORRODED
- THE EXTERNAL LARGE SLIDING DOORS TO THE HANGAR, INCLUDING TRACKS, ANCHOR POINTS, OUTRIGGERS ARE BADLY DAMAGED AND MISSING STEEL SECTIONS AND ARE UNABLE TO OPERATE.

- EXISTING FLAT METAL ROOFING IS DAMAGED, RUSTING AND DUE TO THE FAILING OF THE STEEL ROOF TRUSSES HAS COLLAPSED. EXISTING LARGE FASCIA GUTTERS, RAINWATER HEADS, DOWNPIPES ARE IN VARIOUS STATE OF DAMAGE. DUE TO THE DAMAGE AND FAILING OF THE BUILDING STRUCTURE THE STRUCTURAL INTEGRITY OF THE BUILDING SHOULD BE FURTHER PROOF THAT THE BUILDING SHOULD BE DEMOLISHED.

- THE CONTRACTORS SHOULD CONFER WITH ASBESTOS REGISTER FOR THIS BUILDING. TO ENSURE THAT ANY ASBESTOS PRESENT IS DISPOSED OF IN CORRECT MANNER AND IN COMPLIANCE WITH REGULATIONS.

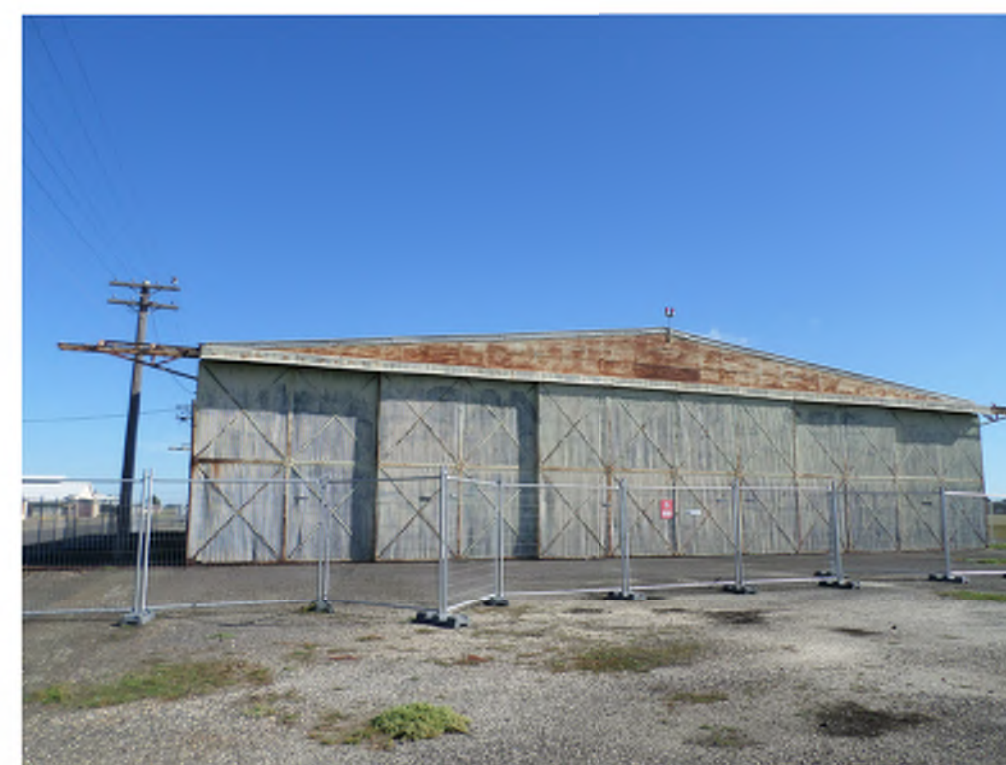
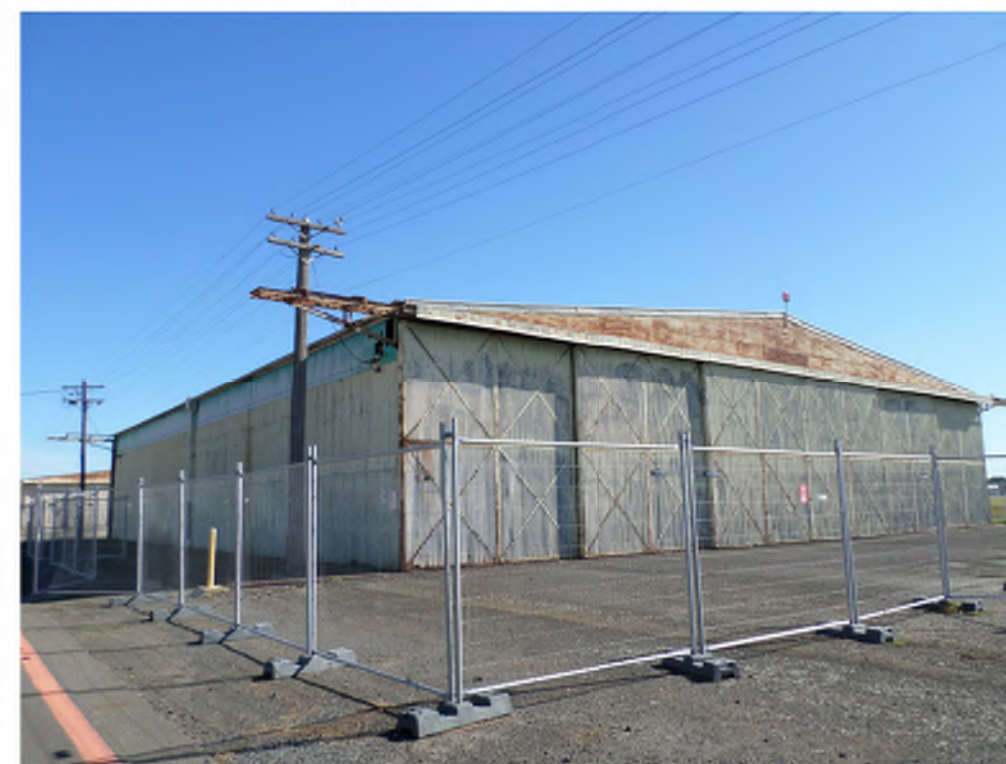
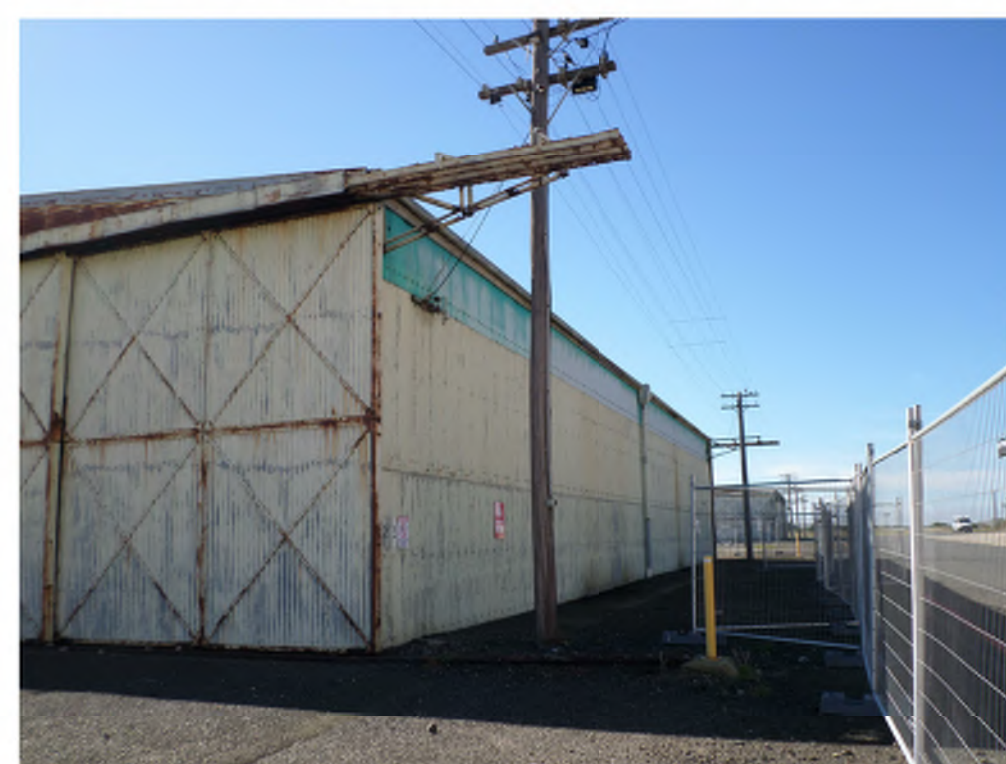
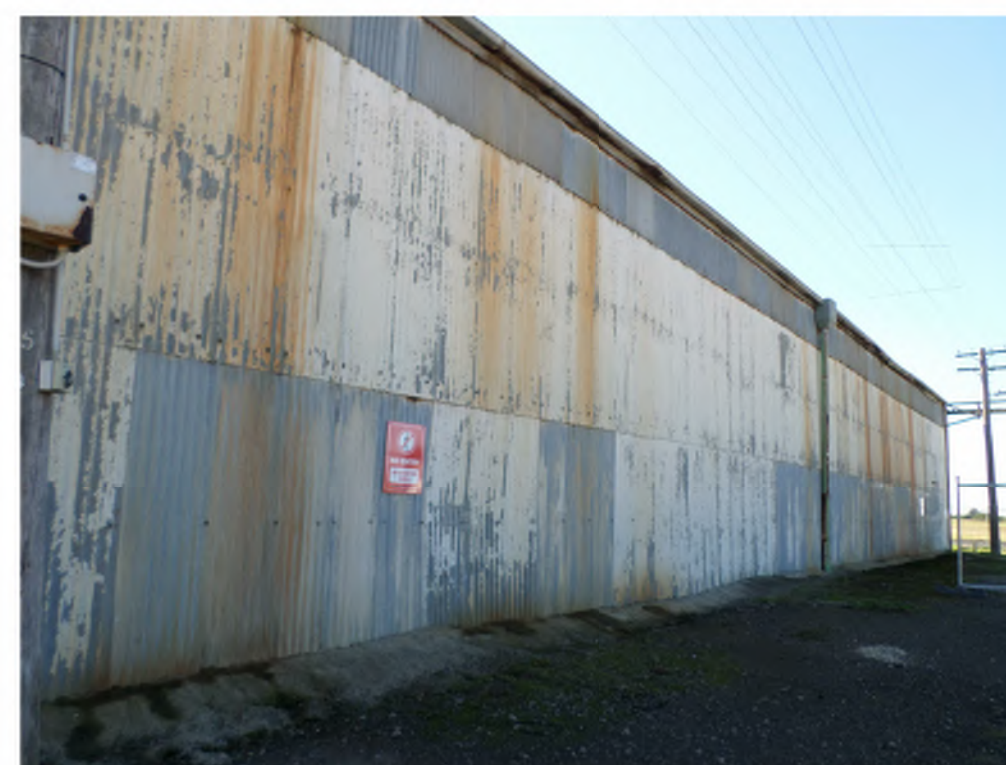
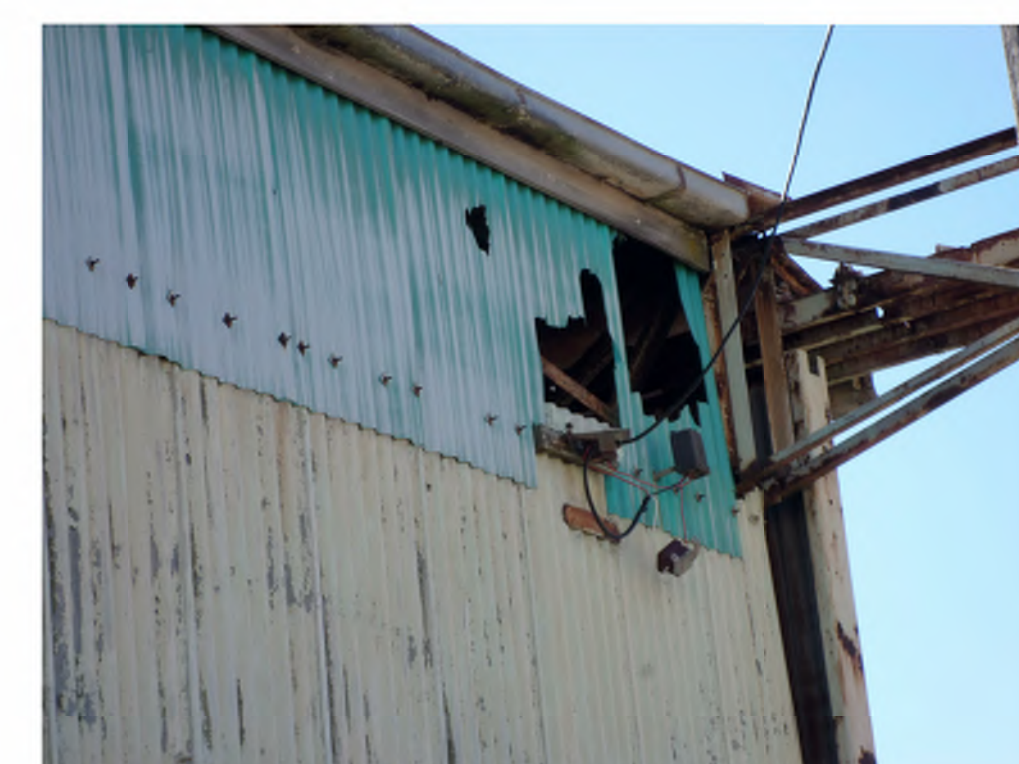
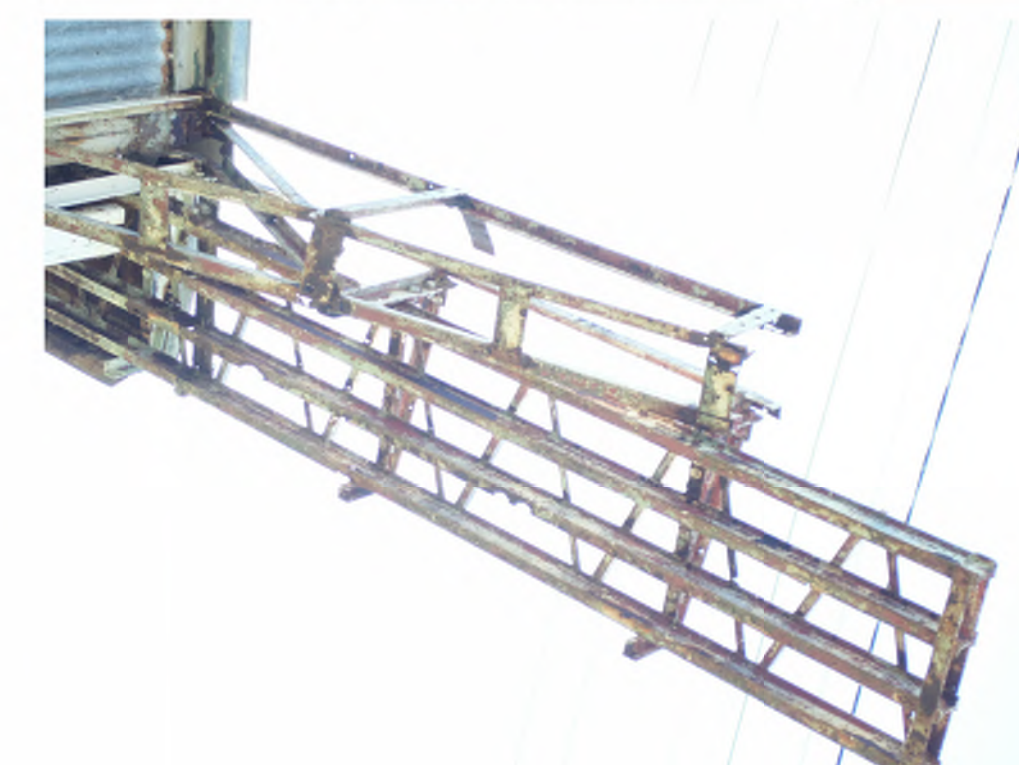
IMAGES OF TYPICAL DETERIORATION

- EXTERNAL METAL WALL CLADDING SHOWS SIGNIFICANT SIGNS OF CORROSION AND DAMAGE WITH SOME PANELS MISSING AND OPEN TO THE ELEMENTS. THIS HAS LED TO FURTHER DETERIORATION TO THE BUILDING INTERNALLY. CORNER WALL FLASHINGS, OVERHEAD DOOR FLASHING ARE MISSING OR BADLY CORRODED
- THE EXTERNAL LARGE SLIDING DOORS TO THE HANGAR, INCLUDING TRACKS, ANCHOR POINTS, OUTRIGGERS ARE BADLY DAMAGED AND MISSING STEEL SECTIONS AND ARE UNABLE TO OPERATE.

- EXISTING FLAT METAL ROOFING IS DAMAGED, RUSTING AND DUE TO THE FAILING OF THE STEEL ROOF TRUSSES HAS COLLAPSED. EXISTING LARGE FASCIA GUTTERS, RAINWATER HEADS, DOWNPIPES ARE IN VARIOUS STATE OF DAMAGE. DUE TO THE DAMAGE AND FAILING OF THE BUILDING STRUCTURE THE STRUCTURAL INTEGRITY OF THE BUILDING SHOULD BE FURTHER PROOF THAT THE BUILDING SHOULD BE DEMOLISHED.

THE CONTRACTORS SHOULD CONFER WITH ASBESTOS REGISTER FOR THIS BUILDING, TO ENSURE THAT ANY ASBESTOS PRESENT IS DISPOSED OF IN CORRECT MANNER AND IN COMPLIANCE WITH REGULATIONS.

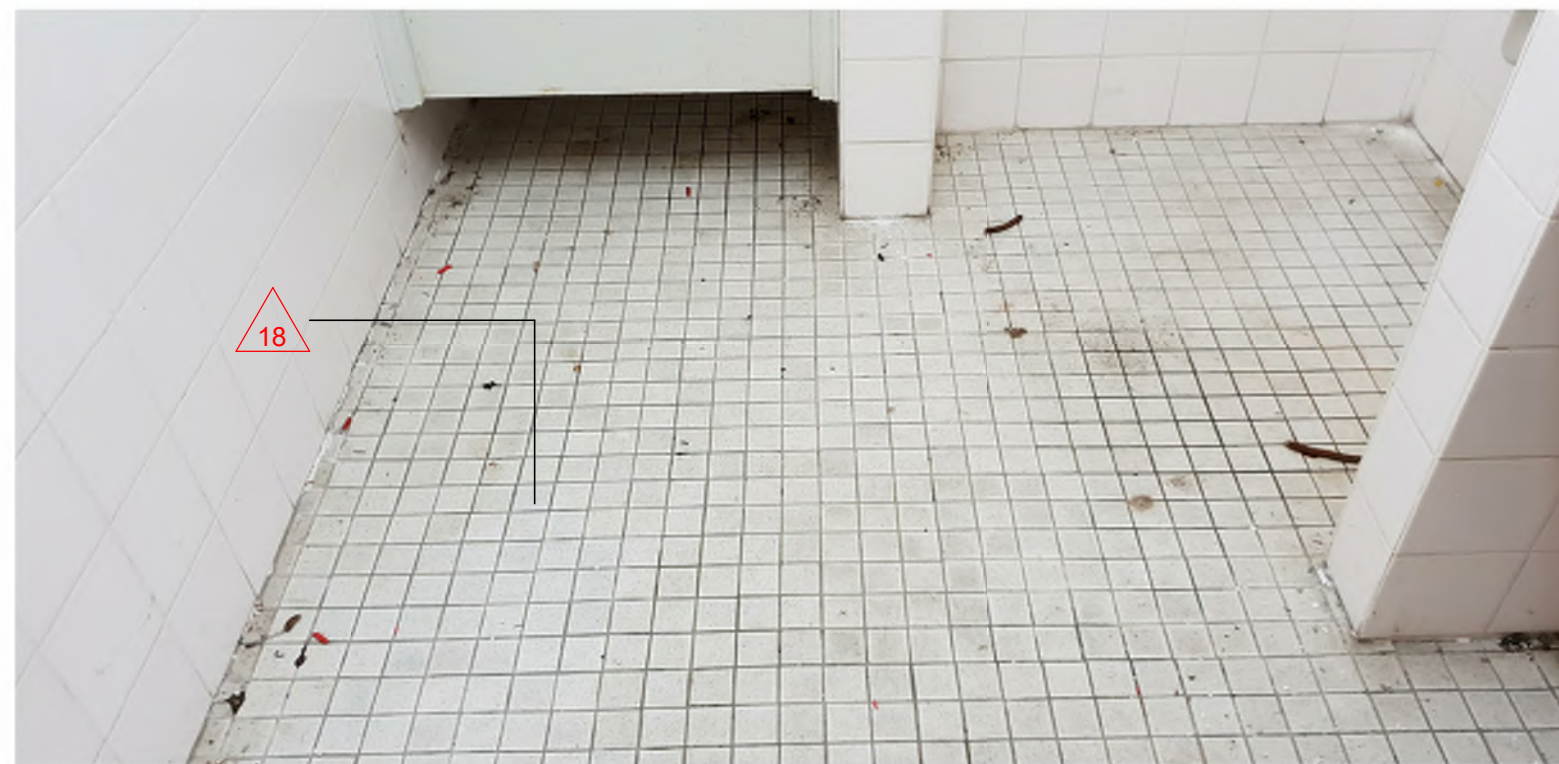
DAMAGED CERAMIC FLOOR AND WALL TILES

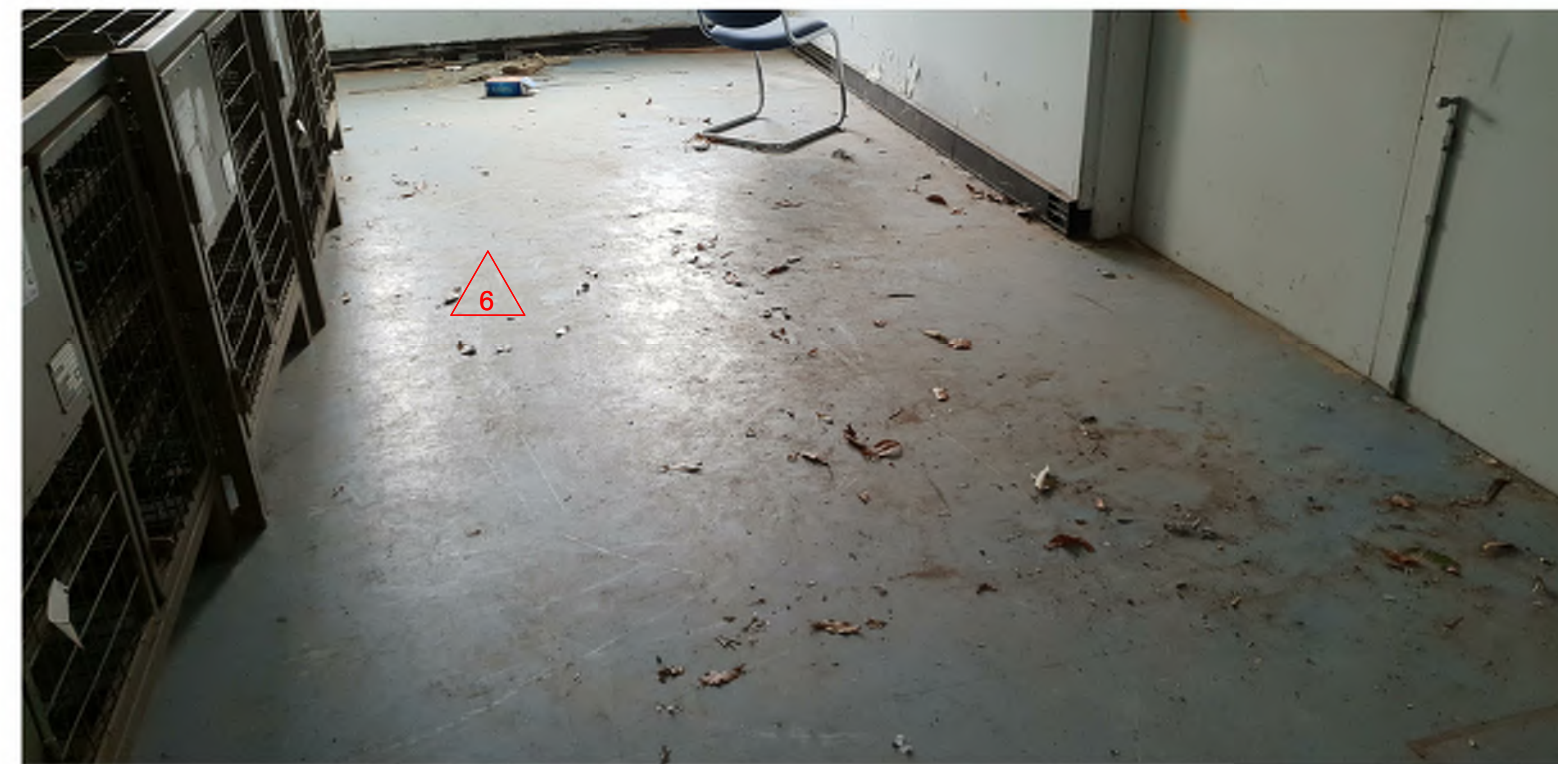
DAMAGED VINYL FLOOR SHEETING

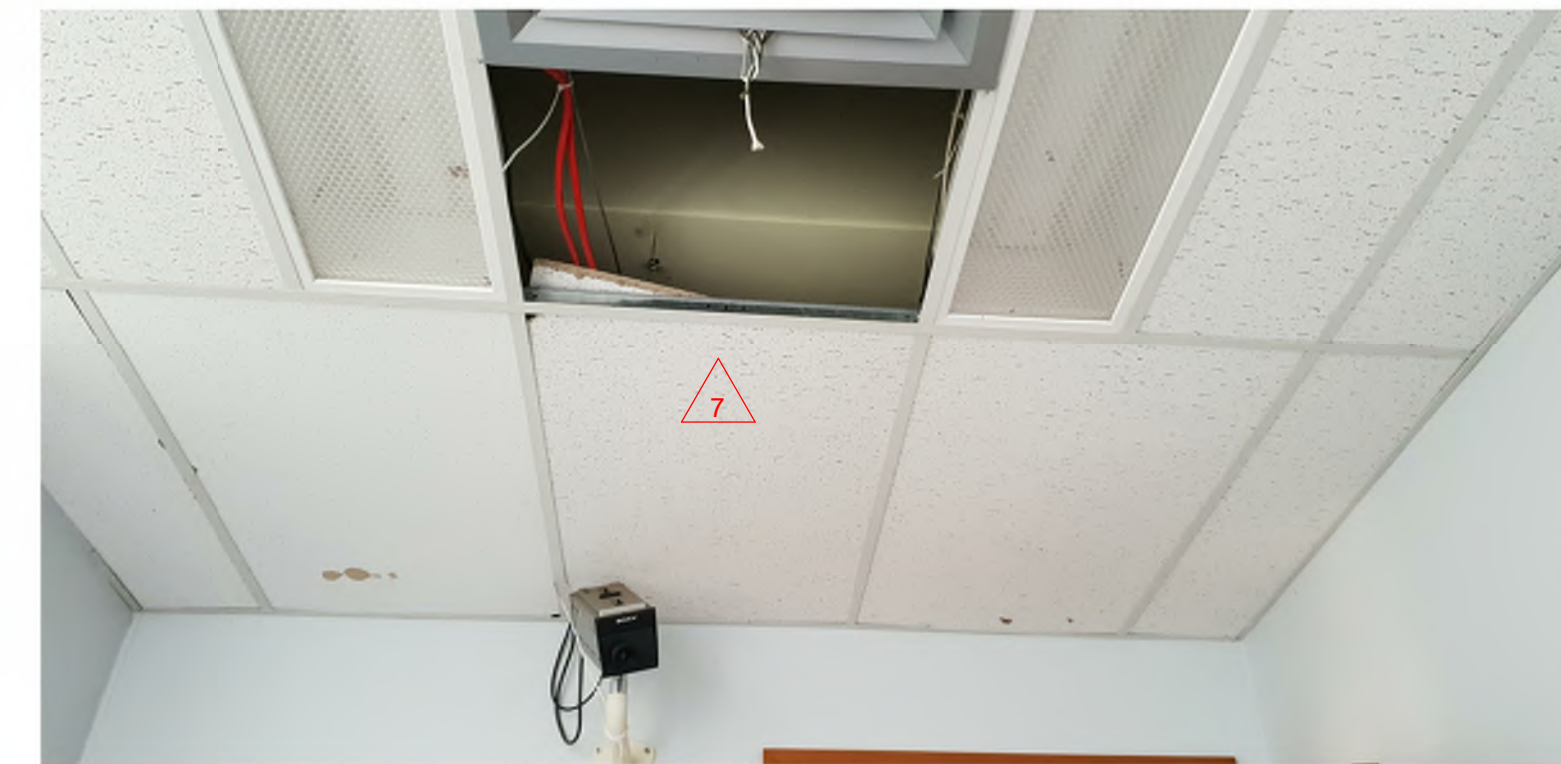
MISSING AND DAMAGED CEILING TILES

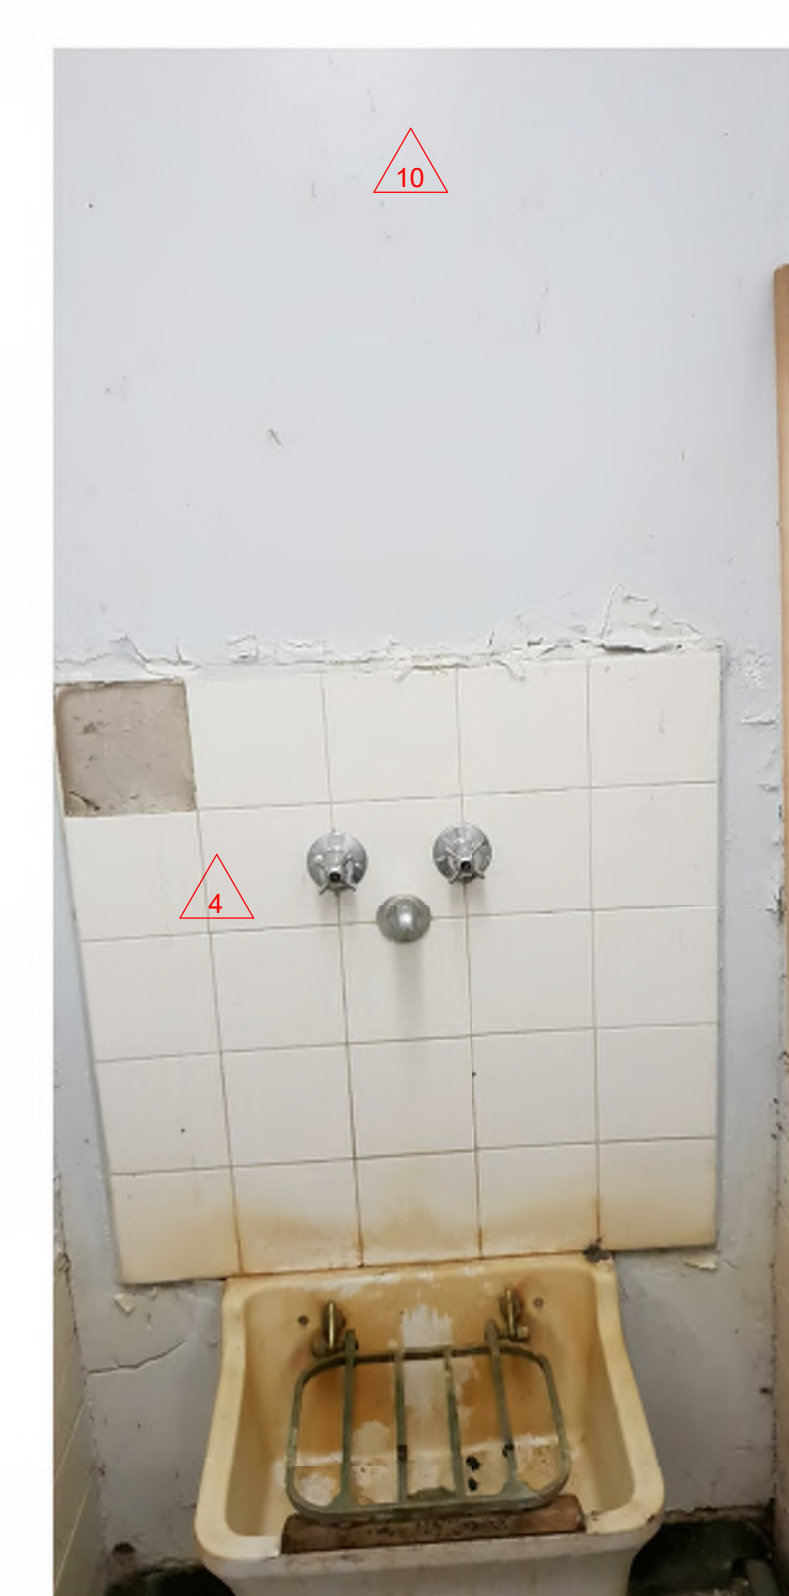
CLEANERS TROUGH DAMAGE

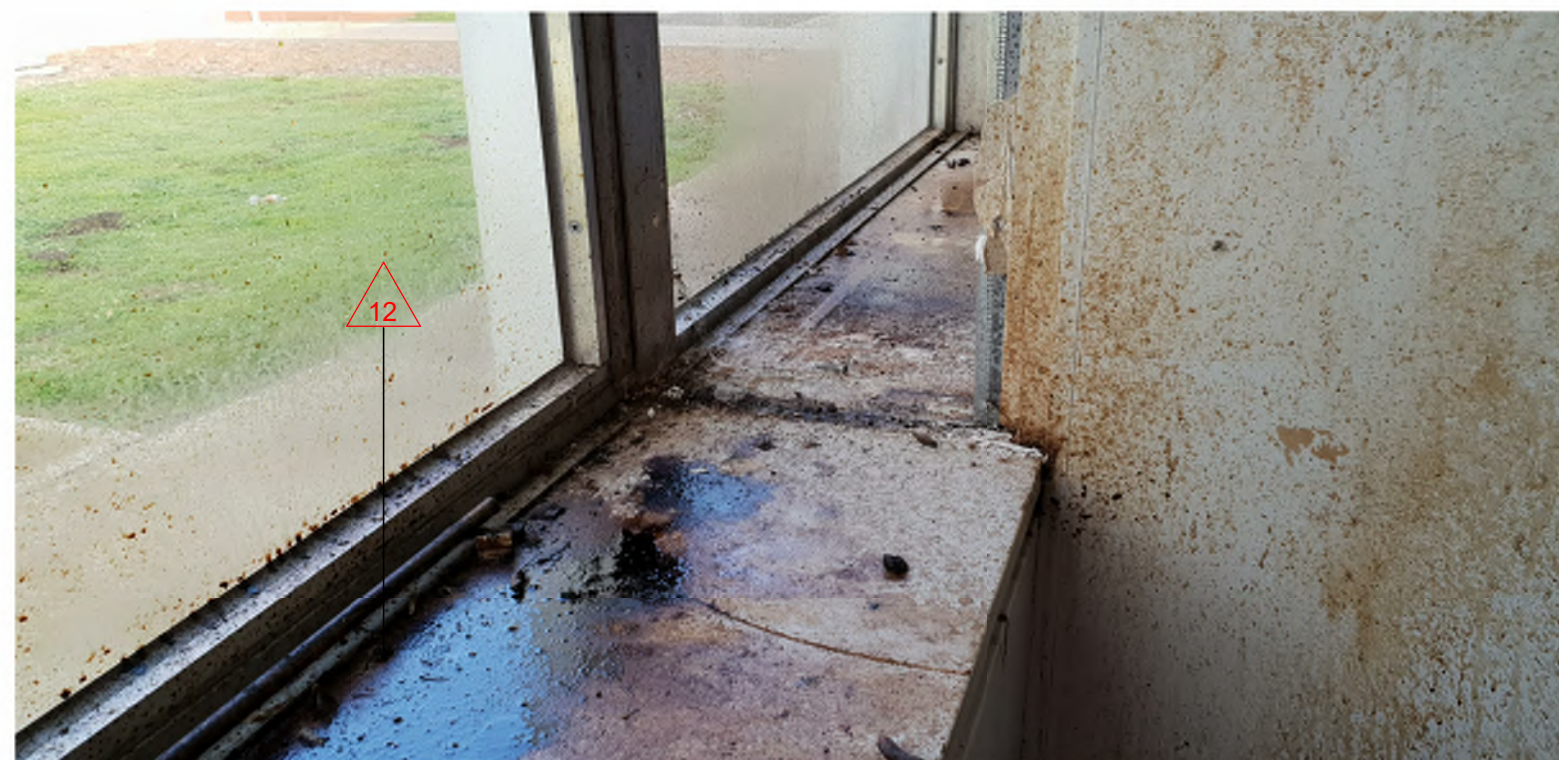
DAMAGED TO WINDOW SILLS / WINDOW AND WALLS

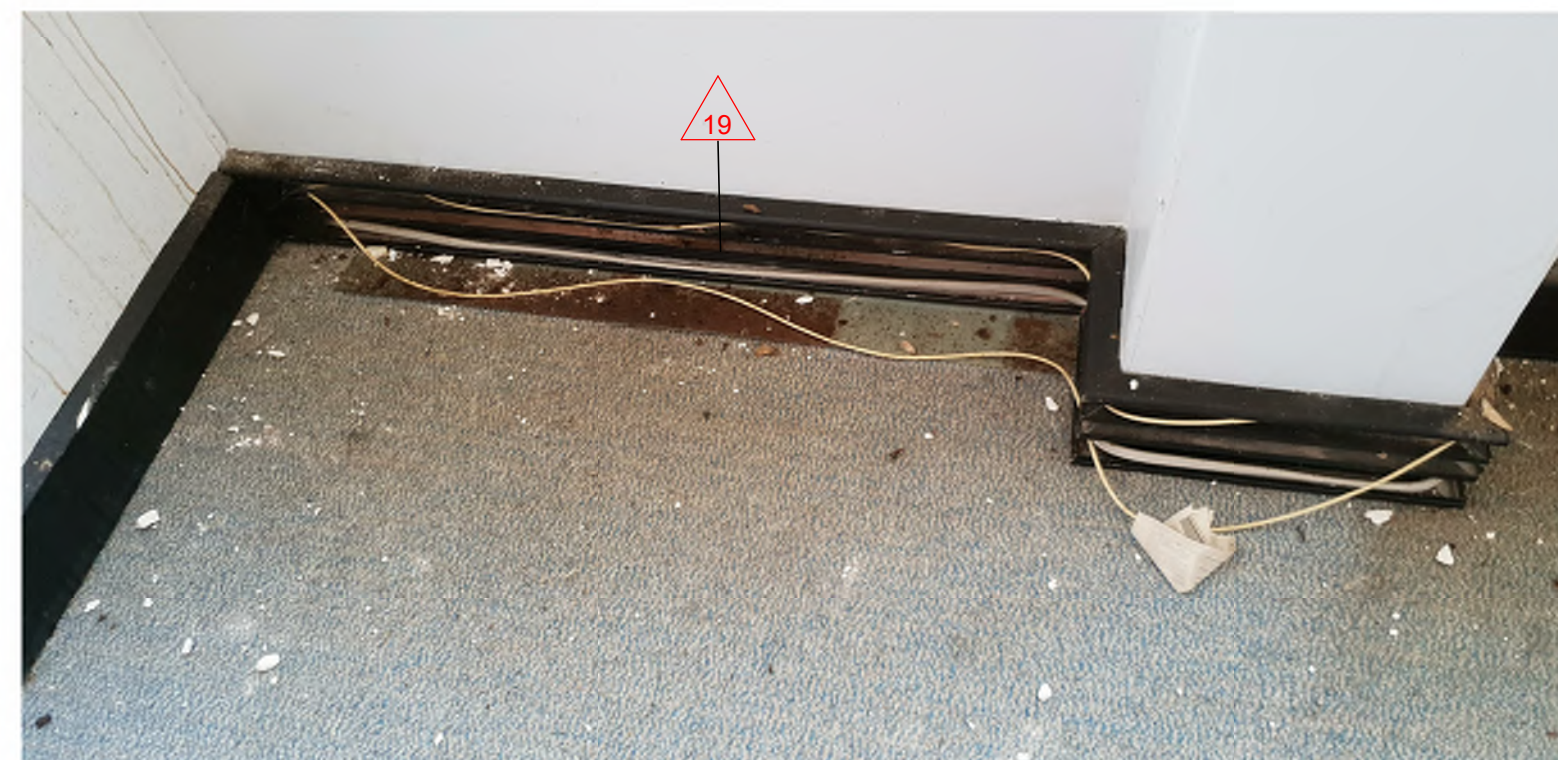
DAMAGE TO CARPETS AND SKIRTING DUCT

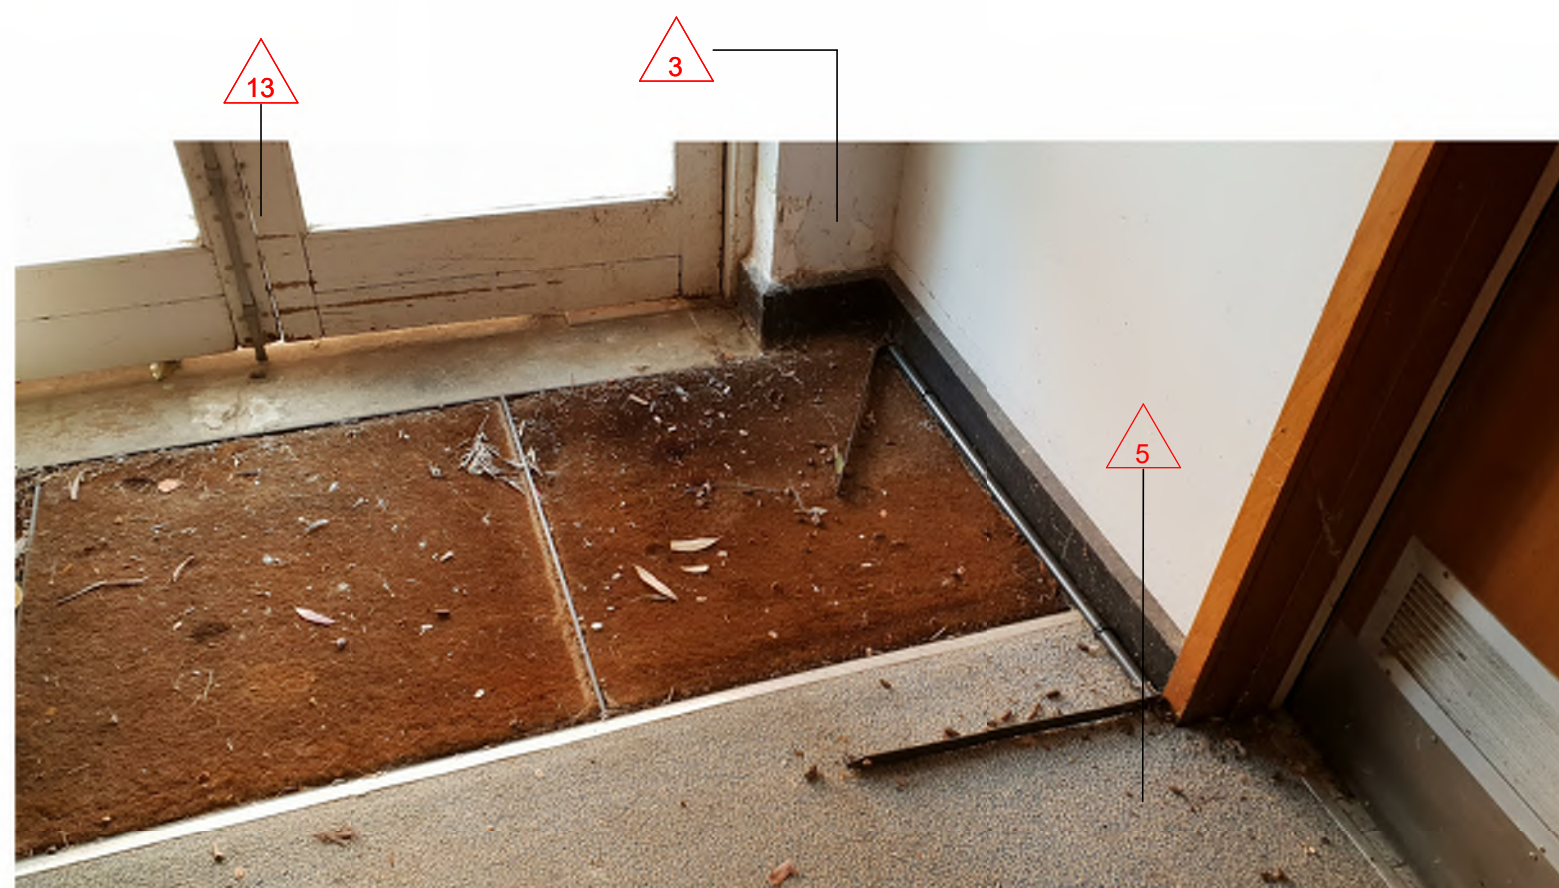
DAMAGE TO SKIRTING DUCT AND VINYL SHEETING

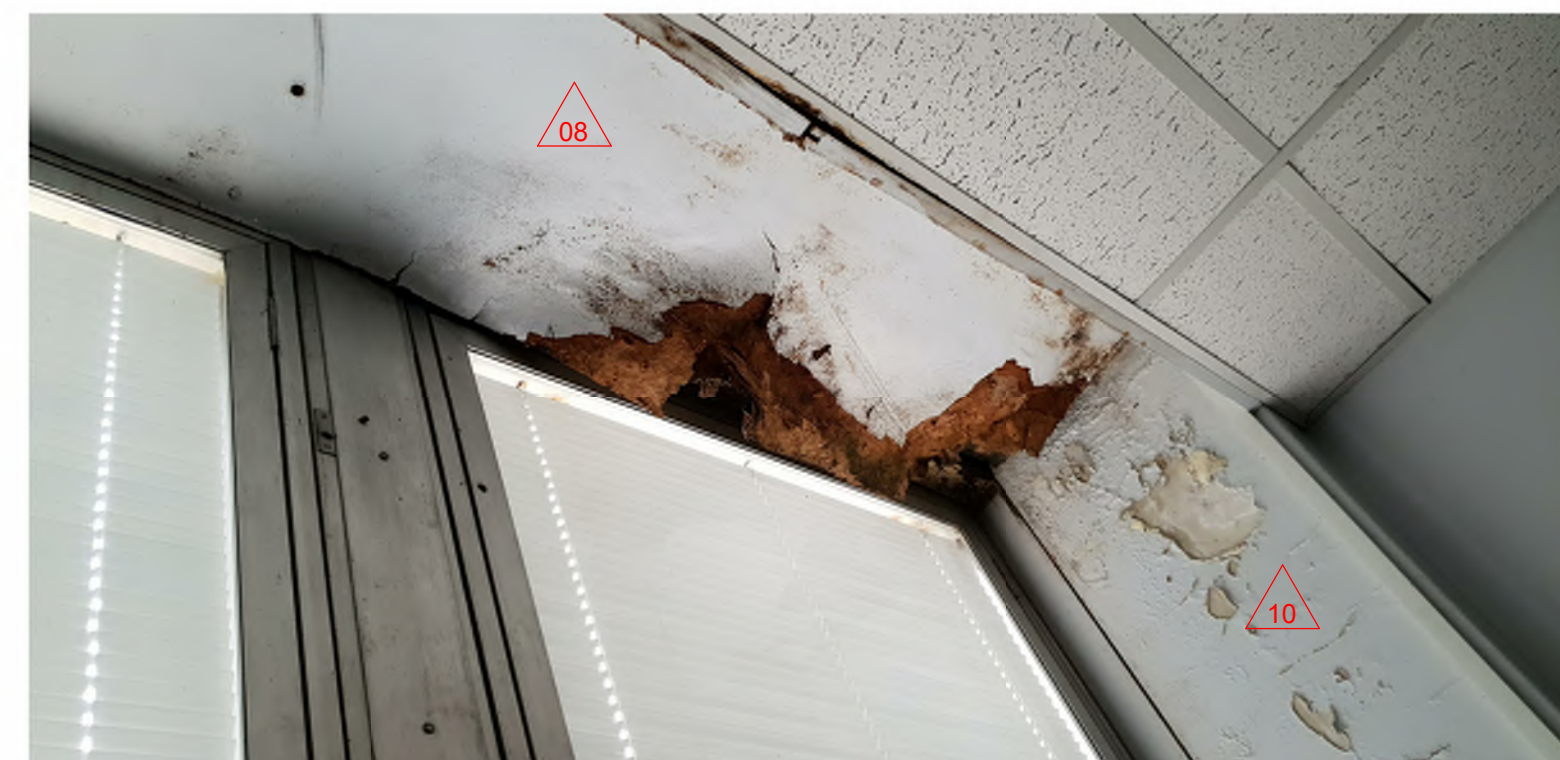
WATER DAMAGE OVER WINDOWS

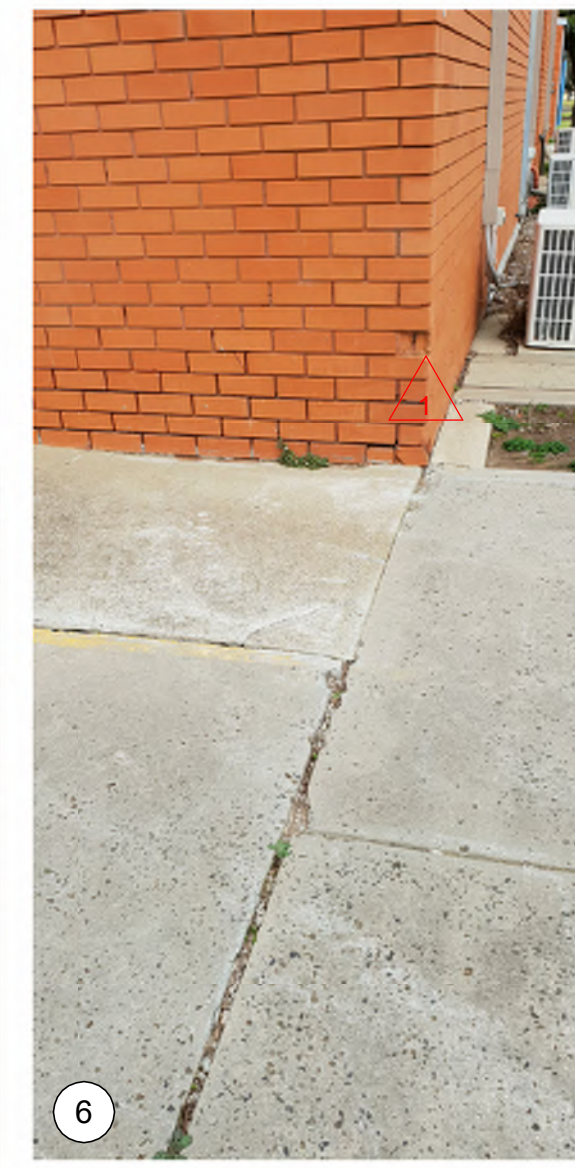
EXTERNAL BRICK WALLS ARE GENERALLY IN GOOD CONDITION. THE BUILDING IS A MIXTURE OF BRICK VENEER WITH CURTAIN WALL WINDOWS. THEY BRICKWORK WILL REQUIRE SOME CLEANING AND SOME MINOR MORTAR REPAIRS TO STEPPED CRACKING. THE ALUMINIUM CURTAIN WINDOW WALL IS GENERALLY SOUND, WITH SOME AREAS REQUIRING REPLACEMENT OF DAMAGED AND RUSTING FLASHINGS BOTH TO THE TOP PARAPET WALL AND TO THE BOTTOM SILL. THESE SHOULD BE REPLACED.

SCOPE 1. CRACKED MASONRY IN EXTERNAL WALL

- EXTERNAL STEPPED CRACKING IN BRICKWORK MORTAR IS TO BE REPAIRED
- DAMAGED FLASHING TO PARAPET WALL/ROOF IS TO BE REPLACED
- INTERNAL WALLS ARE TO BE PATCHED AND PAINTED

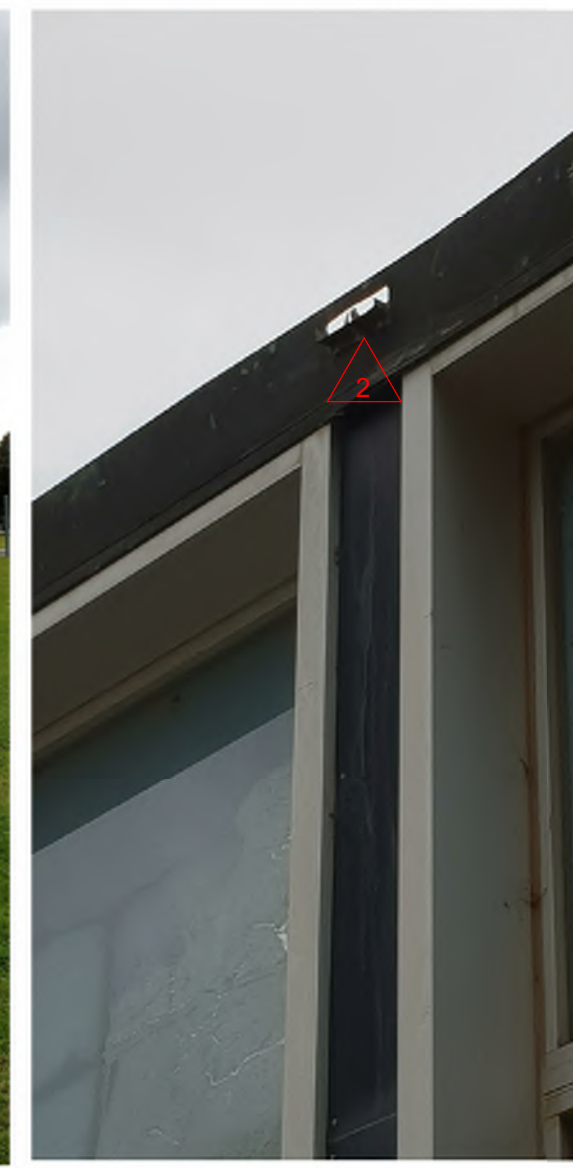
SCOPE 2 - IMAGE OF DAMAGED FLASHING
