PRELIMINARY DOCUMENTATION REPORT

Demolition of Structures at RAAF Williams – Point Cook, Victoria

(EPBC 2019/8514)

November 2023

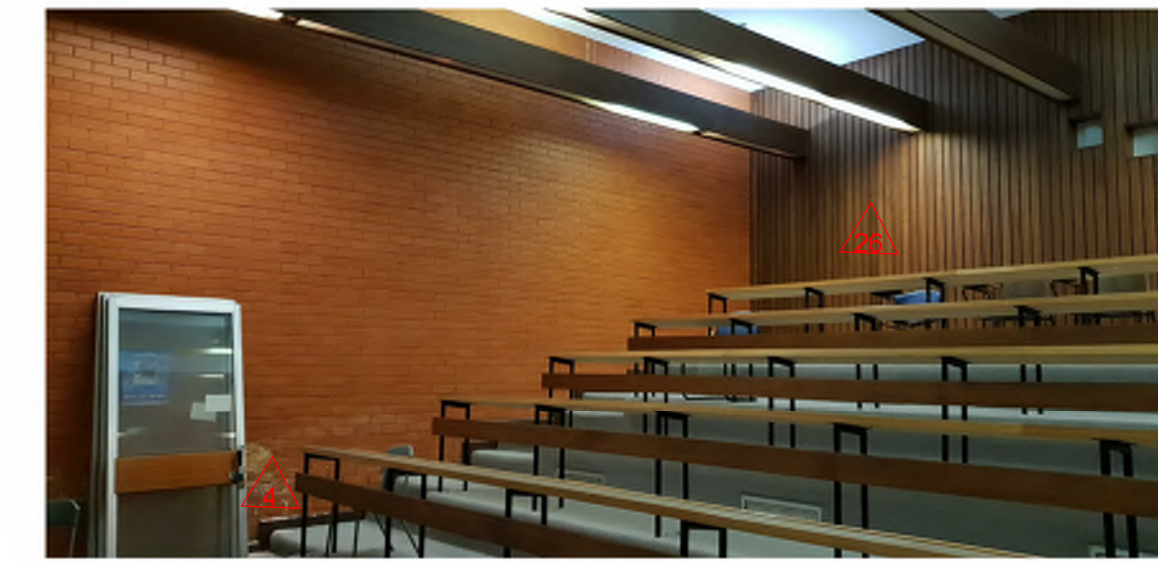
INTERNAL PLASTERBOARD WALLS ARE GENERALLY IN STRUCTURALLY GOOD CONDITION IN MOST OF THE OFFICE AREAS AND IN MOST CASES DO NOT REQUIRE MUCH WORK. IN SOME AREAS, ESPECIALLY IN THE LECTURE THEATRE THE PLASTERBOARDS IS FLAKING, POWDERY AND WATER DAMAGED AND WILL REQUIRE TO BE EITHER PATCHED AND PAINTED OR REPLACED IN SOME SECTIONS. GENERALLY THE WHOLE OF THE BUILDING SHOULD BE AT THE LEAST CLEANED DOWN, BUT OUR RECOMMENDATION WOULD BE TO REPAIR THE ENTIRE BUILDING INTERNALLY. AS WELL AS SOME WATER DAMAGE TO PLASTERBOARD IN THE THEATRE, SOME MASONRY BRICK WALLS HAVE ALSO EFFLORESCENCE AND WATER DAMAGE SHOWINGS AND THESE AREAS SHOULD HAVE FURTHER INVESTIGATION UNDERTAKEN TO DETERMINE THE EXTENT AND WHERE THE WATER DAMAGE IS COMING FROM.

VIEW INSIDE THE LECTURE THEATRE

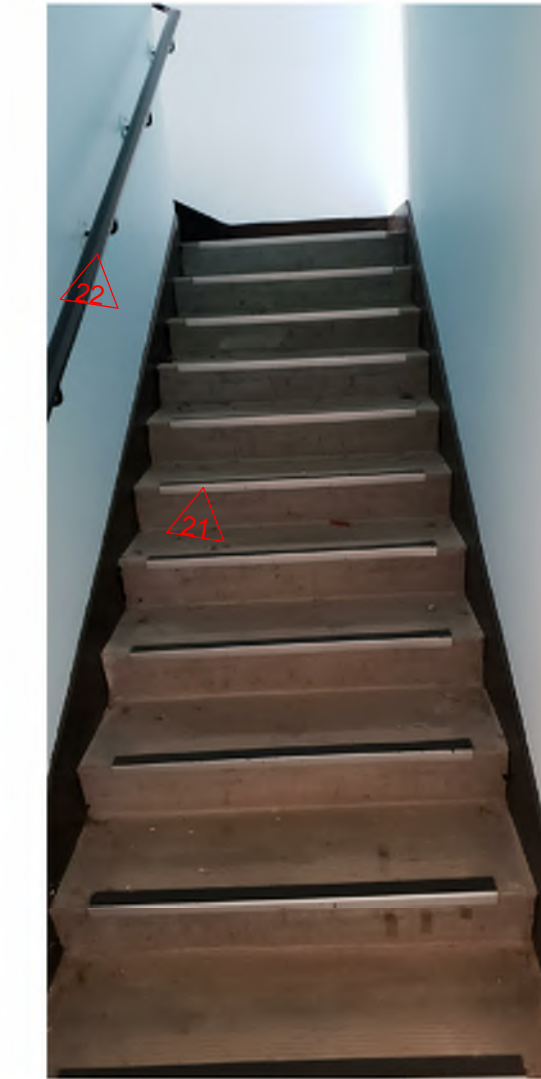
INTERNAL CONCRETE STAIRS SHOULD BE CLEANED, RESEALED AND REPAINTED, AND NEW TACTILE INDICATORS SHOULD BE INSTALLED. BALUSTRADING TO THE STAIRS IS BELOW MIN HEIGHT AND SHOULD BE REPLACED.

VIEW INTERNAL CONCRETE STAIRS

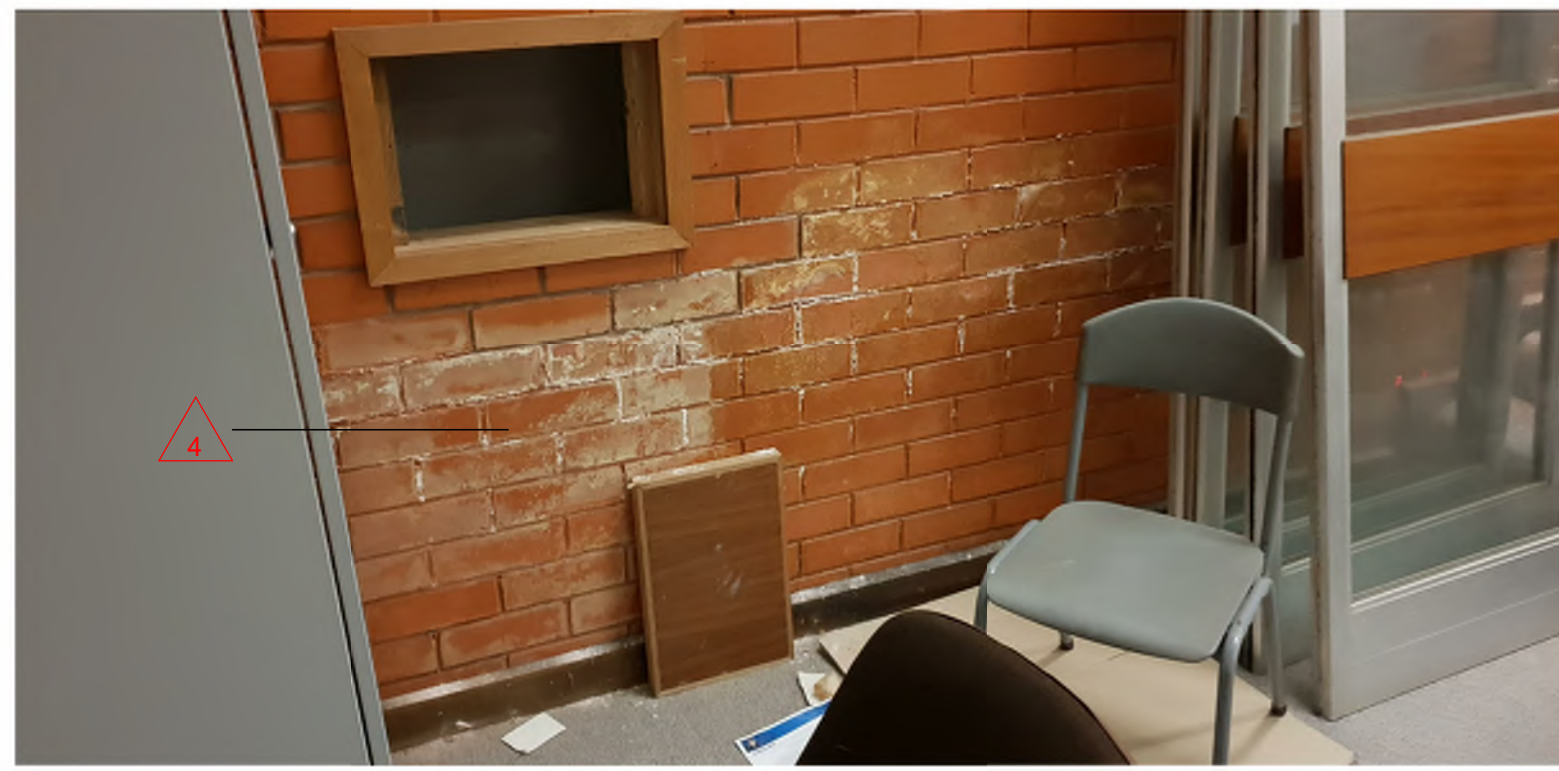
SCOPE 4 - IMAGE OF TYPICAL WATER DAMAGE TO MASONRY WALLS

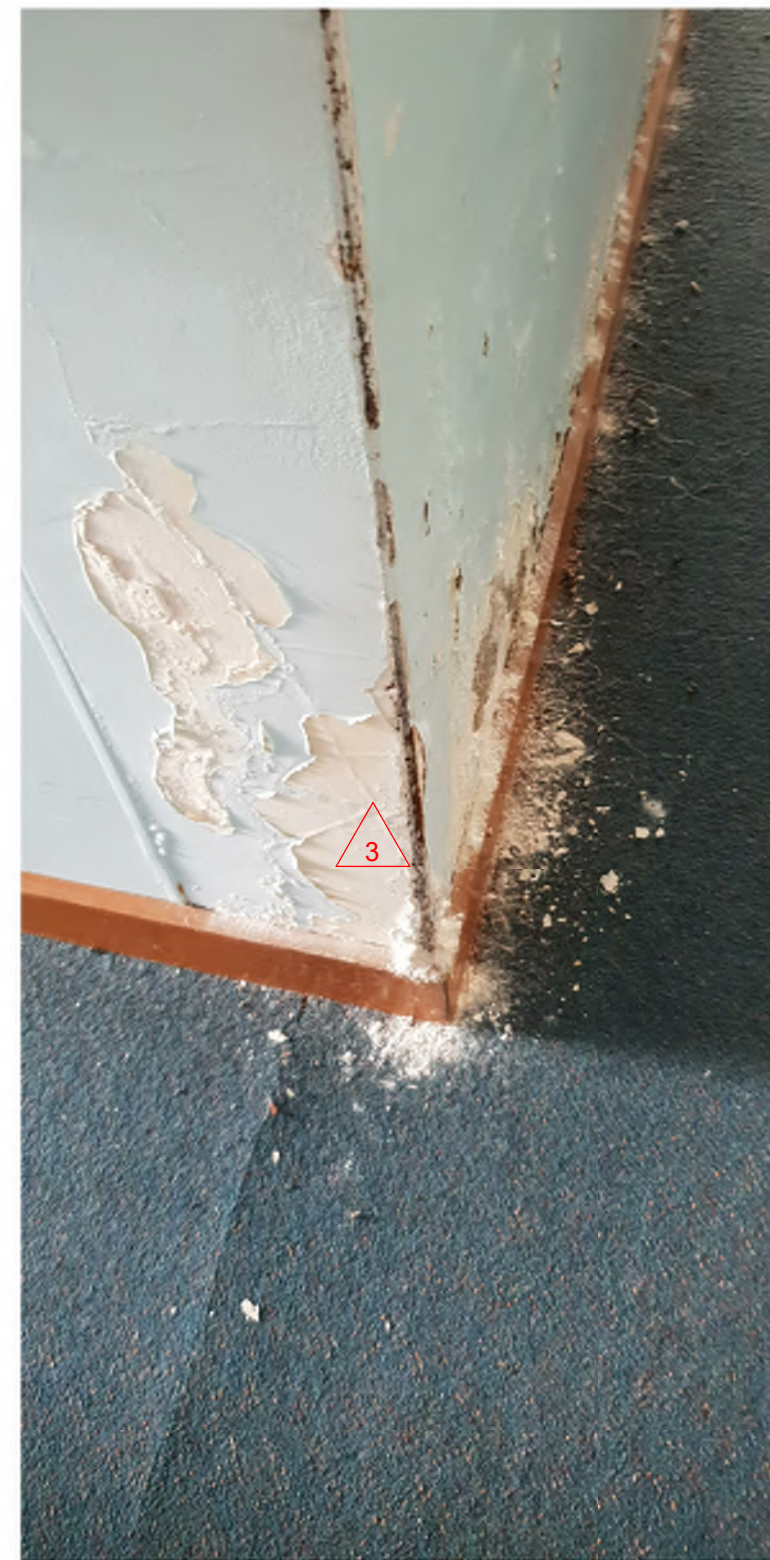
SCOPE 3 - IMAGE OF DAMAGED INTERNAL WALL TO THEATRE

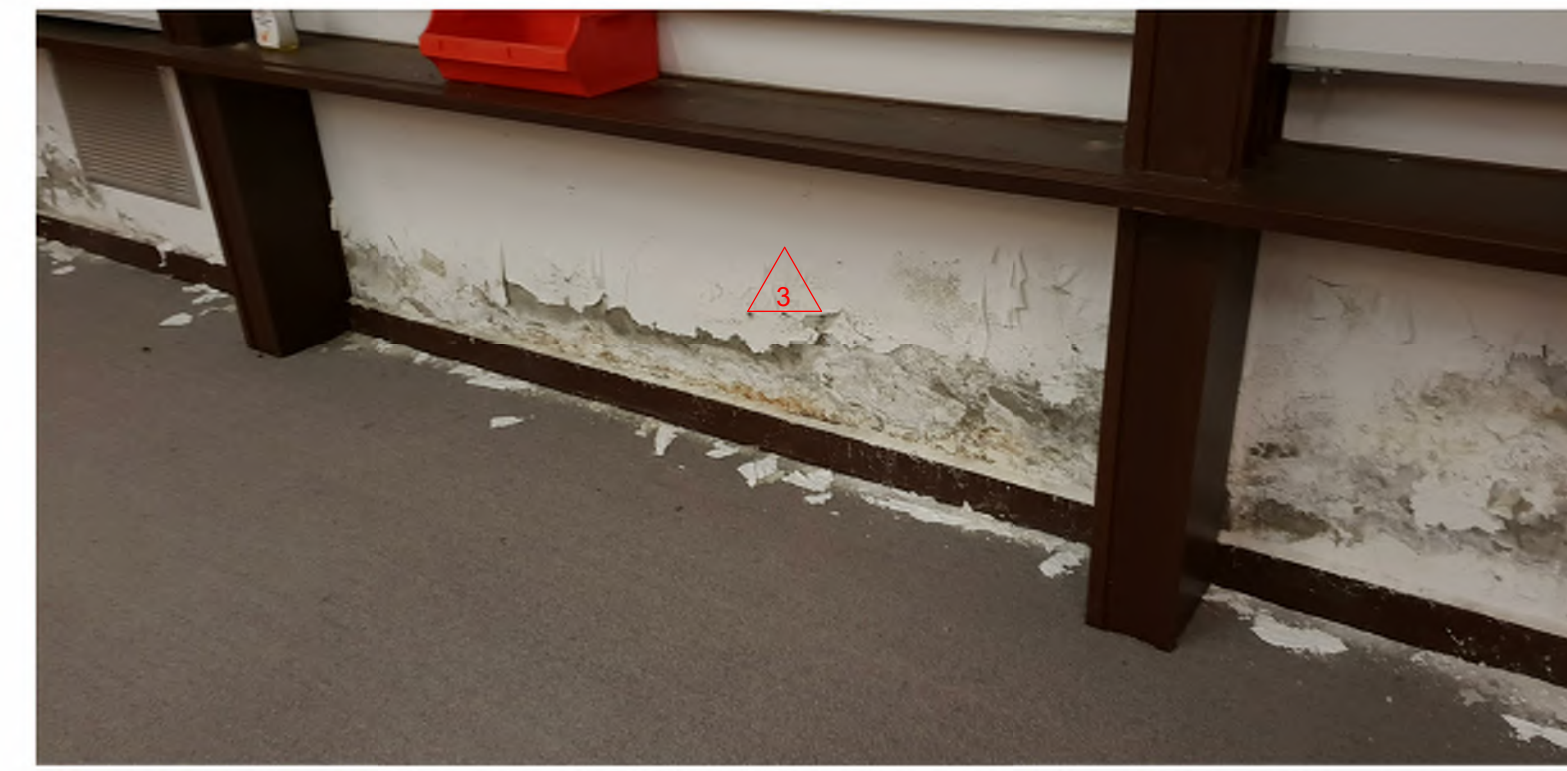
SCOPE 3 - IMAGE OF DAMAGED INTERNAL WALL TO THEATRE

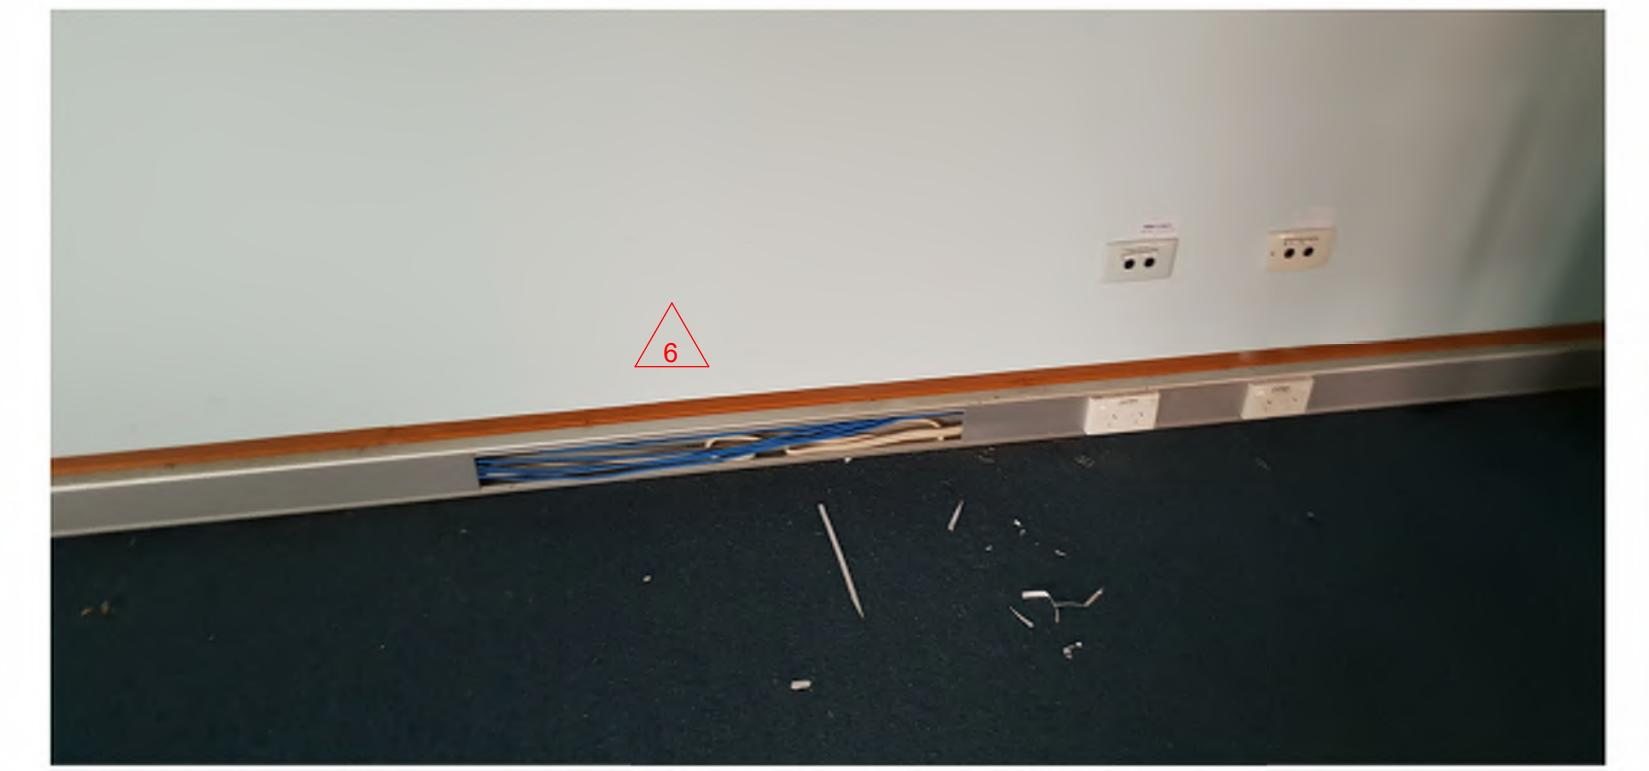
TYPICAL IMAGE OF DAMAGED INTERNAL SKIRTING FOR ELECTRICAL CONDUITS

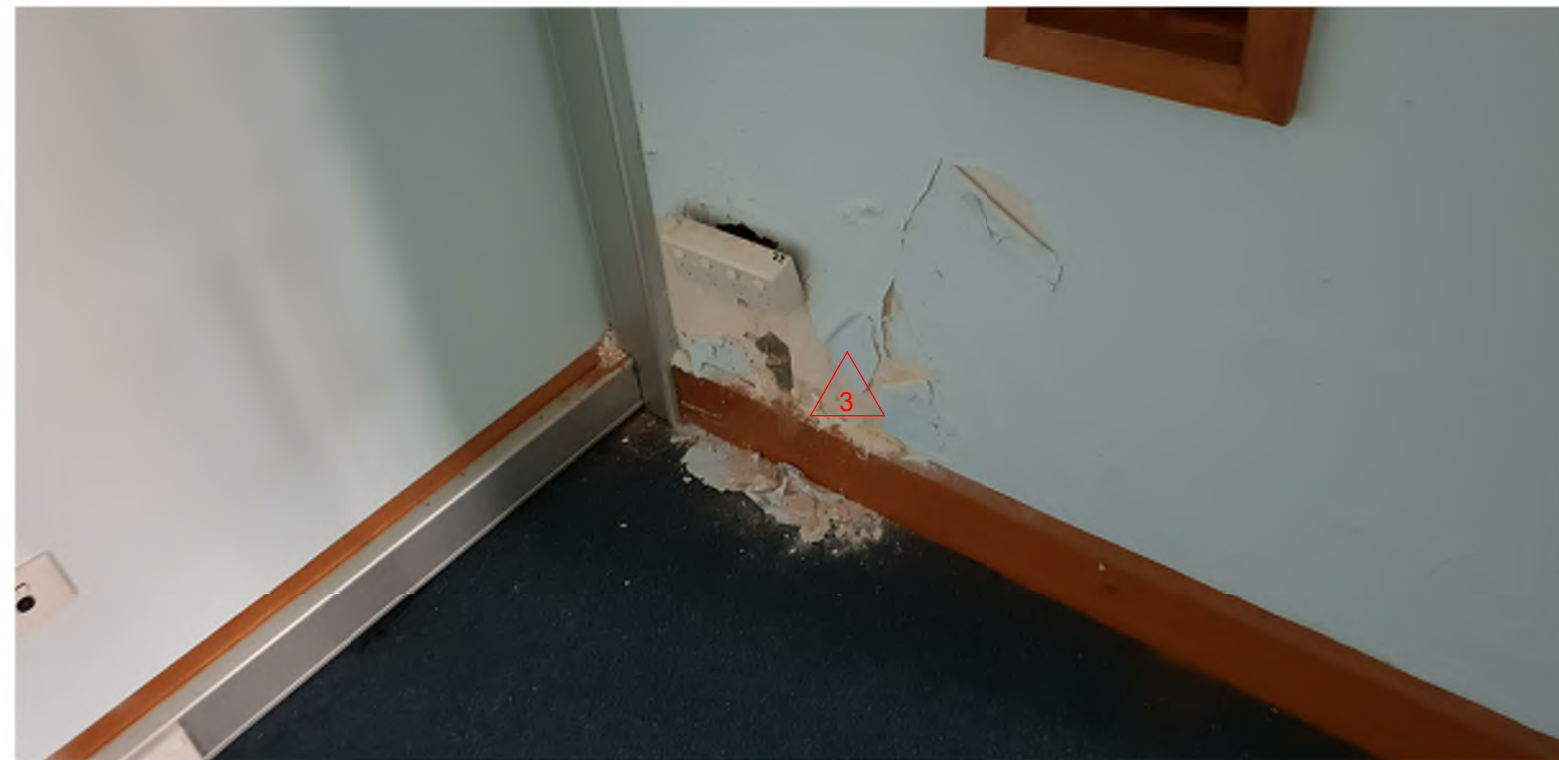
SCOPE 3 - IMAGE OF TYPICAL INTERNAL WALLS DAMAGE TO BE PATCHED AND PAINTED

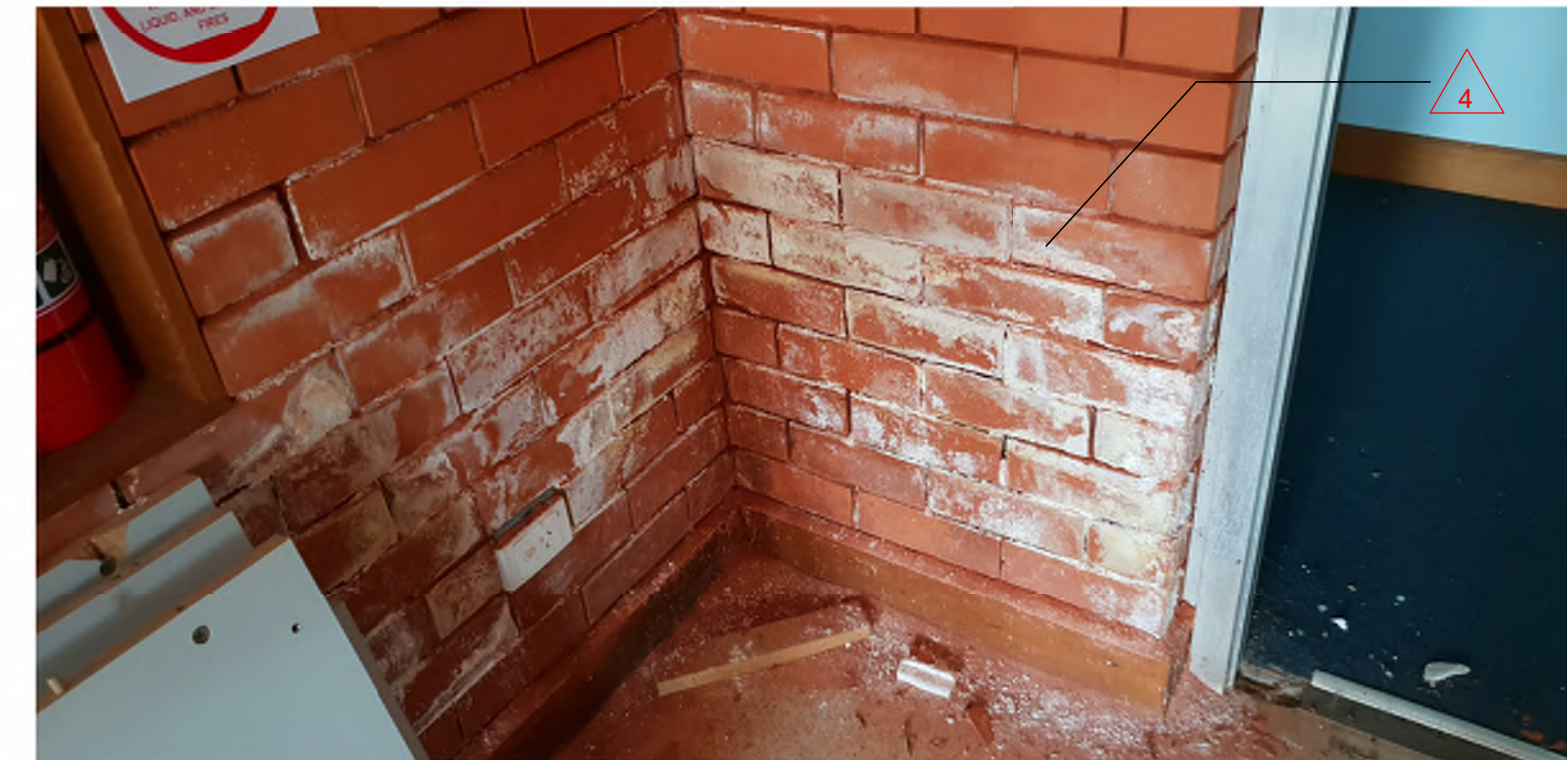
SCOPE 4 - IMAGE OF TYPICAL WATER DAMAGE TO MASONRY WALLS

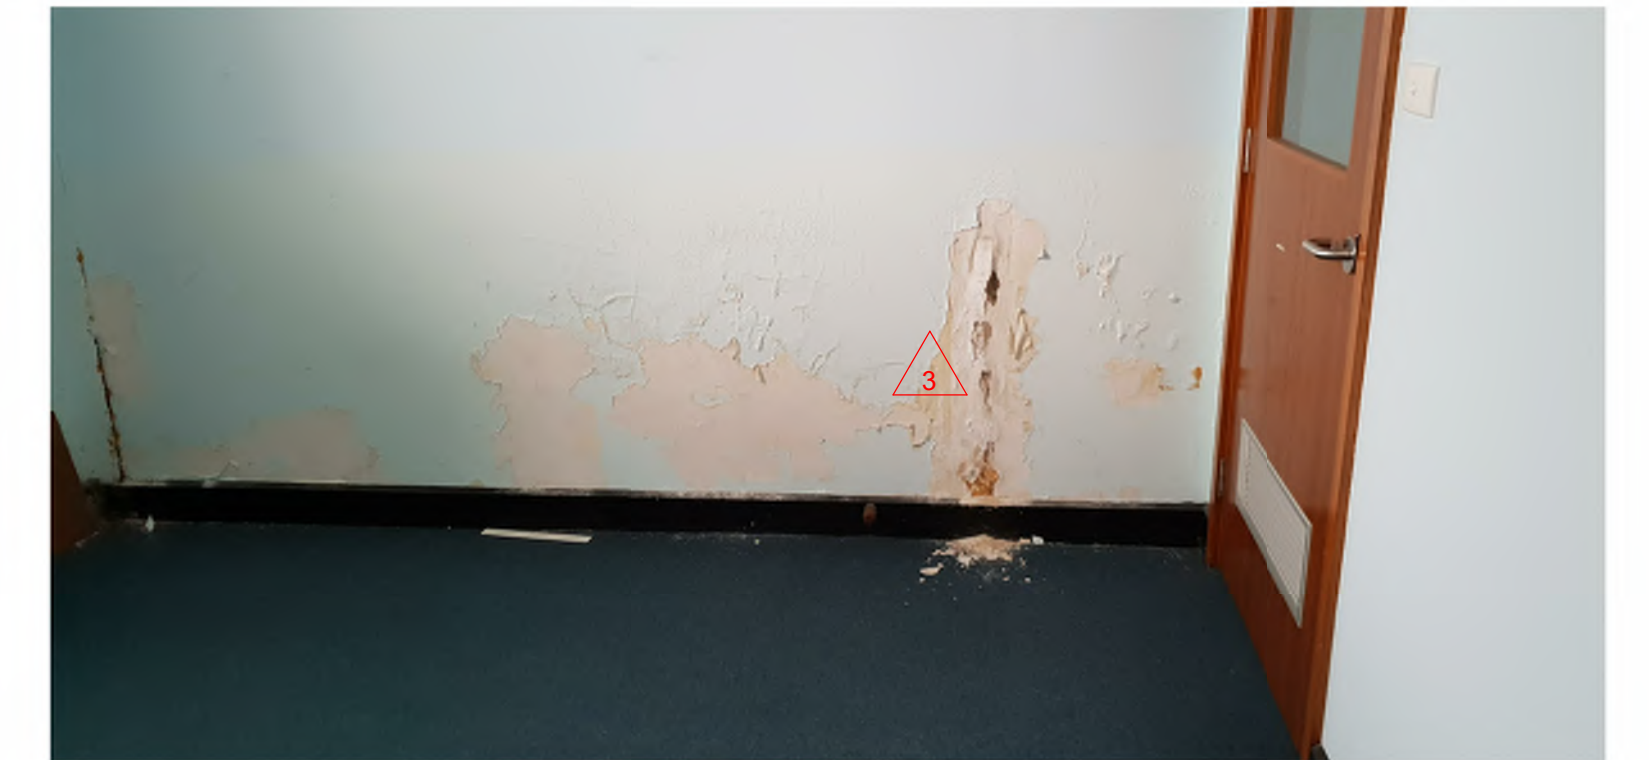
TYPICAL IMAGE OF DAMAGED WALLS

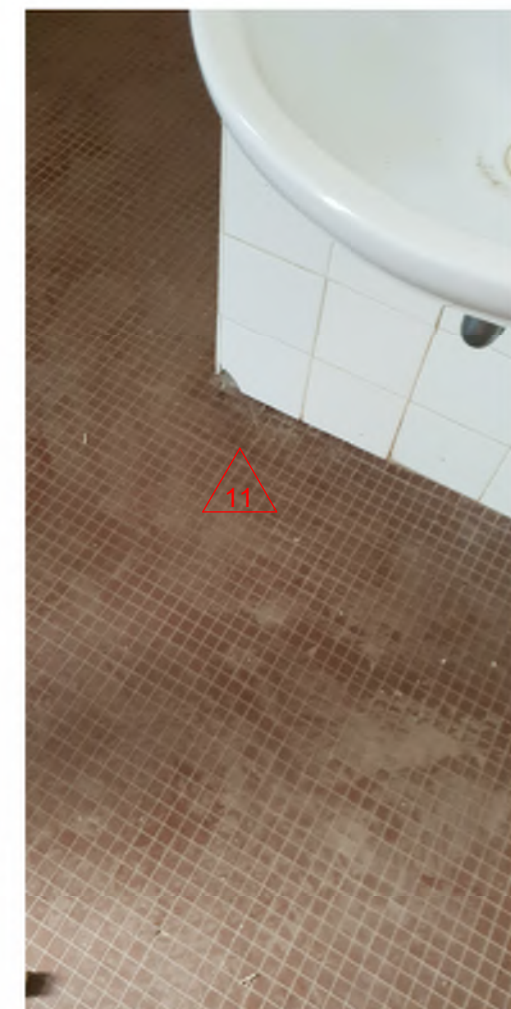
SCOPE 8 - IMAGE OF BATHROOM TILES NEED REPLACEMENT

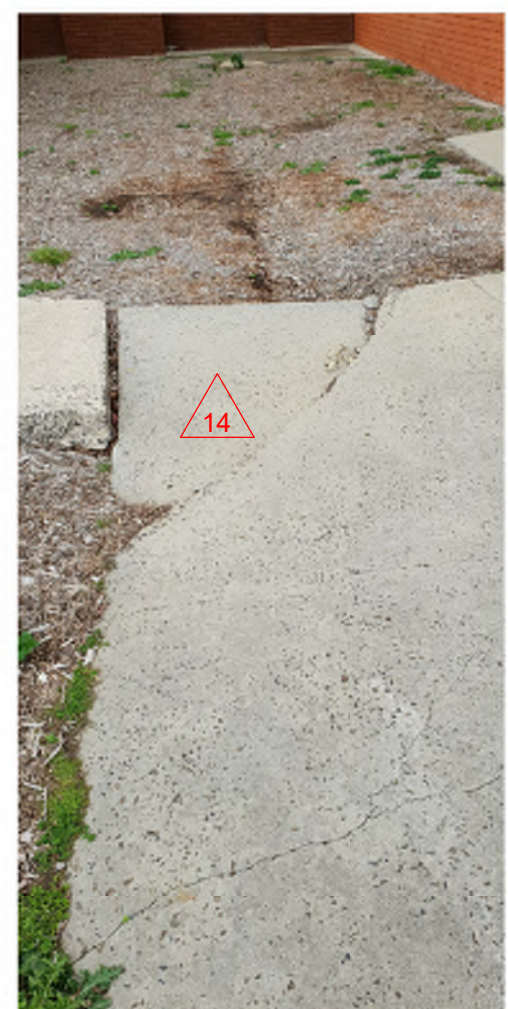
SCOPE 14 - TYPICAL CRACKED TILES

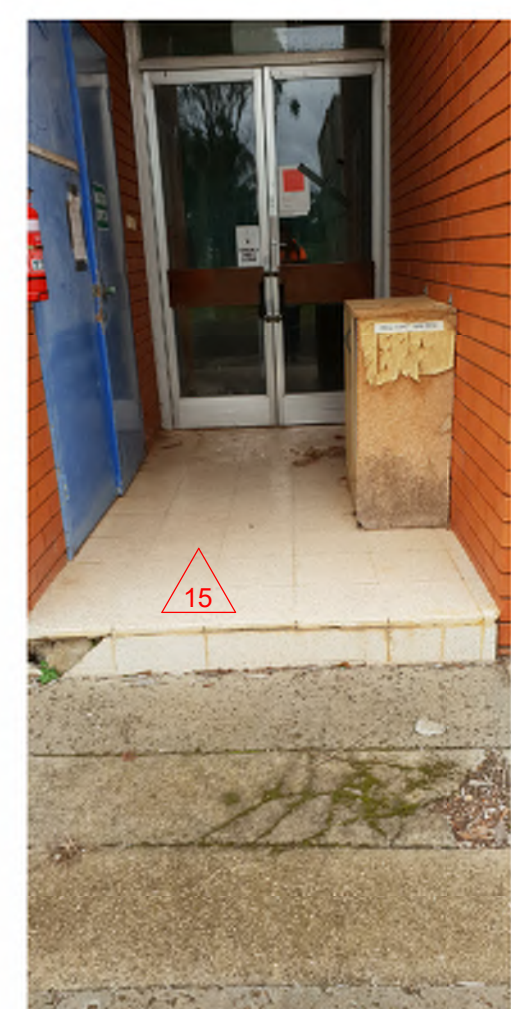
SCOPE 15 - TYPICAL CRACKED FLOOR TILES

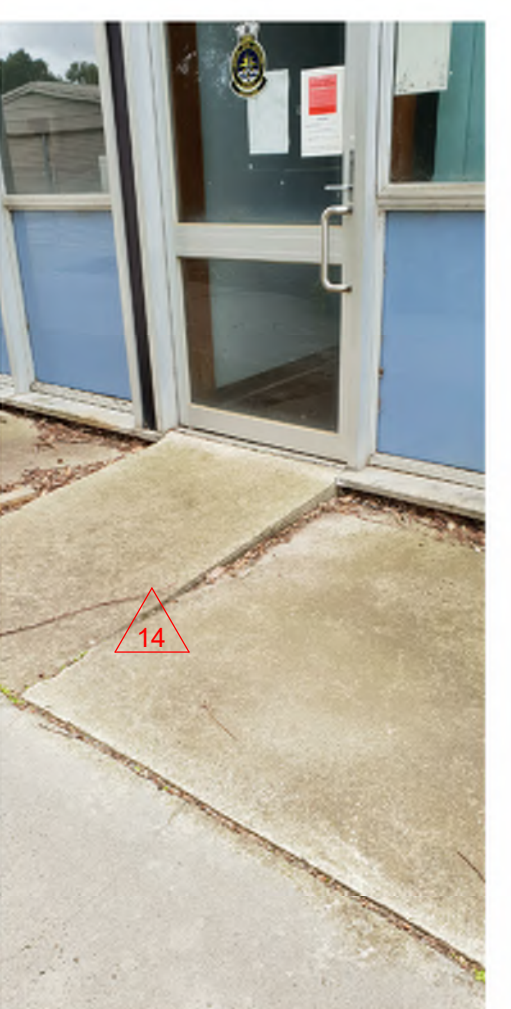
SCOPE 15 - TYPICAL CRACKED FLOOR TILES & PRESSURE CLEANED

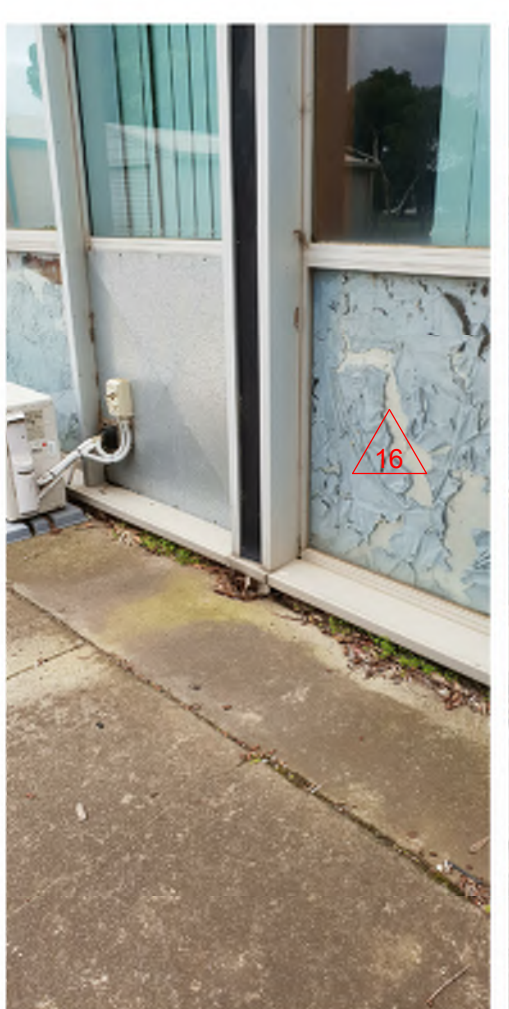
SCOPE 16 - CRACKED GLAZING TO BE REPLACED

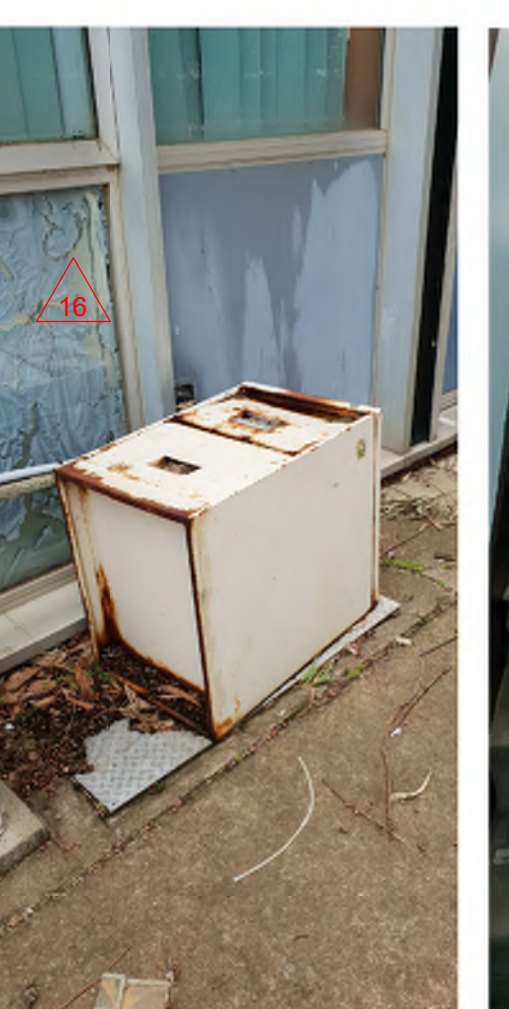
SCOPE 16 - CRACKED GLAZING TO BE REPLACED

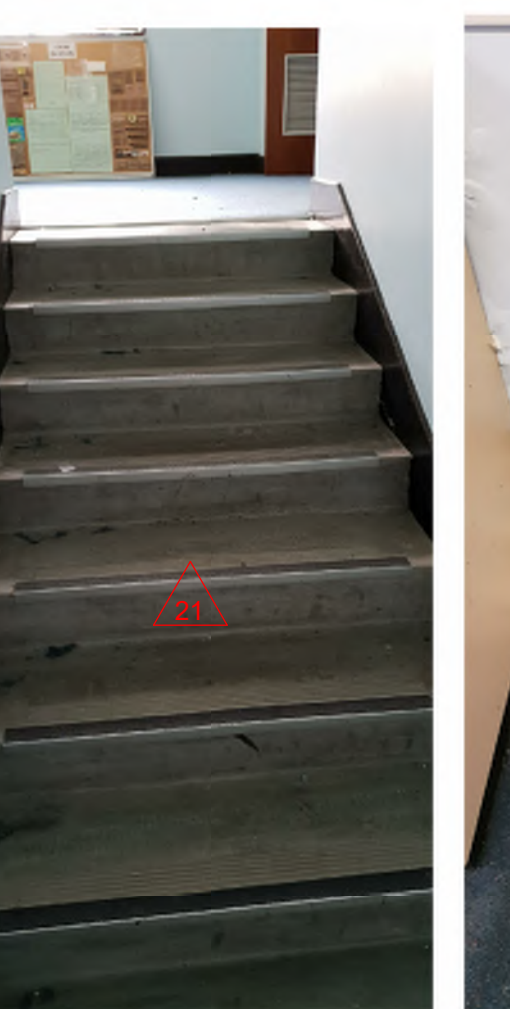
SCOPE 21 - CONCRETE STAIRS TO BE CLEANED, SEALED AND TACTILE INDICATORS APPLIED

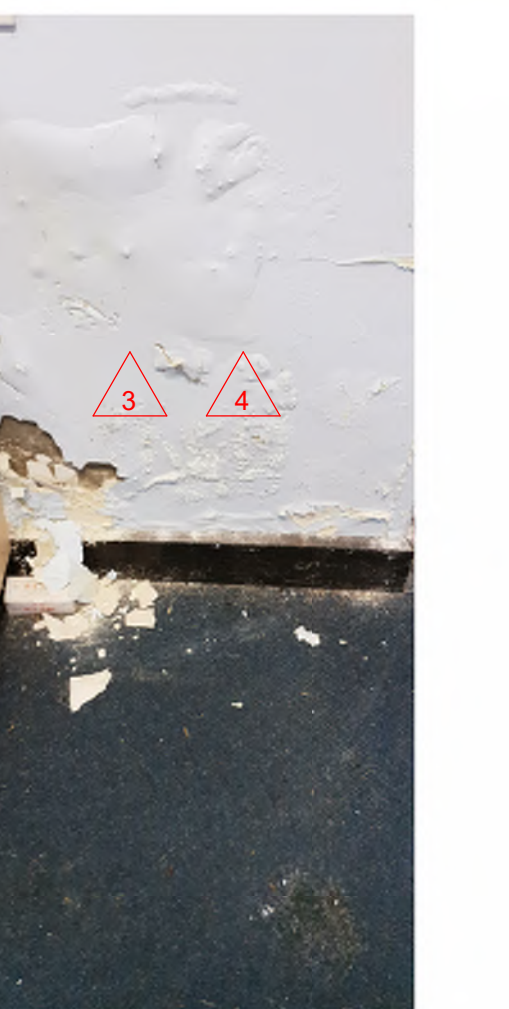
TYPICAL INTERNAL WALL DAMAGE

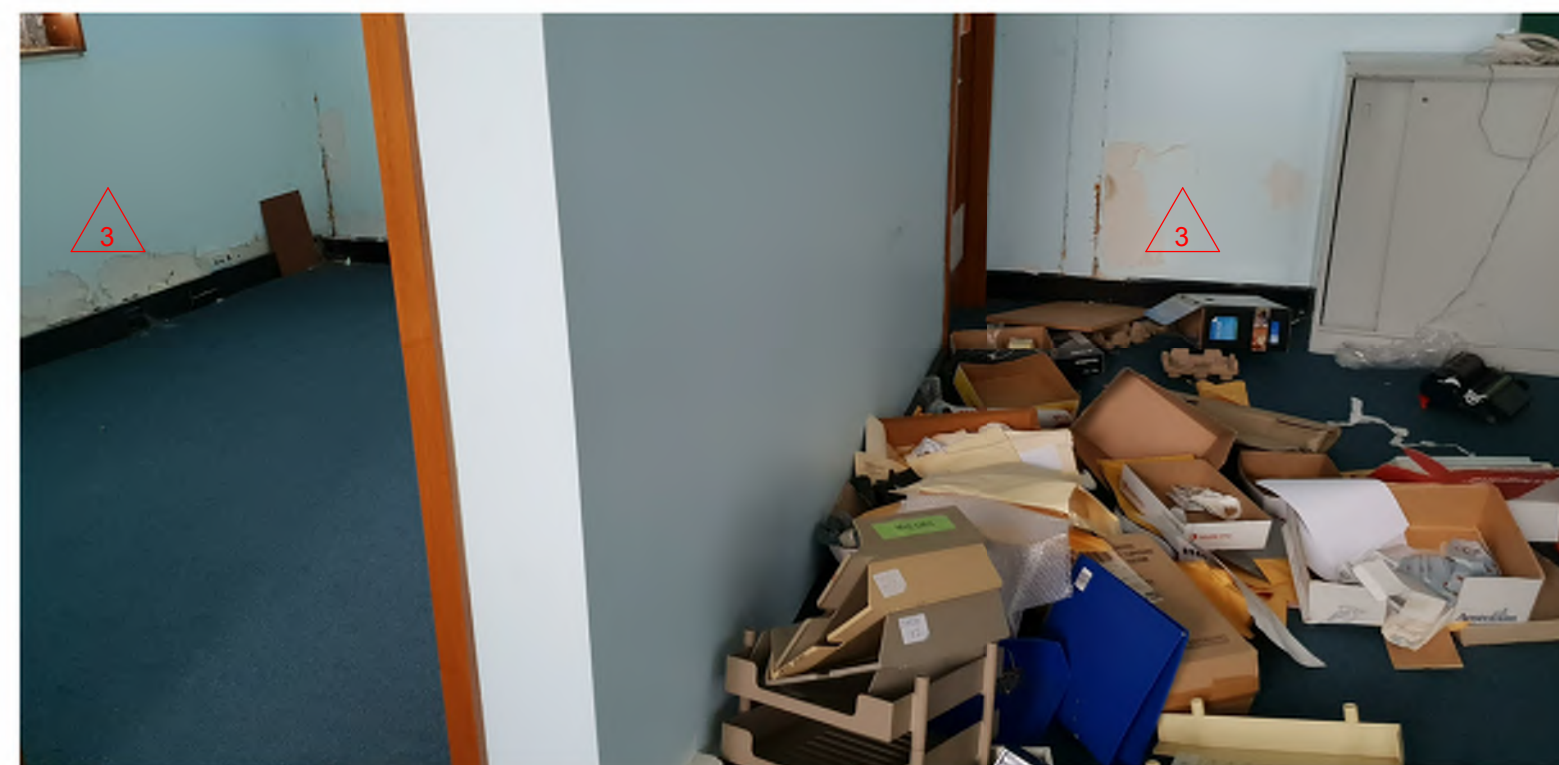
TYPICAL INTERNAL WALL DAMAGE AND LOOSE FURNITURE DEBRIS WITHIN THE OFFICES

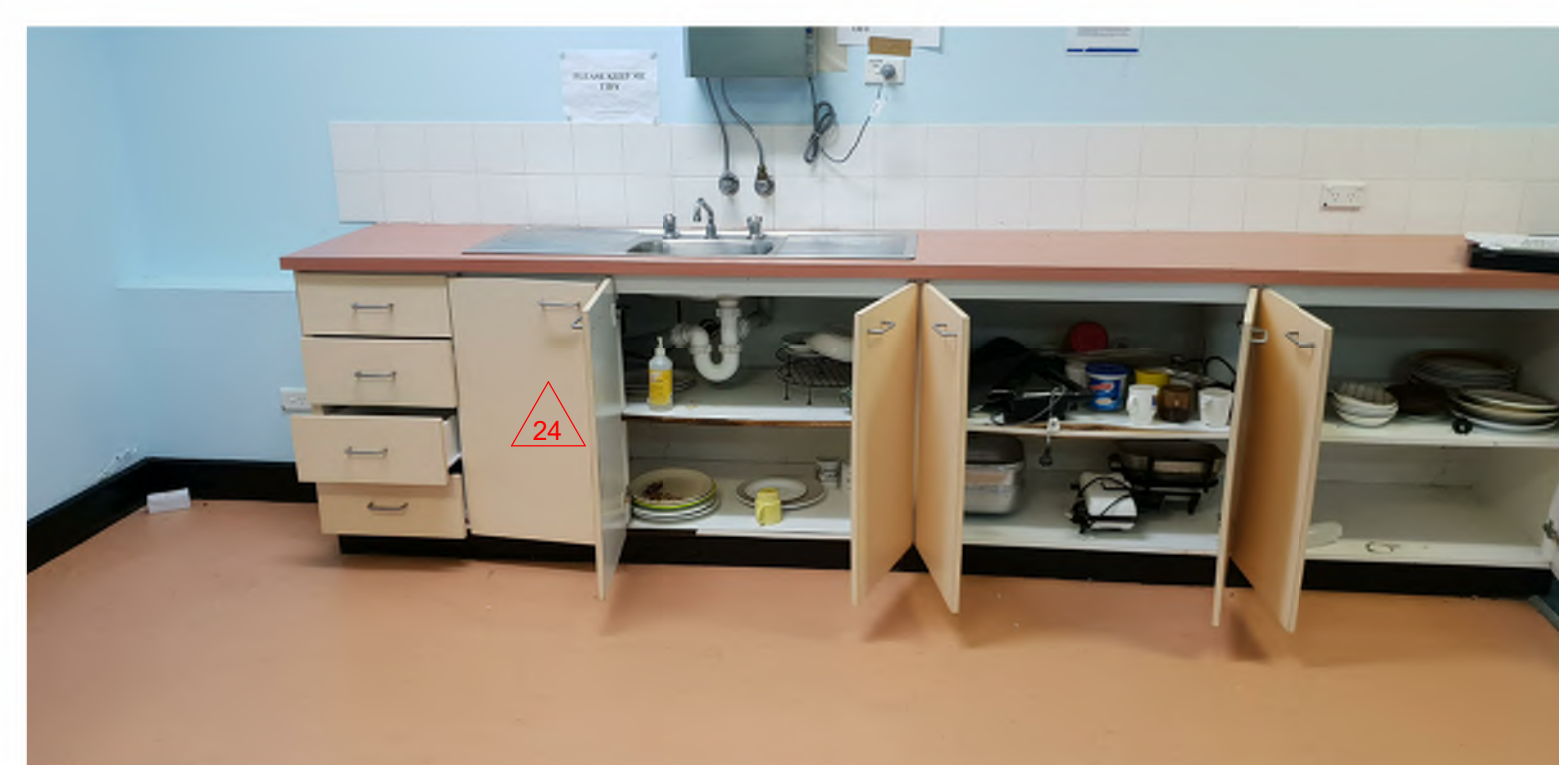
TYPICAL CUSTOM BUILT FURNITURE TO BE CLEANED

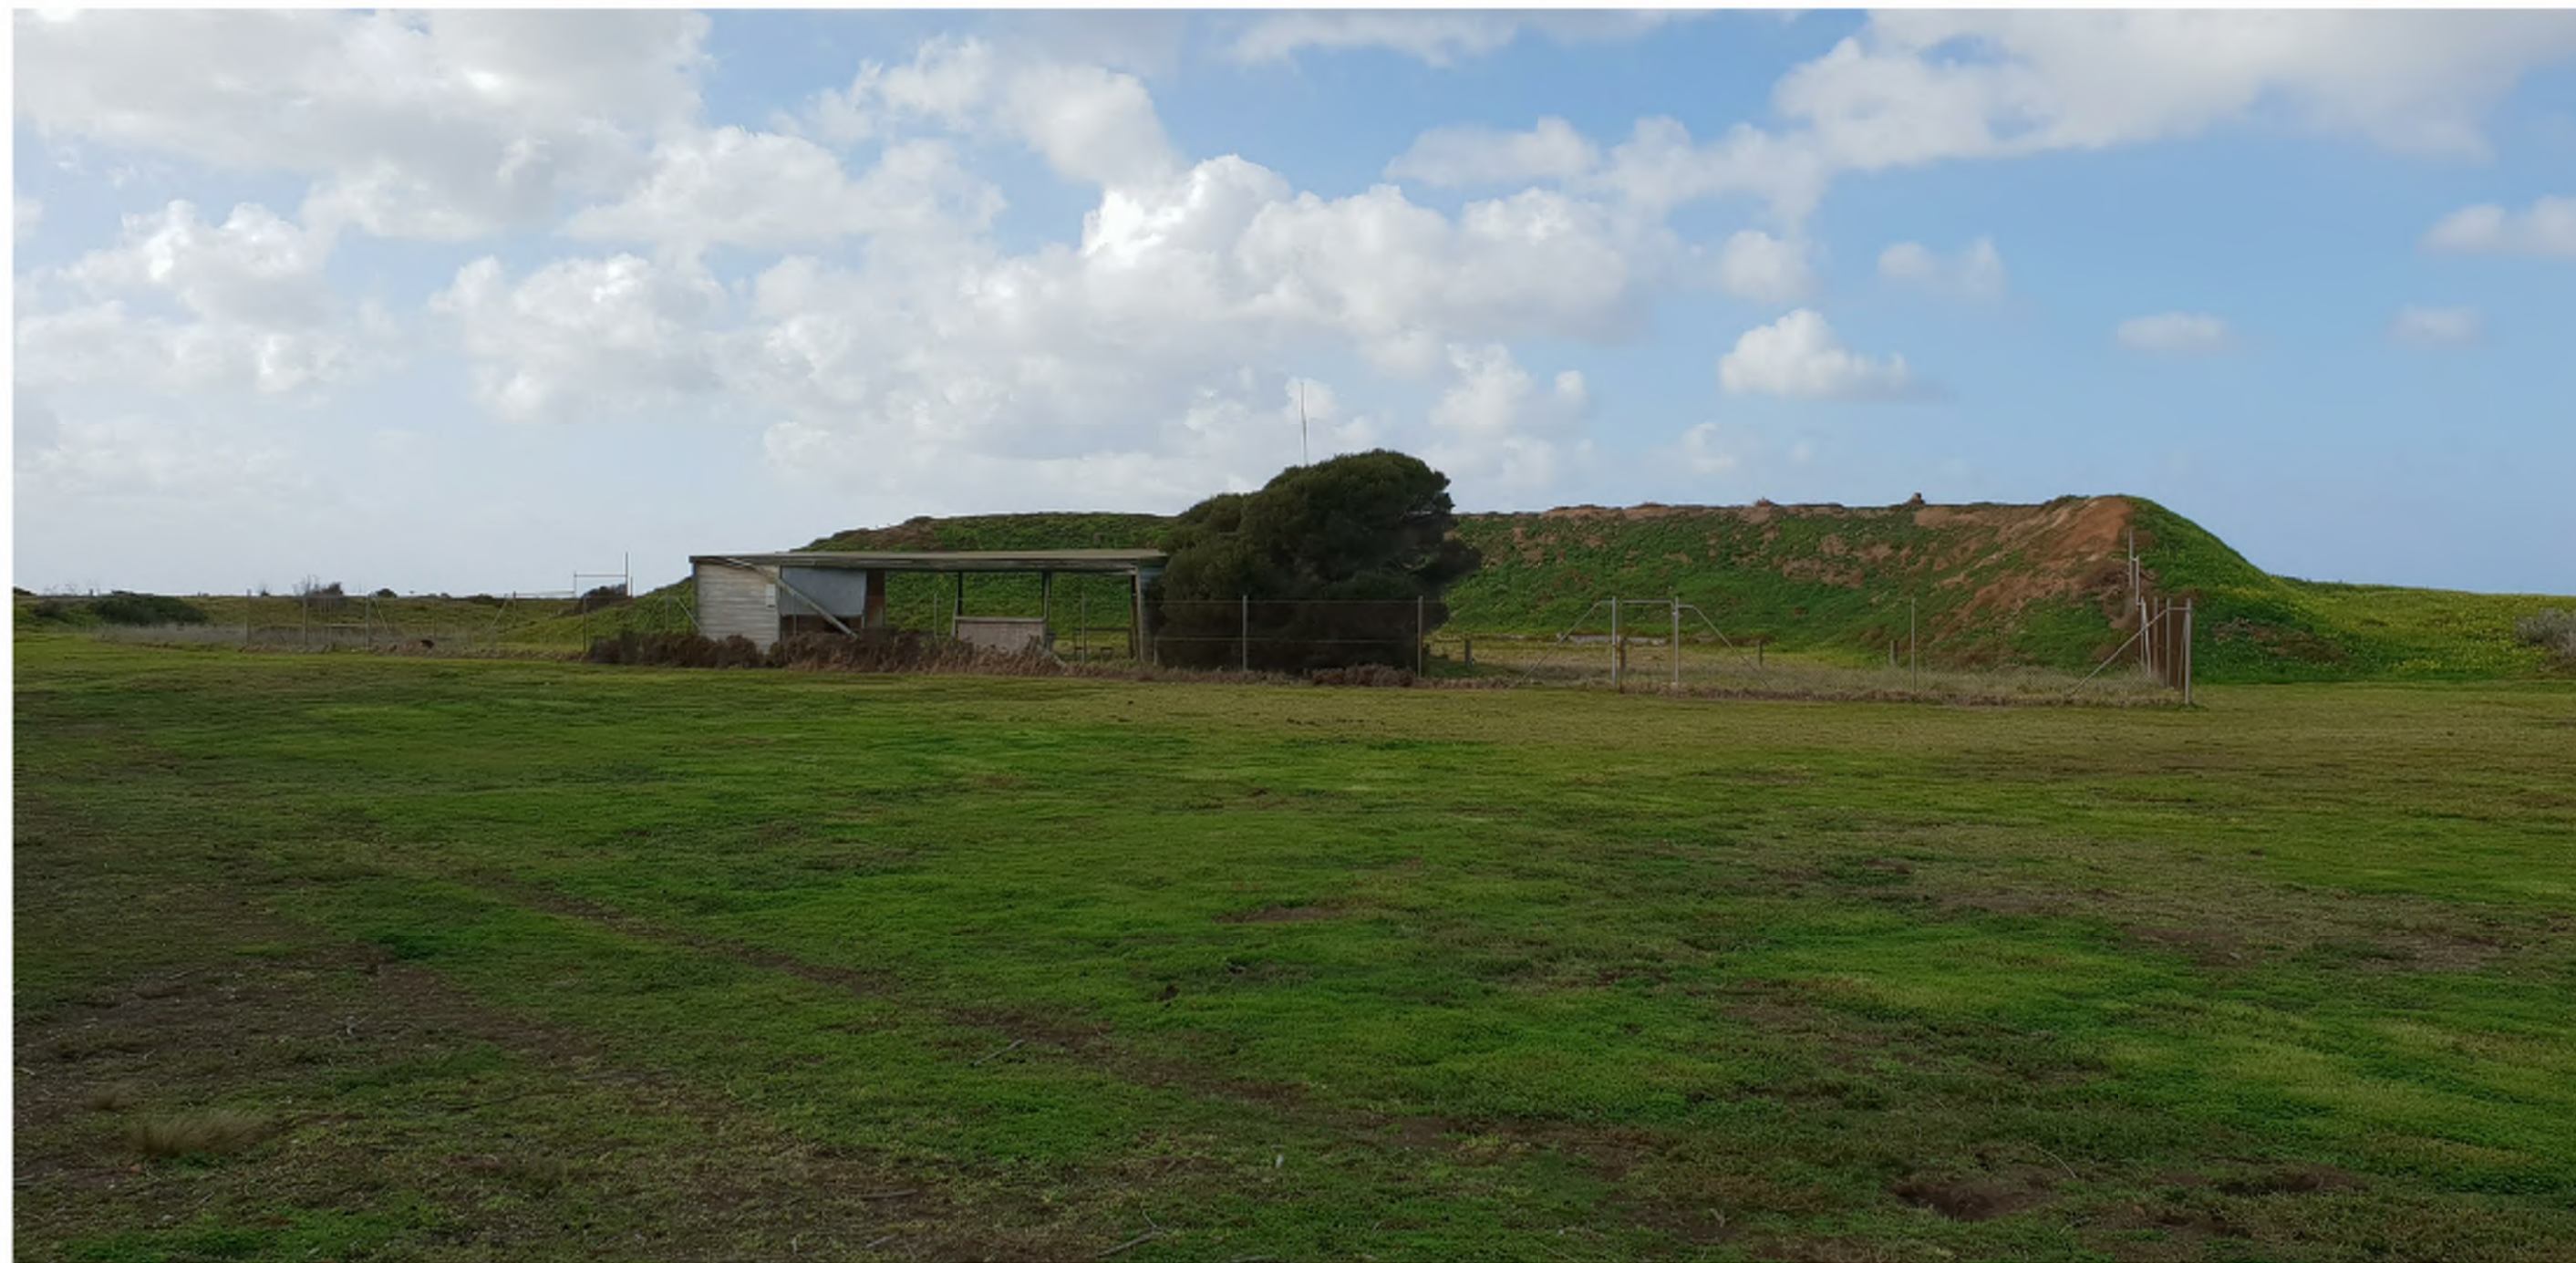
EARTH BANK SET BEHIND FIRING RANGE

- THE EXISTING MOUND IS A LARGE EARTHEN MOUND USED TO STOP BULLETS USED AT THE FIRING RANGE.
- THE SOIL IS TO BE REMOVED FROM SITE AND THE AREA IS TO BE LEVELLED TO MATCH ADJOINING LEVELS OF GROUND. THE CONTRACTOR SHOULD ALLOW FOR CAREFULL REMOVAL AND DISPOSAL OF ANY EARTH, AS THERE WILL BE CONTAMINANTS, INCLUDING LEAD BULLETS.
- ANY REMOVAL SHOULD BE COMPLETED IN ACCORDANCE WITH DEFENCE GUIDELINES AND BE CORRECTLY DISPOSED AND TREATED BY CONTRACTOR.

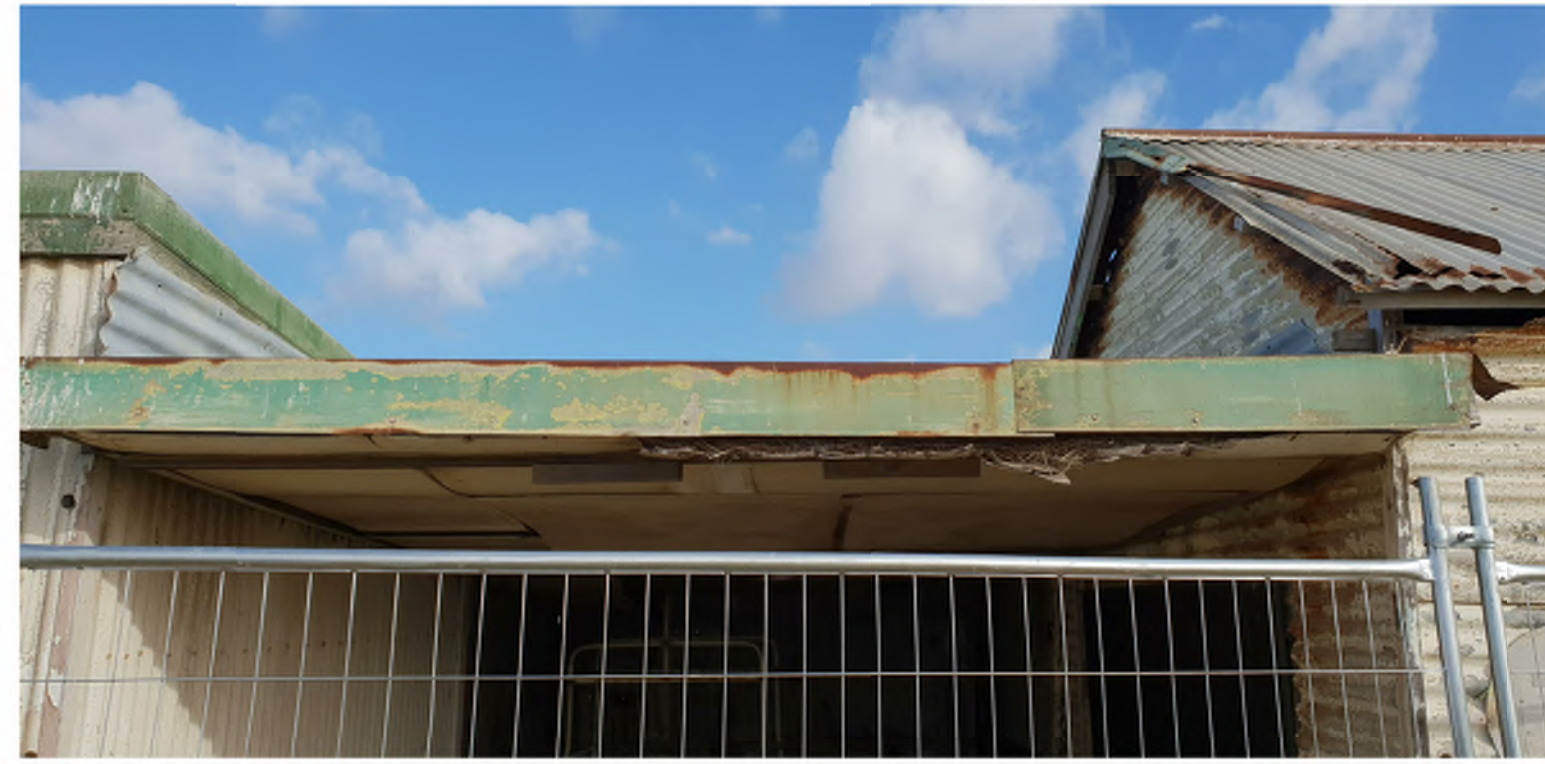
VIEW OF SOUTH ELEVATION - UNDERCOVER AREA - SHOWING FLASHING DETERIORATION

1. CONTRACTOR IS TO ALLOW TO CAP AND SEAL UP ALL SERVICES TO BUILDING, PRIOR TO ANY DEMOLITION WORKS PROCEEDING
2. DEMOLISH AND BREAK UP AND REMOVE EXISTING CONCRETE SLAB, PAVING, ETC.
3. DEMOLISH AND REMOVE ENTIRE BUILDING, INCLUDING WALLS, ROOF, AND FLOOR STRUCTURE.
4. ENSURE THAT ANY SERVICE PITS ARE CAPPED AND SEALED, PRIOR TO REMOVAL.
5. CONTRACTOR IS TO REFER TO ASBESTOS REGISTER FOR THIS BUILDING TO ENSURE THAT ANY ASBESTOS PRESENT IS DISPOSED OF IN CORRECT MANNER AND IN COMPLIANCE WITH REGULATIONS.

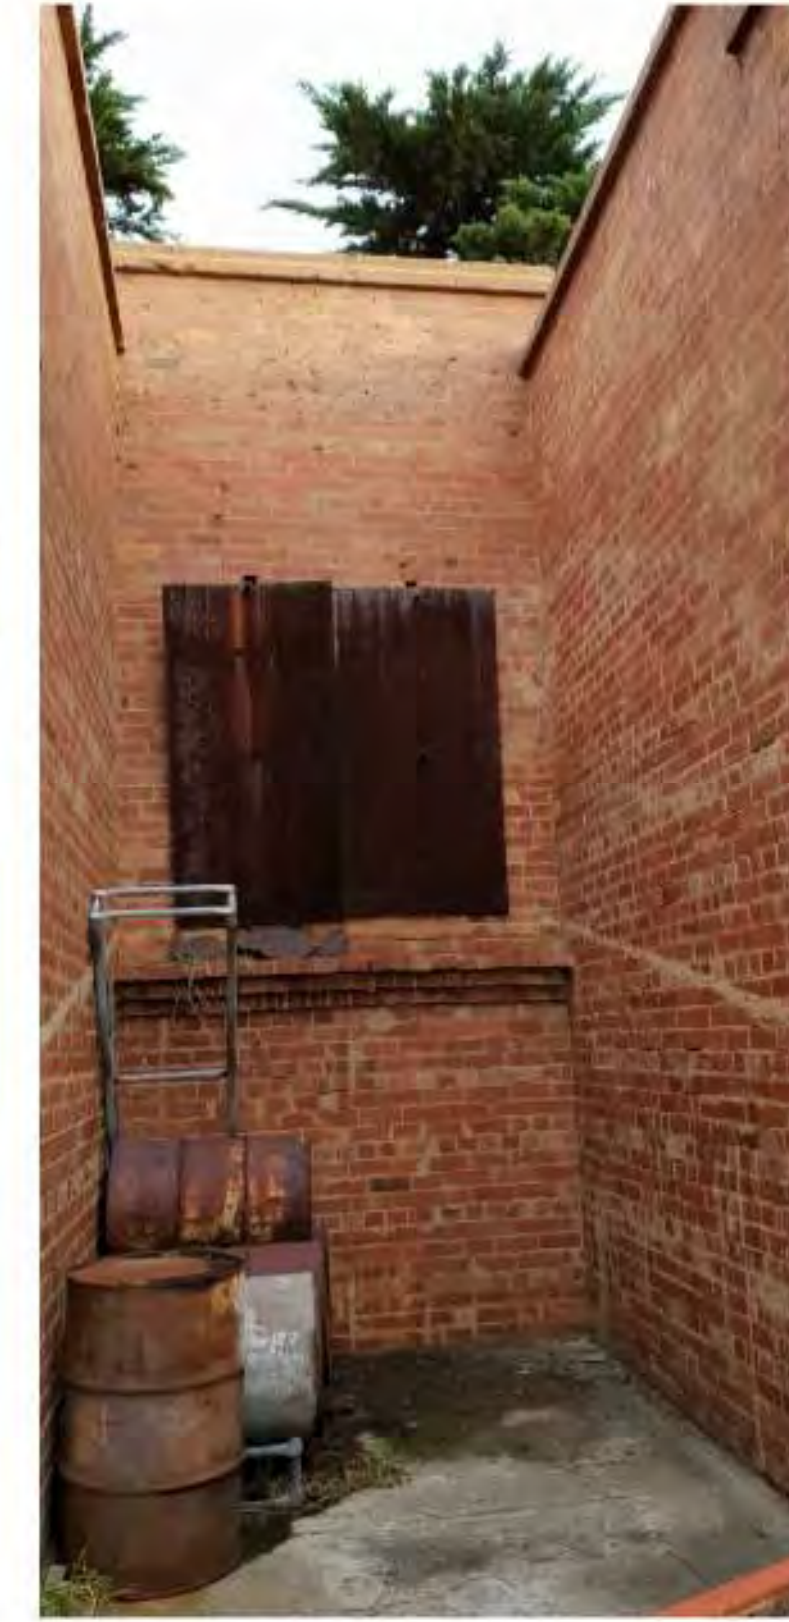
PHOTO NO 4 - VIEW INTO THE STRUCTURE, SHOWING RUSTING SHEET PANELS
