PRELIMINARY DOCUMENTATION REPORT

Demolition of Structures at RAAF Williams – Point Cook, Victoria

(EPBC 2019/8514)

November 2023

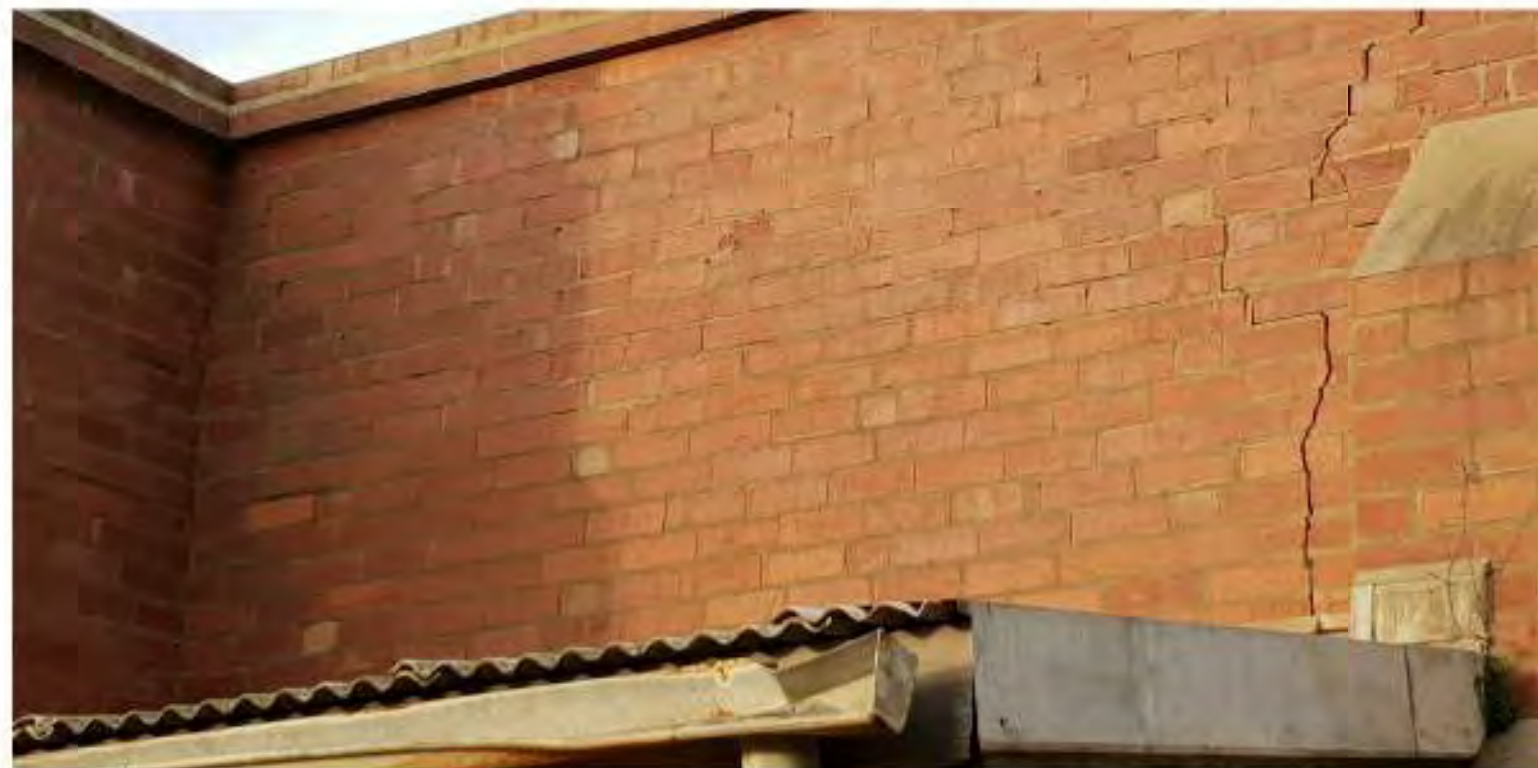
- EXTERNAL MASONRY WALLS ARE SHOWING LARGE SIGNIFICANT CRACKS IN THE WALLS, DUE TO MOVEMENT IN THE FOOTINGS AND A STRUCTURAL ASSESSMENT SHOULD BE COMPLETED, PRIOR TO ANY WORKS STARTING. THE EXISTING FOOTINGS WILL NEED TO BE UNDERPINNED AND CRACKING REPAIRED. REFER TO PHOTO NO 3 AND 5 FOR DAMAGE.
- REPLACE EXISTING TIMBER DOORS AND DOOR FRAME (TO STORE AREA) WITH NEW MATCHING TIMBER DOOR AND FRAME, DOORS 1400W X 2040 HIGH
- DEMOLISH AND REMOVE EXISTING ROOF STRUCTURE (TO STORE AREA) AND REPLACE WITH NEW TIMBER RAFTERS, ROOFING BATTENS, COLORBOND CORRUGATED ROOF SHEETING AND TIMBER FASCIA, FASCIA GUTTER AND 90 X 90MM METAL DOWNPIPE.
- REMOVE ALL RUBBISH AND DEBRIS AROUND THE BUILDING AND ALLOW TO SAND BLAST AND CLEAN EXISTING CONCRETE SLAB IN THE GUN ZONE AREA.

PHOTO NO 3 - VIEW OF SHED ROOF AND CRACKING IN WALL

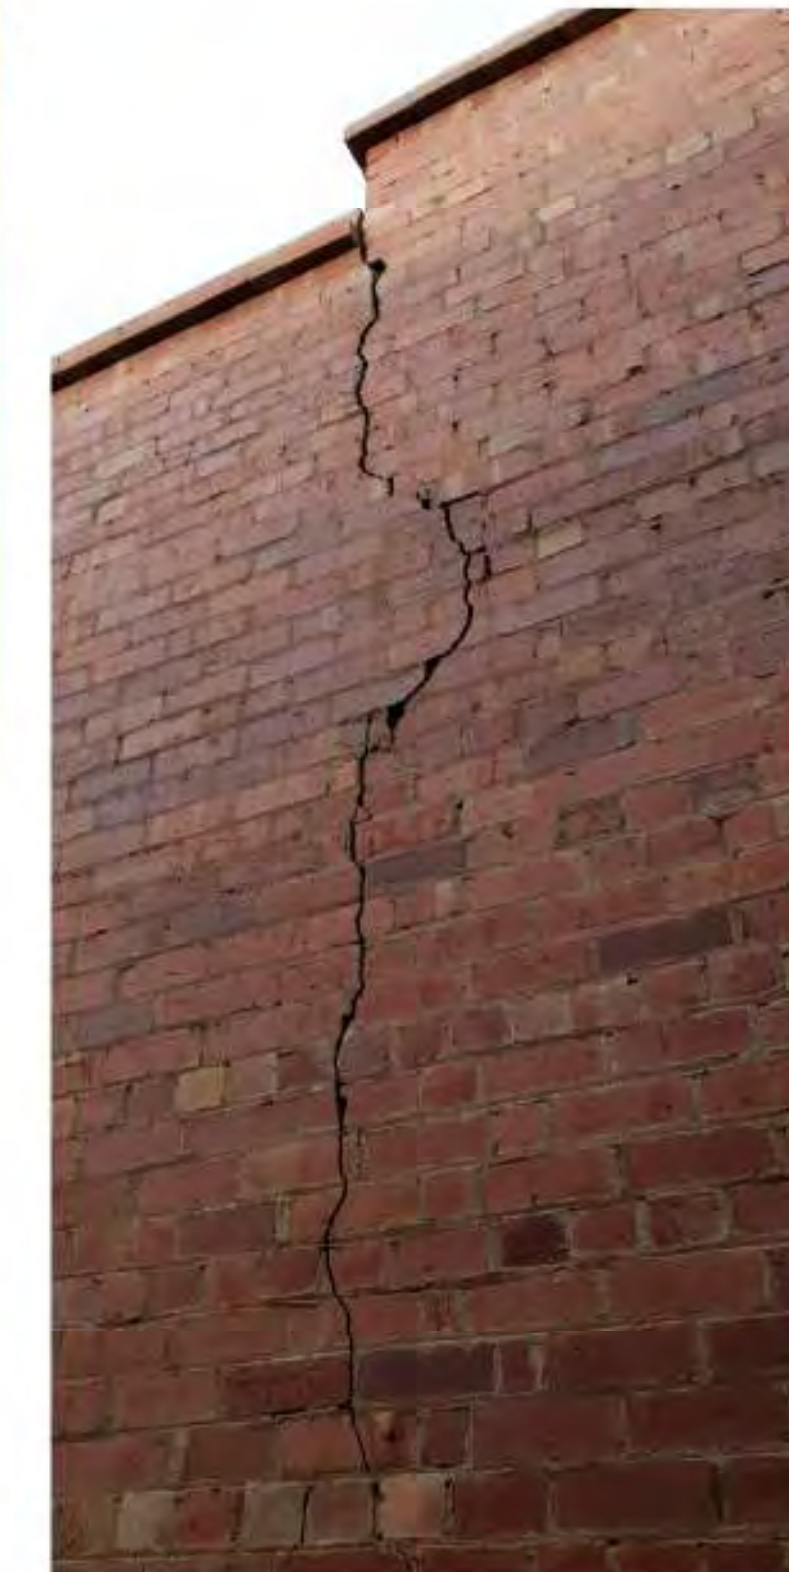
PHOTO NO 5 - VIEW OF CRACK IN WALL TO BE REPAIRED

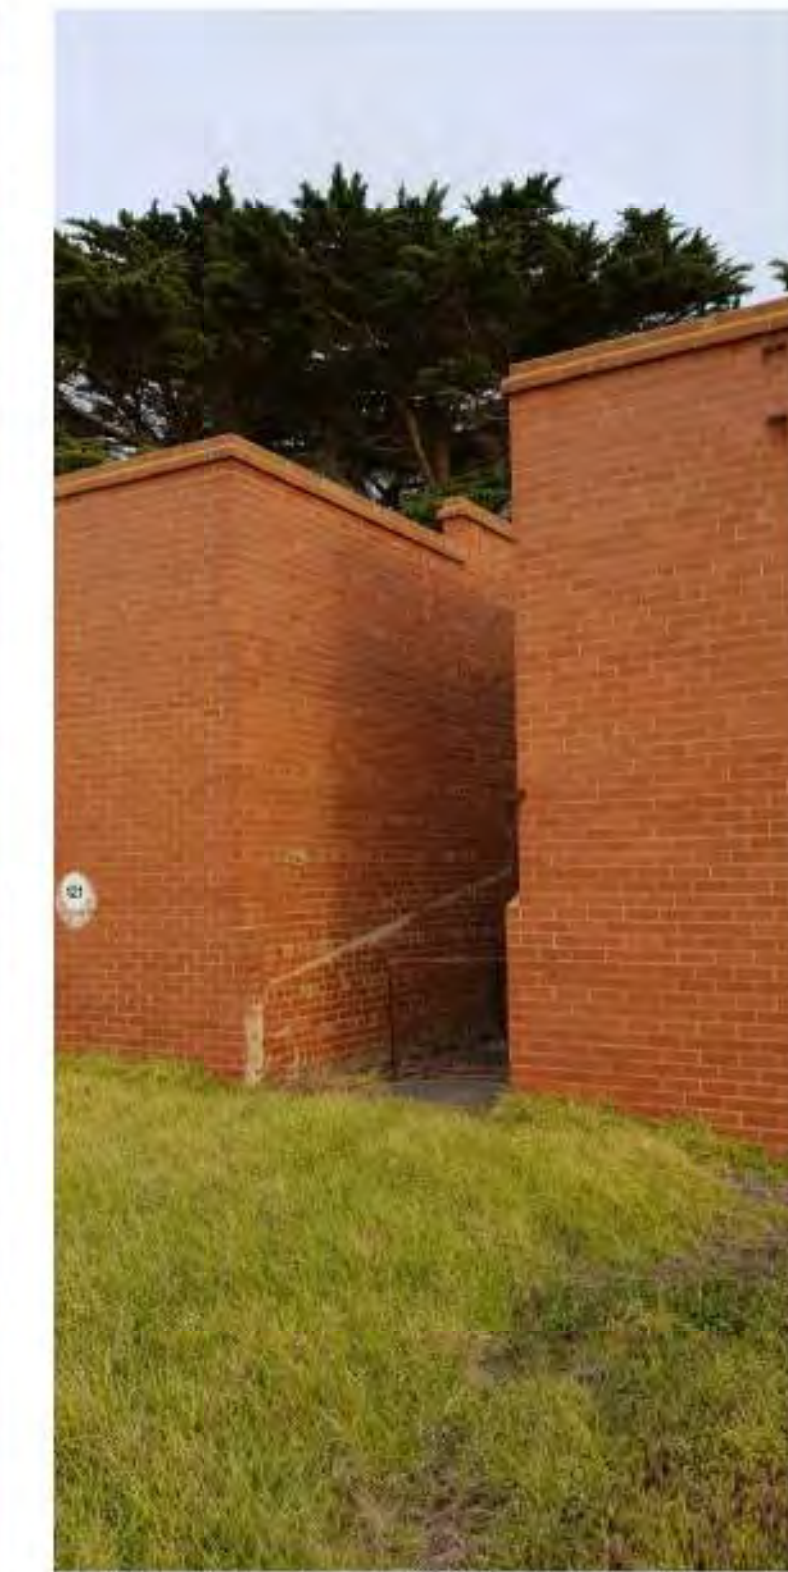
PHOTO NO 6 - VIEW OUTSIDE THE STRUCTURE, WITH VEGETATION TO BE REMOVED

- THE AREA AROUND THE BUILDING WHICH CONSISTS OF WEEDS, BUFFALO GRASS AND SMALL SHRUBS, SHOULD BE CLEARED AWAY FROM BUILDING (MIN 4.0M AROUND BUILDING) AND REMOVED FROM SITE.
- CONTRACTOR SHOULD ALSO REMOVE VEGETATION TO PROVIDE A CLEAR PATH TO THE BUILDING, ESPECIALLY THE STORE AREA SO ACCESS CAN BE PROVIDED, WITHOUT HAVING TO WALK THROUGH LONG GRASS, WEEDS, AS THIS AREA CAN BE A BREEDING GROUND FOR SNAKES.

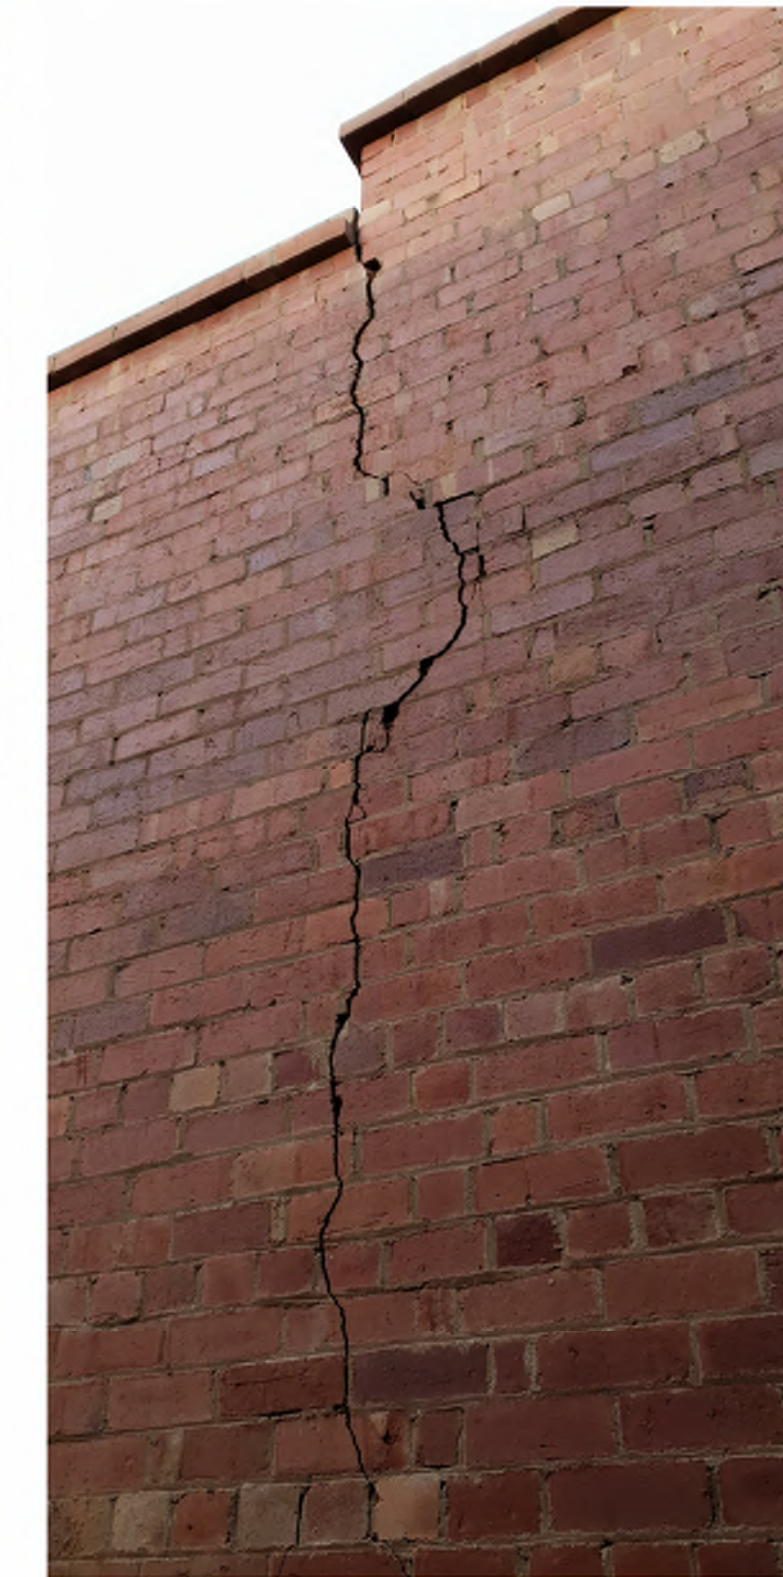
VIEW OF CRACK IN WALL

- THE STRUCTURE AND SHED SHOULD BE FULLY DEMOLISHED AND REMOVED FROM SITE.
- CONTRACTORS SHOULD BE PROVIDED ACCESS TO EXISTING ASBESTOS REGISTERS FOR THE BUILDING CONTRACTOR IS TO ENSURE ANY ASBESTOS PRESENT IS TO BE DISPOSED OF PROPERLY AND IN ACCORDANCE WITH REGULATIONS, AND COUNCIL GUIDELINES.
- ANY SERVICE PITS, PIPING, ETC SHOULD BE CAPPED AND DEMOLISHED.
- CONTRACTOR IS TO ALLOW TO LEVEL THE AREA AFTER REMOVAL OF THE BUILDING AND PROVIDE NEW SOIL AND SEEDING TO THE SITE AREA, LEVEL WITH ADJACENT GROUND.

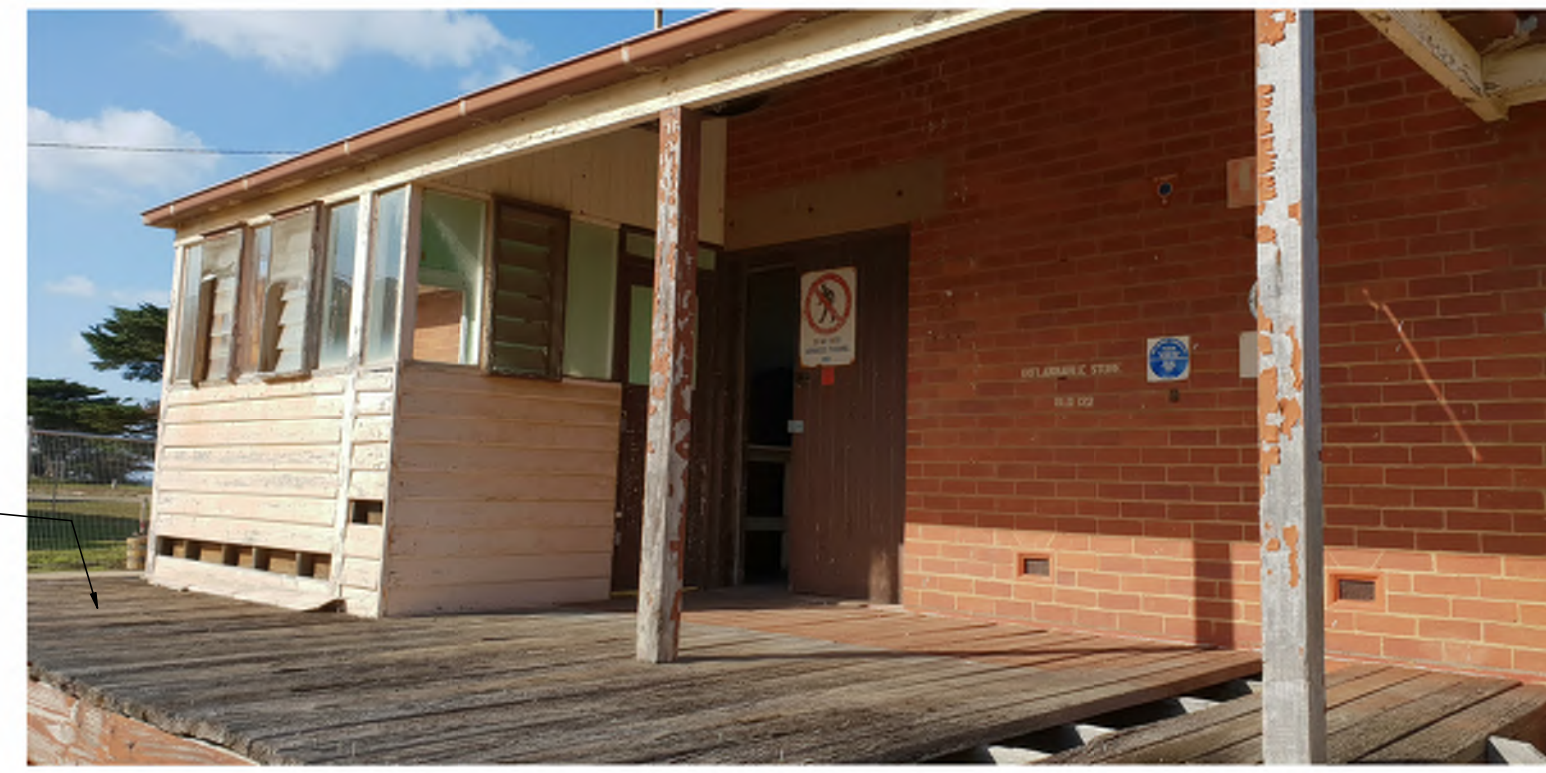
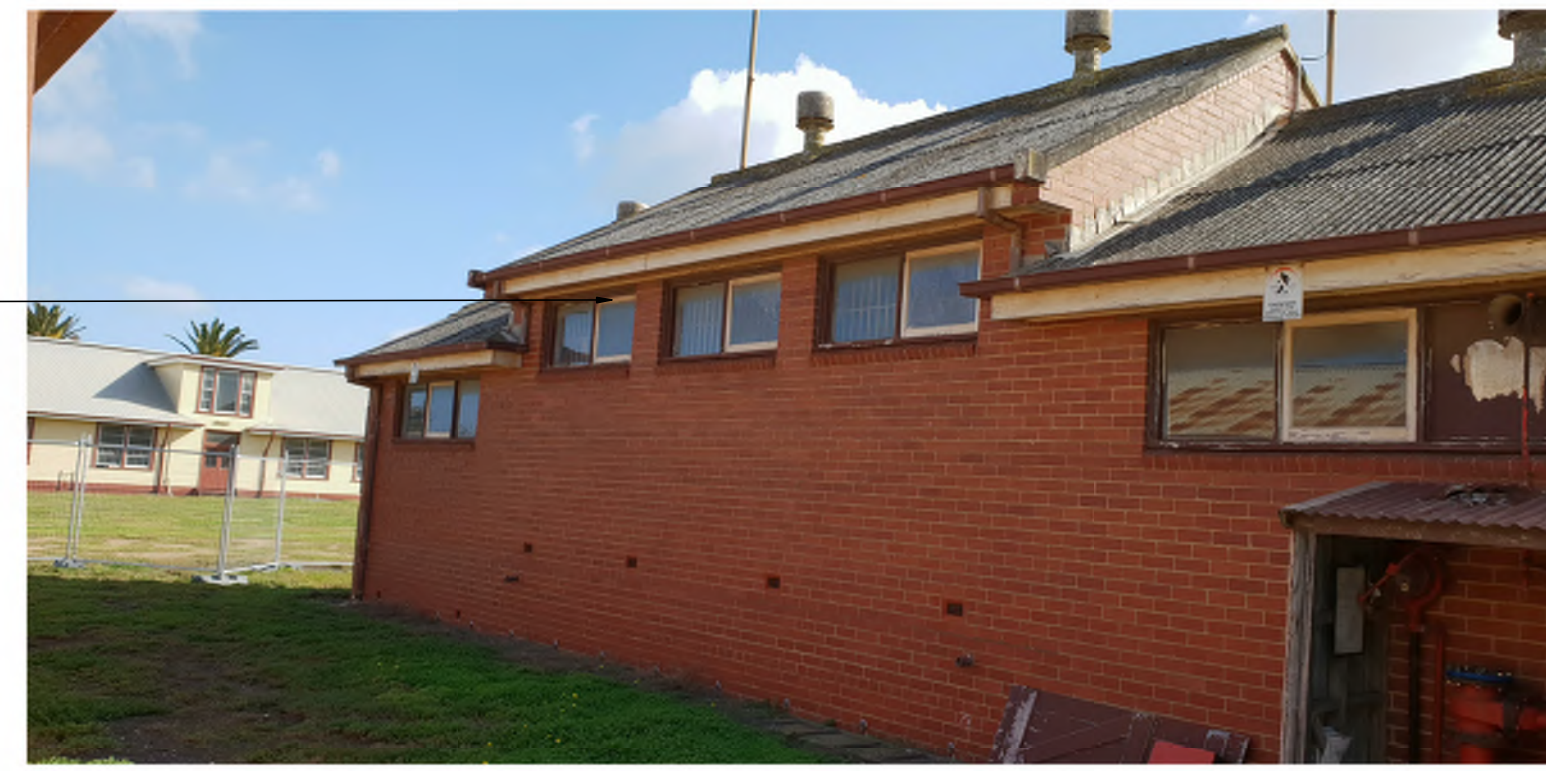
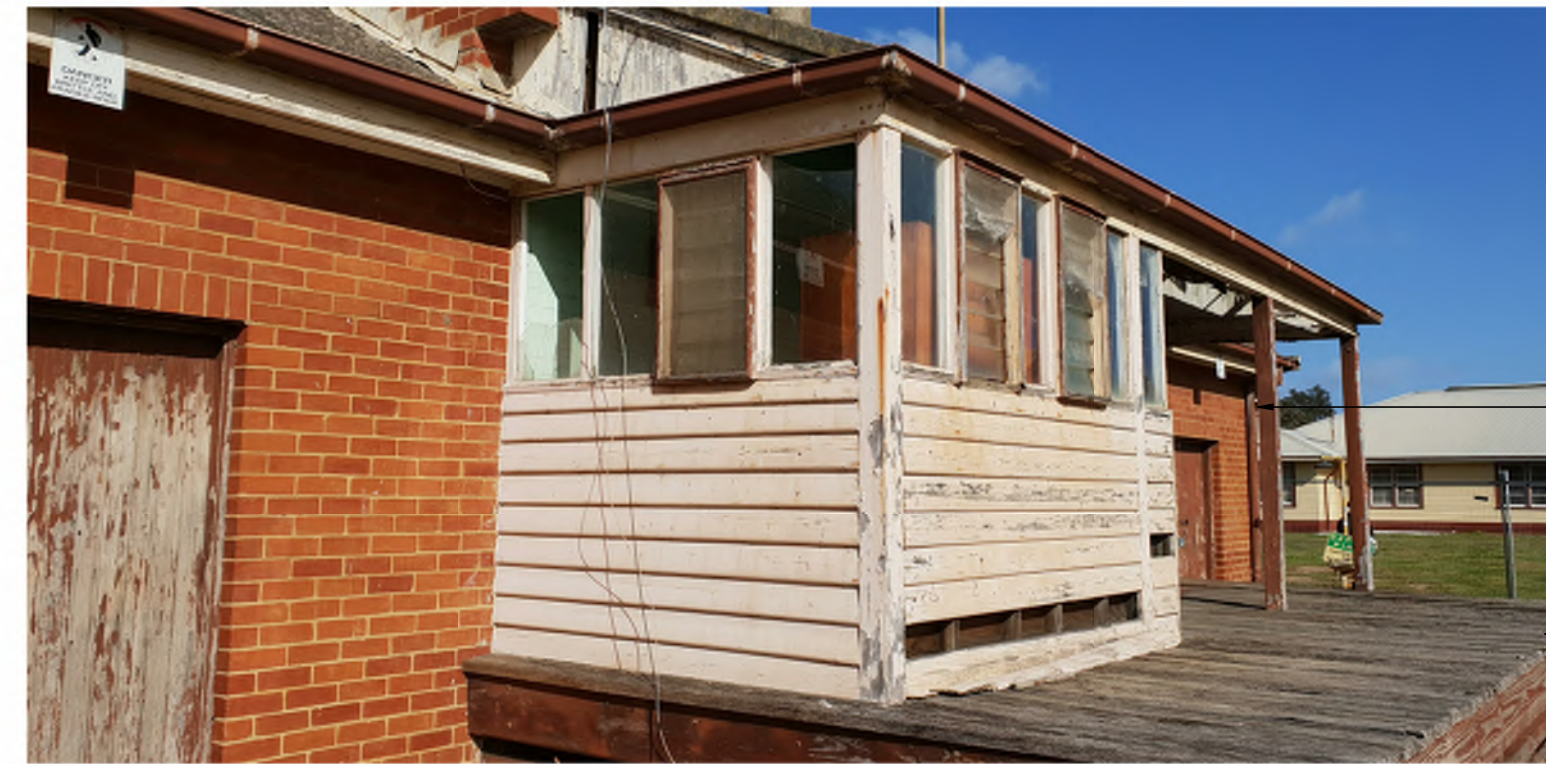
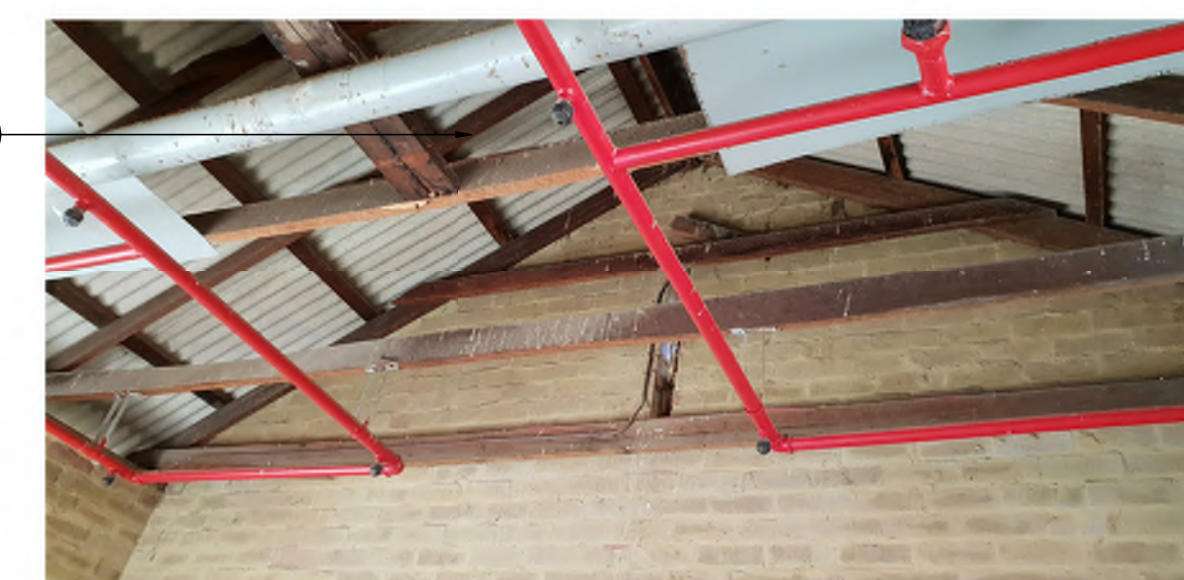
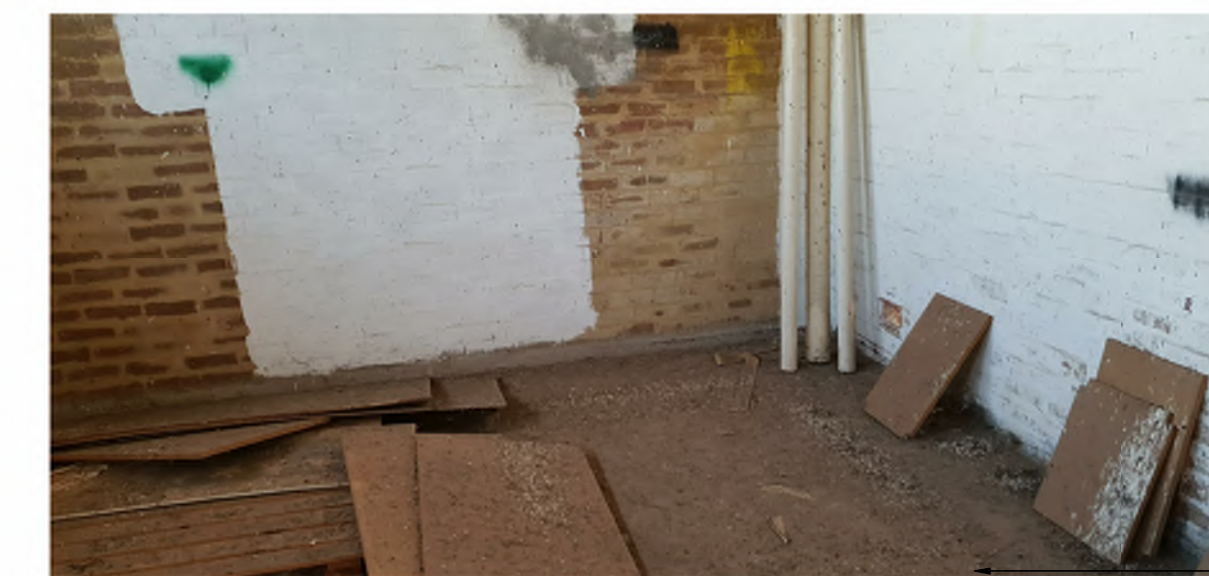
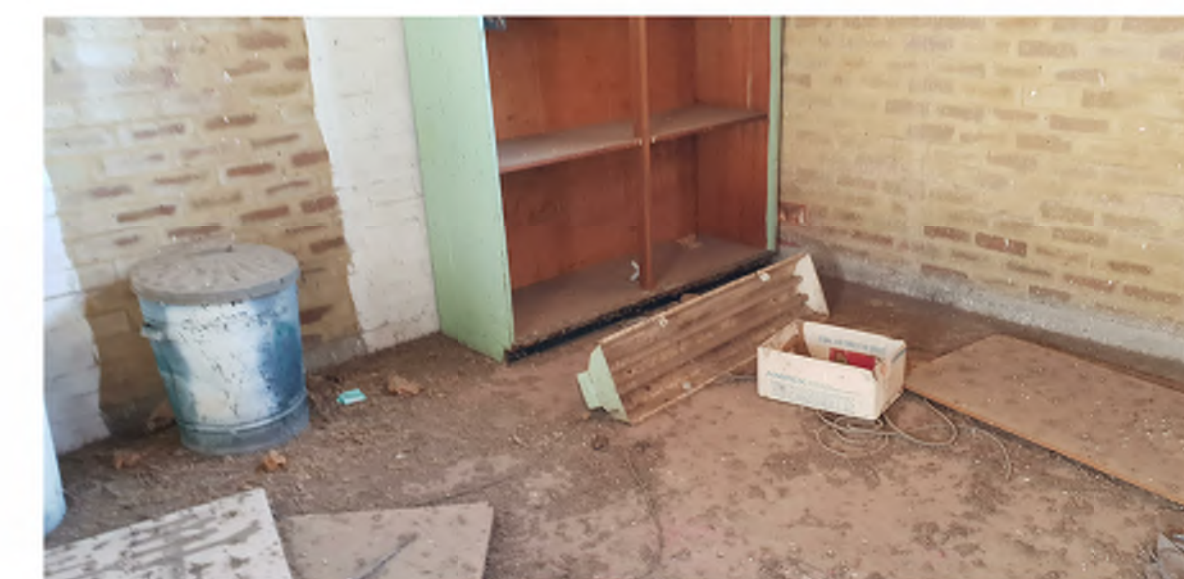
IMAGES OF TYPICAL DETERIORATION

- 6 CEILING
THERE IS NO CEILING LININGS TO HAZARDOUS STORES, AND THE EXISTING ROOF TRUSS IS EXPOSED. REMOVE EXISTING ROOF SHEETING AND REPLACE WITH NEW, INCLUDING SAFETY WIRE MESH AND INSULATION.

- 7 DOORS
EXISTING EXTERNAL DOORS AND DOOR FRAMES HAVE DETERIORATED AND WILL NEED TO BE REPLACED WITH NEW TIMBER DOOR FRAMES AND NEW SOLID TIMBER DOORS, PRIMED AND PAINTED TO MATCH EXISTING. REPLACE EXISTING DOOR HARDWARE WITH NEW DDA COMPLIANT DOOR HARDWARE.

- 13 REPLACE EXISTING RUSTING DAMAGED PIT COVER NEAR FRONT OF BUILDING AND PRESSURE CLEAN EXISTING DRAINS.
- 14 ALL ELECTRICAL FITTINGS TO BUILDING NEED TO BE CHECKED AND WHERE REQUIRED REPLACED WITH NEW FITTINGS.

- 4 REPLACE ALL TIMBER FASCIA BOARDS AND BARGE BOARDS WITH NEW PRIMED AND PAINTED BOARDS. REPLACE ALL SOFFIT LININGS, WITH NEW 10M VILLABOARD LINING, PAINTED TO MATCH EXISTING.

- 8 WINDOWS
ALLOW TO SAND BACK EXISTING WINDOWS, INCLUDING FRAMES AND PREPARE AND PAINT SURFACES WITH NEW PRIMER AND NEW PAINT TO MATCH EXISTING. REPLACE DAMAGED GLAZING TO WINDOWS.

- 9 EXTERNAL WORKS
ALLOW TO CAP AND SEAL SERVICES TO EXISTING EXTERNAL EMERGENCY SHOWER AND REMOVE SHOWER FOR SITE, INCLUDING REDUNDANT PIPING.
- 10 REPLACE ALL EXTERNAL LIGHT FITTINGS WITH NEW FITTINGS.

- 11 REPLACE EXISTING VENT IN ROOF WITH NEW STAINLESS STEEL ROTARY VENTS.
- 12 CAP AND SEAL SERVICES TO FIRE PUMP, HYDRANT IN REAR COVERED SHED, AND REMOVE ALL FITTINGS FROM SITE.

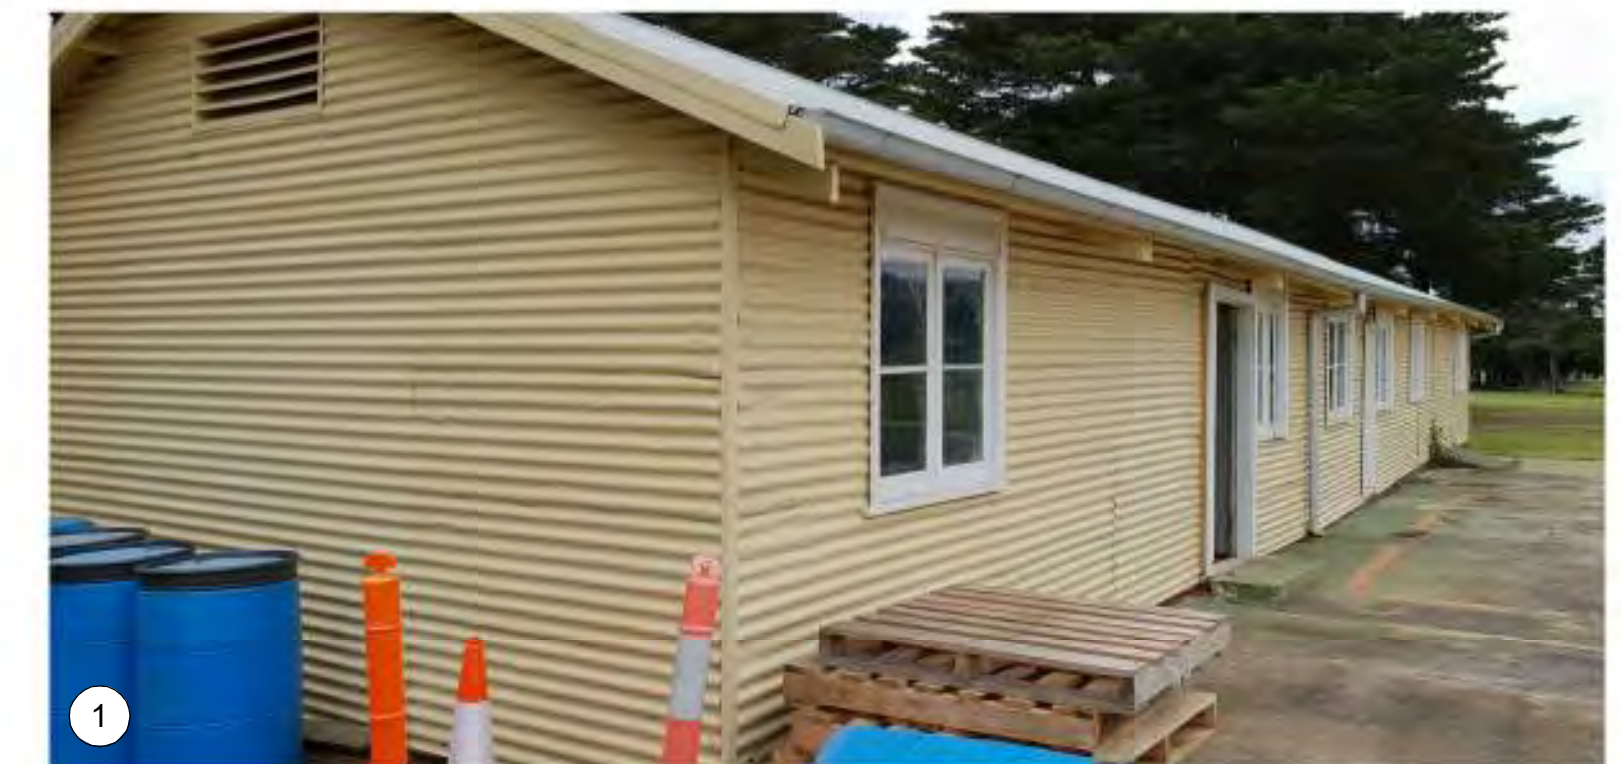
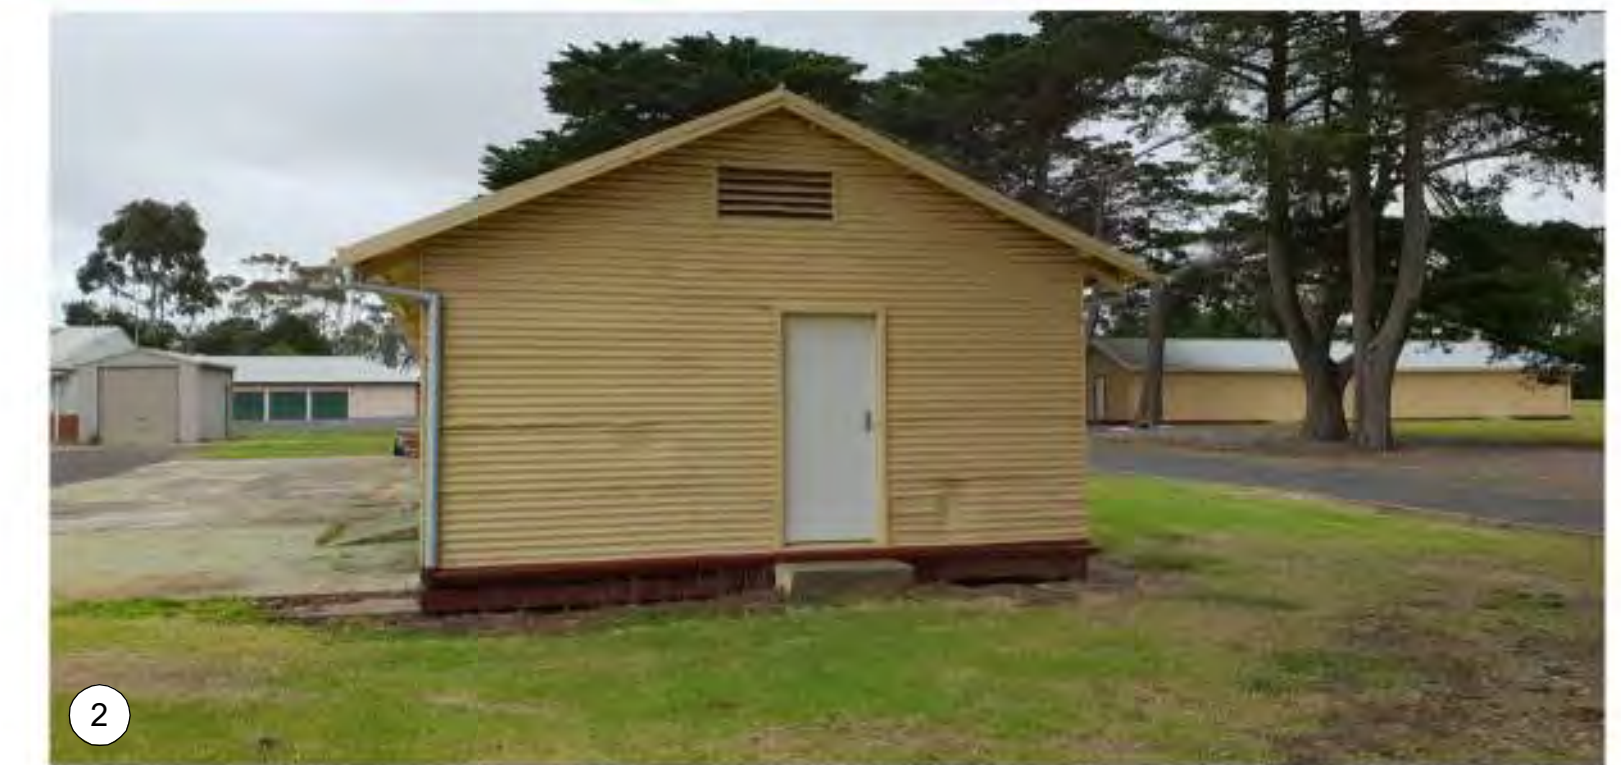
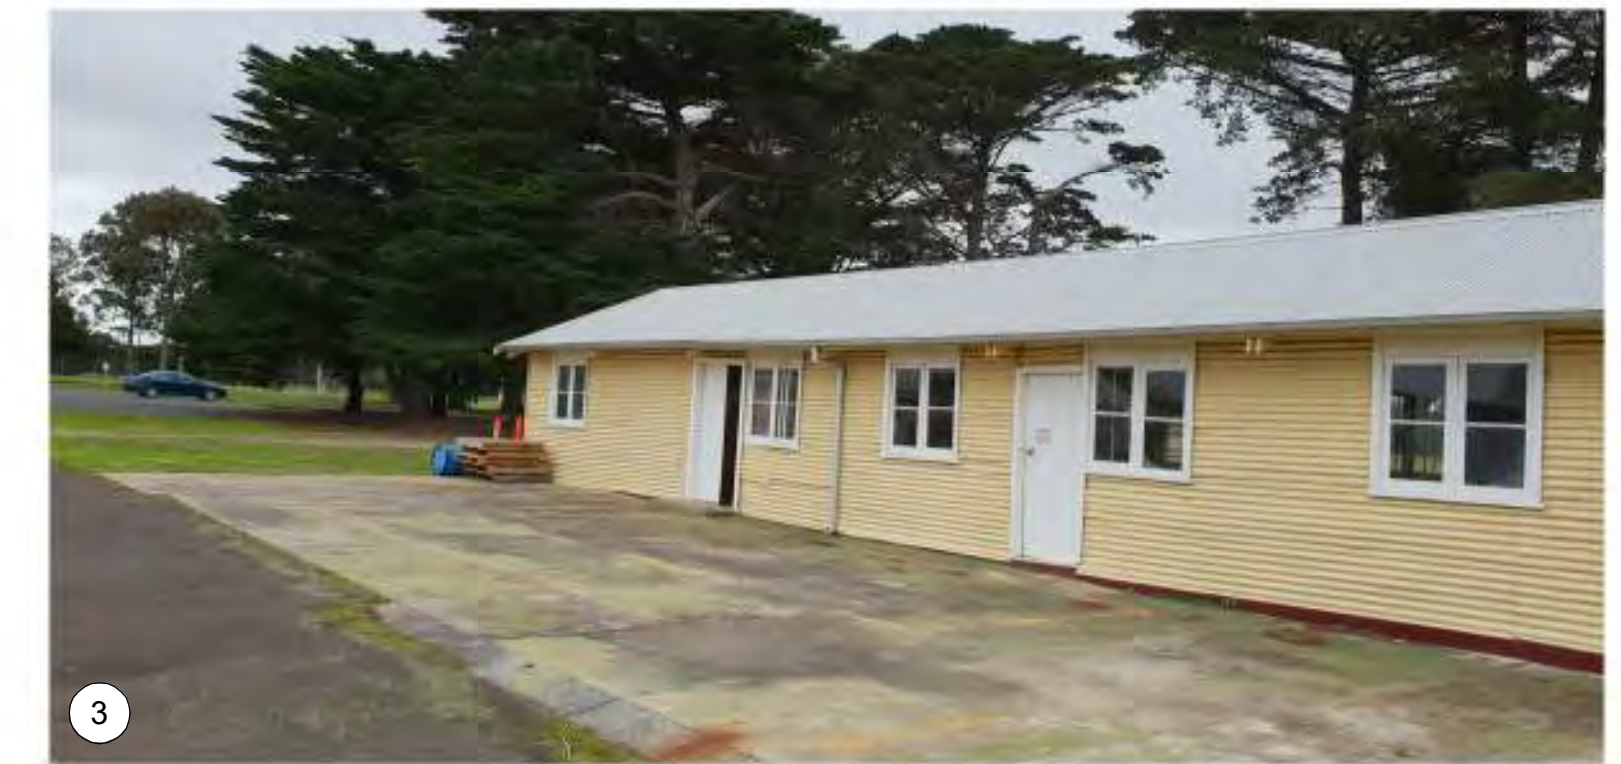
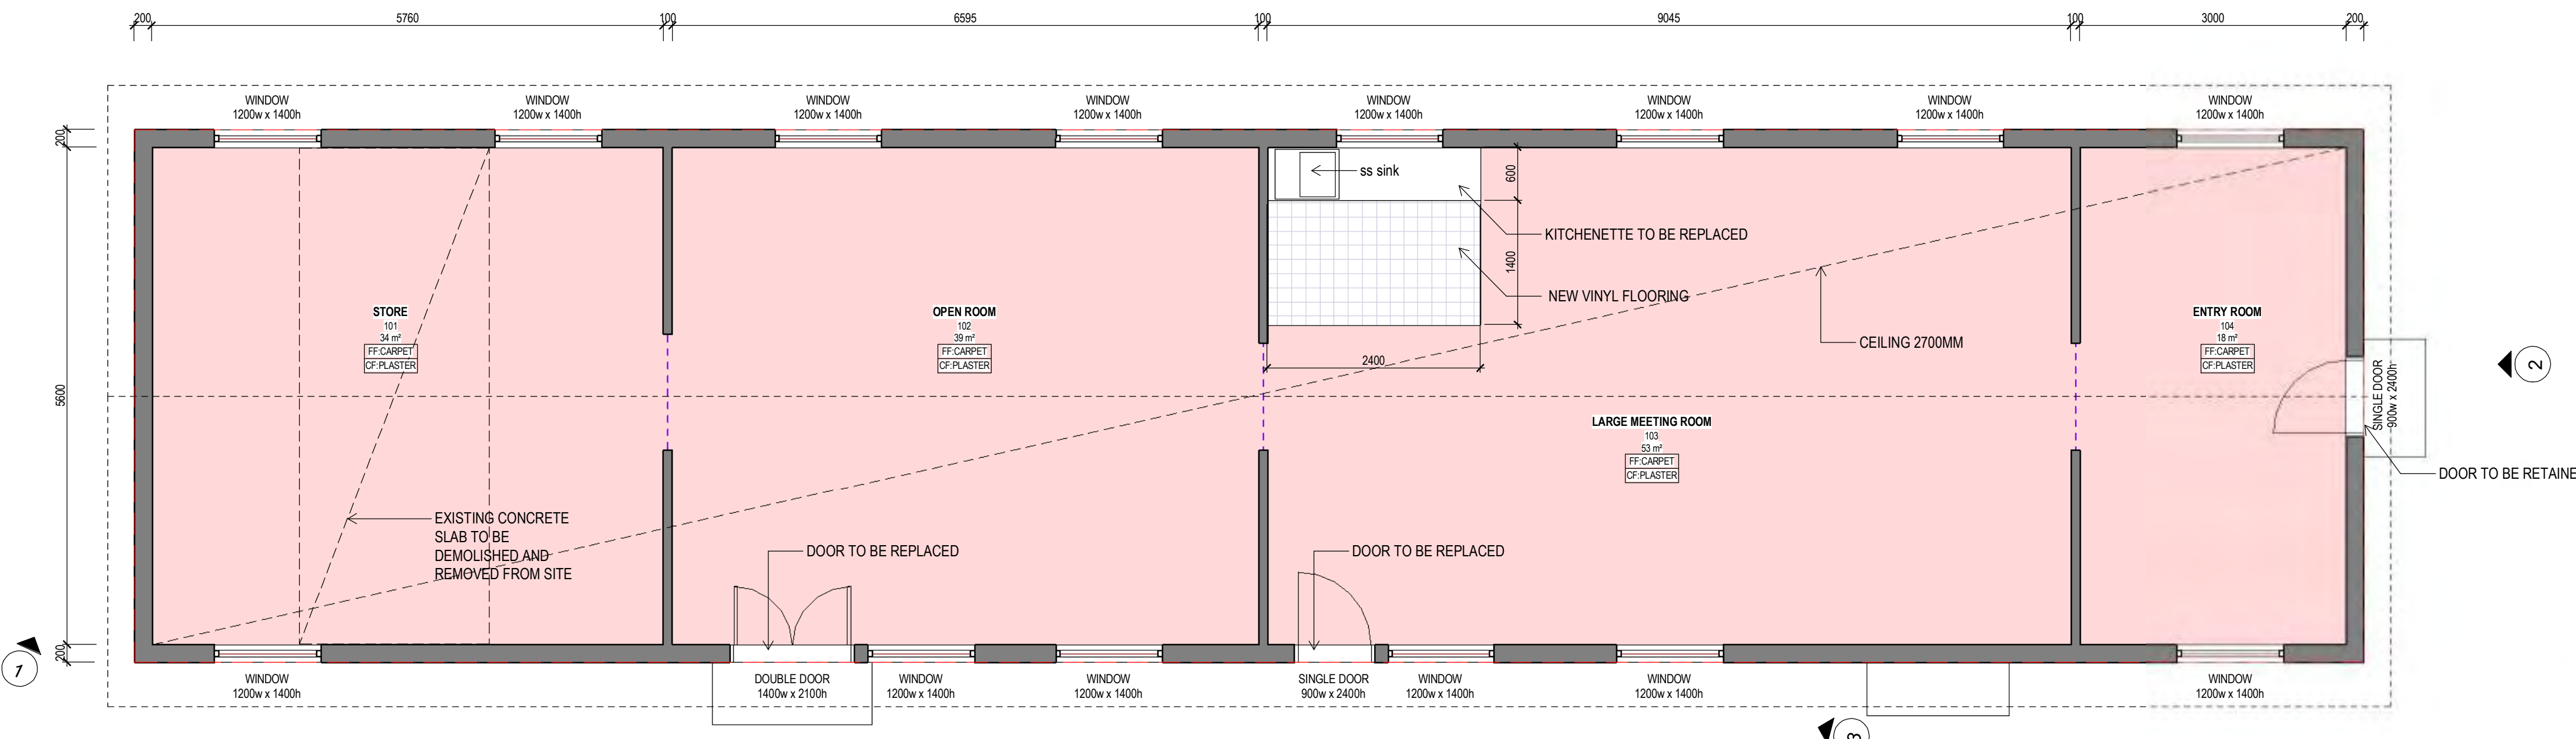
1 BUILDING A0125 - EXISTING CONDITIONS - NEW REFURBISHMENT WORKS
1:50

- THE EXISTING EXTERNAL AND INTERNAL WALLS, WHICH WERE NOT PLUMB AND STRAIGHT, SHOULD BE SET LEVEL AFTER THE BUILDING IS RESTUMPED. EXTERNAL WALL LININGS, WHICH CONSIST OF PAINTED CORRUGATED SHEETING SHOULD BE REPLACED WITH NEW MATCHING CORRUGATED SHEETING.

- THE EXTERNAL TIMBER WINDOWS WHICH ARE UNABLE TO BE OPENED, SHOULD BE ABLE TO BE OPENED AFTER BUILDING HAS BEEN RESTUMPED. REPLACE INTERIOR AND EXTERIOR CASINGS TO WINDOWS, AND CONTRACTOR TO ENSURE THAT ALL WINDOWS ARE OPERABLE.

- EXISTING BUILDING SHOULD BE RESTUMPED, INCLUDING NEW CONCRETE PADS, NEW 90 X 90 CONCRETE STUMPS, NEW TIMBER BEARERS AND FLOOR JOISTS, AND 18MM STRUCTURAL SHEETING TO THE WHOLE OF THE BUILDING.
- EXISTING BUILDING FLOORING IS A MIXTURE OF TIMBER FLOORBOARDS, AND LARGE CONCRETE PAD, WHICH SIT IN THE CENTRE OF THE BUILDING.
- EXISTING CONCRETE PAD SHOULD BE DEMOLISHED AND REMOVED FROM SITE PRIOR TO REPLACEMENT OF THE EXISTING FLOOR STRUCTURE.
- CONTRACTOR SHOULD ALLOW TO PROVIDE NEW SELECTED CARPET TILES TO THE BUILDING AS WELL AS VINYL SHEETING TO THE AREA NEAR THE KITCHEN.

- INTERNAL WALL LININGS AND CEILING LININGS SHOULD BE REMOVED AND REPLACED WITH NEW PAINTED 10MM PLASTERBOARD LININGS TO THE WHOLE OF THE BUILDING AND ALLOW FOR NEW PAINTED TIMBER SKIRTINGS, ARCHITRAVES TO THE WHOLE OF THE BUILDING.

- RETAIN EXISTING SINGLE DOOR TO EAST ELEVATION
- REMOVE EXISTING SINGLE AND DOUBLE DOORS TO SOUTH ELEVATION AND REPLACE WITH NEW TIMBER DOORS, MATCHED TO EXISTING, INCLUDING NEW DOOR HARDWARE.

- EXISTING ROOF STRUCTURE WHICH CONSISTS OF TIMBER FRAMED ROOF TRUSSES, AND TIMBER ROOF BATTENS LOOK IN GOOD CONDITION.
- EXISTING ZINCALUME CORRUGATED ROOF SHEETING IS IN VERY GOOD CONDITION AND DOES NOT NEED TO BE REPLACED
- EXISTING METAL GUTTERS AND DOWNPIPES NEED TO BE REPLACED. GUTTERS SHOULD BE SET TO LINE AND TO FALL TO OUTLETS. NEW 90MM DIA DOWNPIPES SHOULD BE INSTALLED AND THEY SHOULD BE CONNECT INTO EXISTING STORMWATER DRAINAGE SYSTEM.
- REPLACE EXISTING SOFFIT LINING WITH NEW 9MM VILLABOARD LINING, PAINTED FINISH.

- EXISTING INTERNAL KITCHENETTE SHOULD BE DEMOLISH AND REMOVED FROM SITE AND REPLACED WITH NEW KITCHENETTE IN SAME CONFIGURATION, WITH NEW SINGLE STAINLESS STEEL SINK AND TAPS, AND NEW CABINERY.
- ALLOW TO PROVIDE HOT AND COLD WATER TO SINK WITH NEW UNDERBENCH HOT WATER UNIT.

- ALL SERVICES TO THE BUILDING WOULD NEED TO BE CAPPED AND CUT TO THE BUILDING PRIOR TO ANY WORKS PROCEEDING.
- THIS WOULD INCLUDE ELECTRICAL, MECHANICAL, AND HYDRAULIC SERVICES TO THE BUILDING.
- FITTINGS WOULD ALSO NEED TO BE REMOVED AND THESE INCLUDE EXISTING SINK.
- OTHER SERVICES THAT NEED TO BE CUT WOULD INCLUDE STORMWATER DOWNPIPES, WATER PIPING AND ANY ELECTRICAL CONDUITS THAT SERVICE THE BUILDING AND THESE SHOULD BE REPLACED WITH NEW SERVICES.
