PRELIMINARY DOCUMENTATION REPORT

Demolition of Structures at RAAF Williams – Point Cook, Victoria

(EPBC 2019/8514)

November 2023

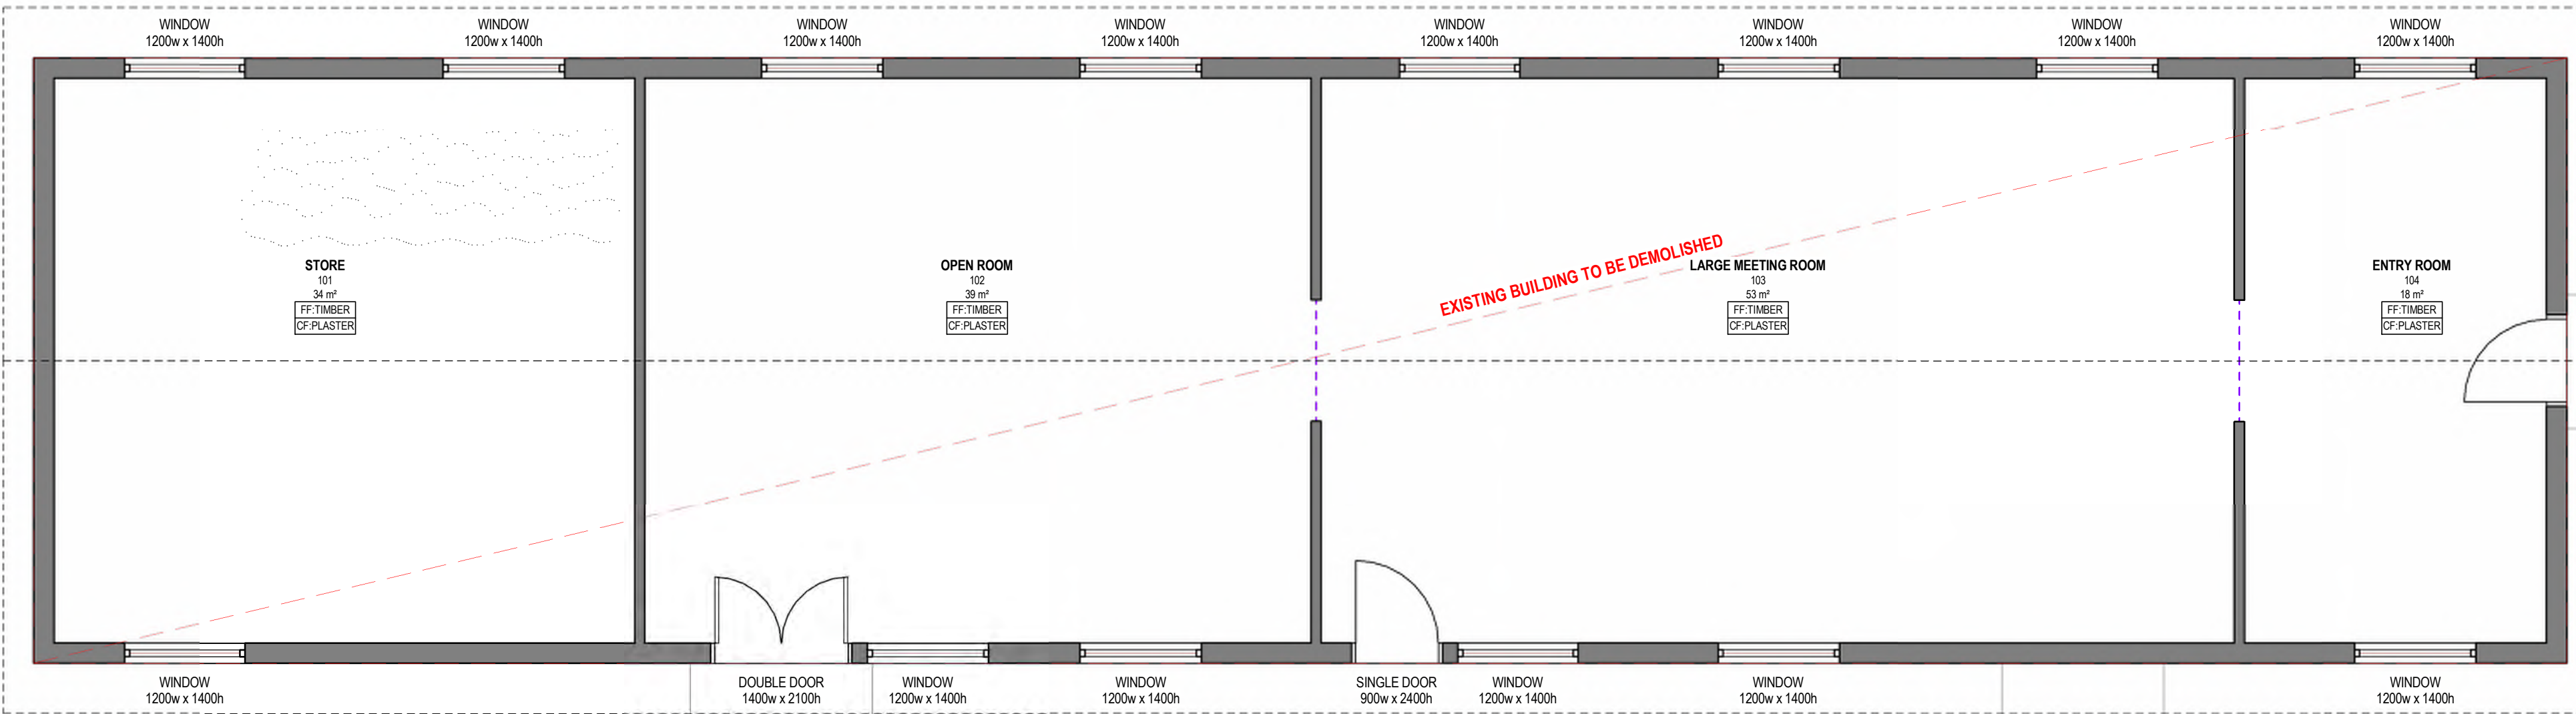
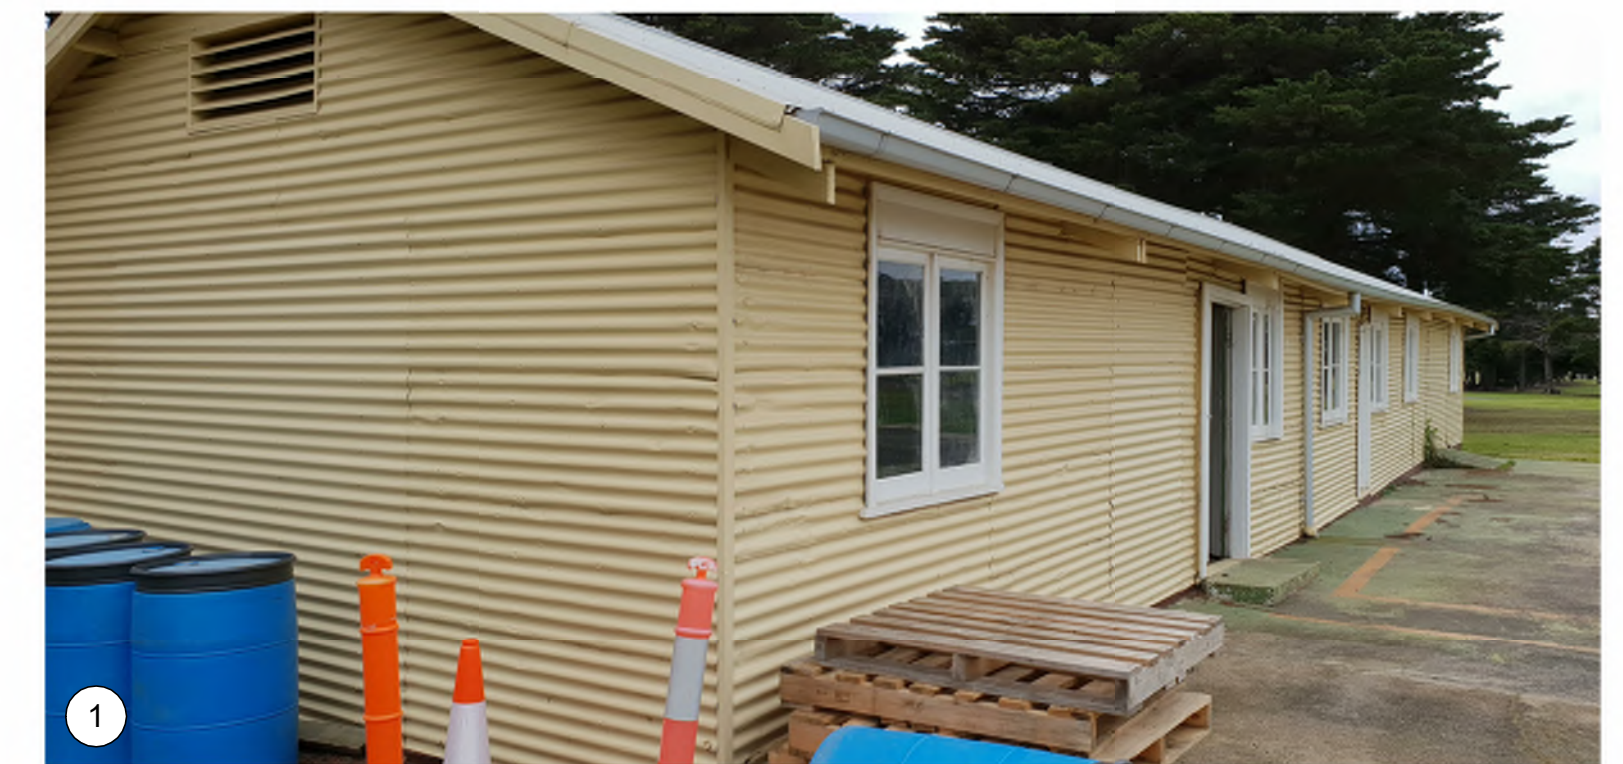
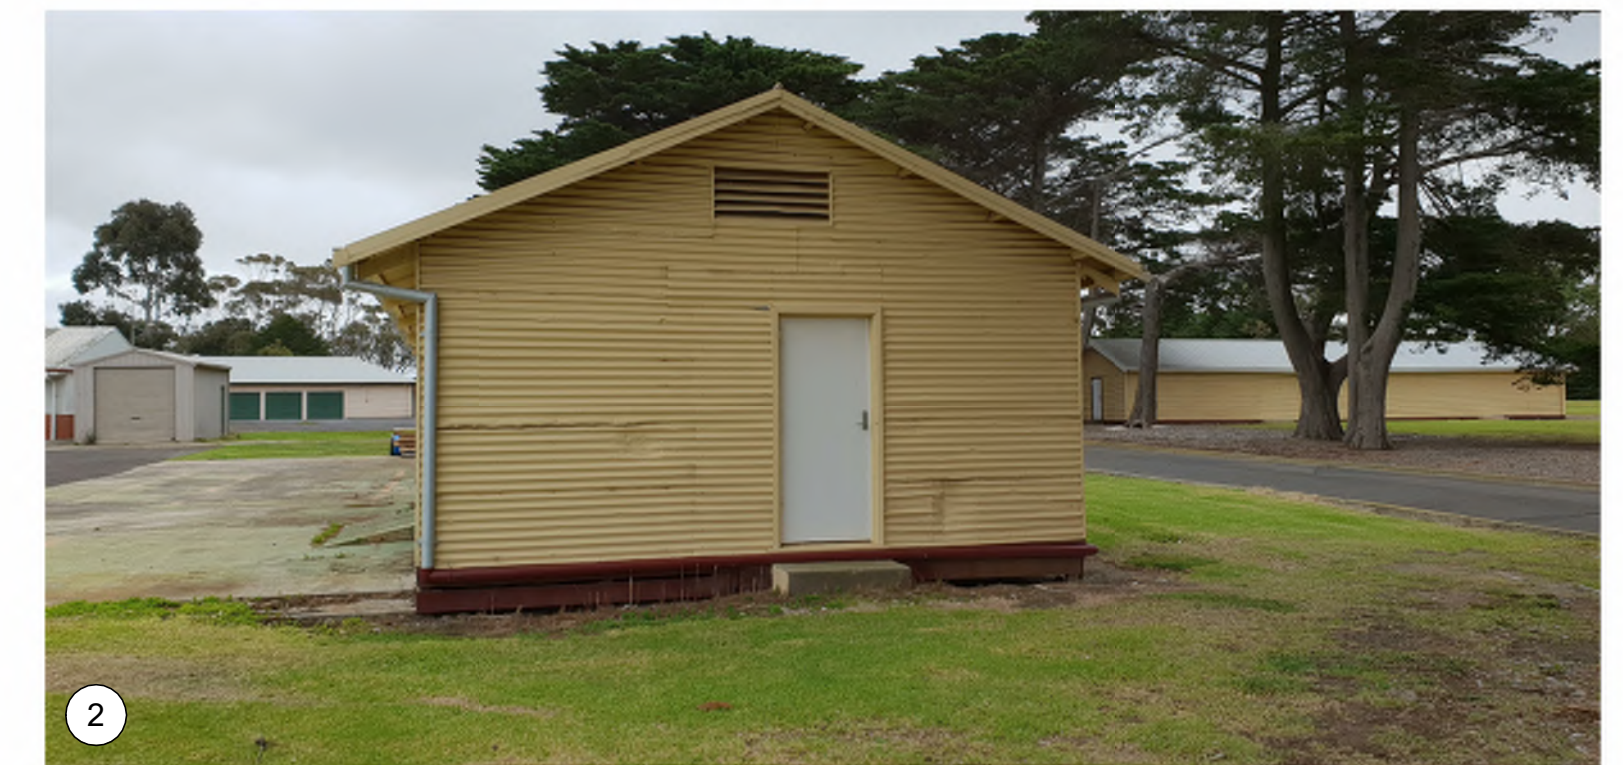
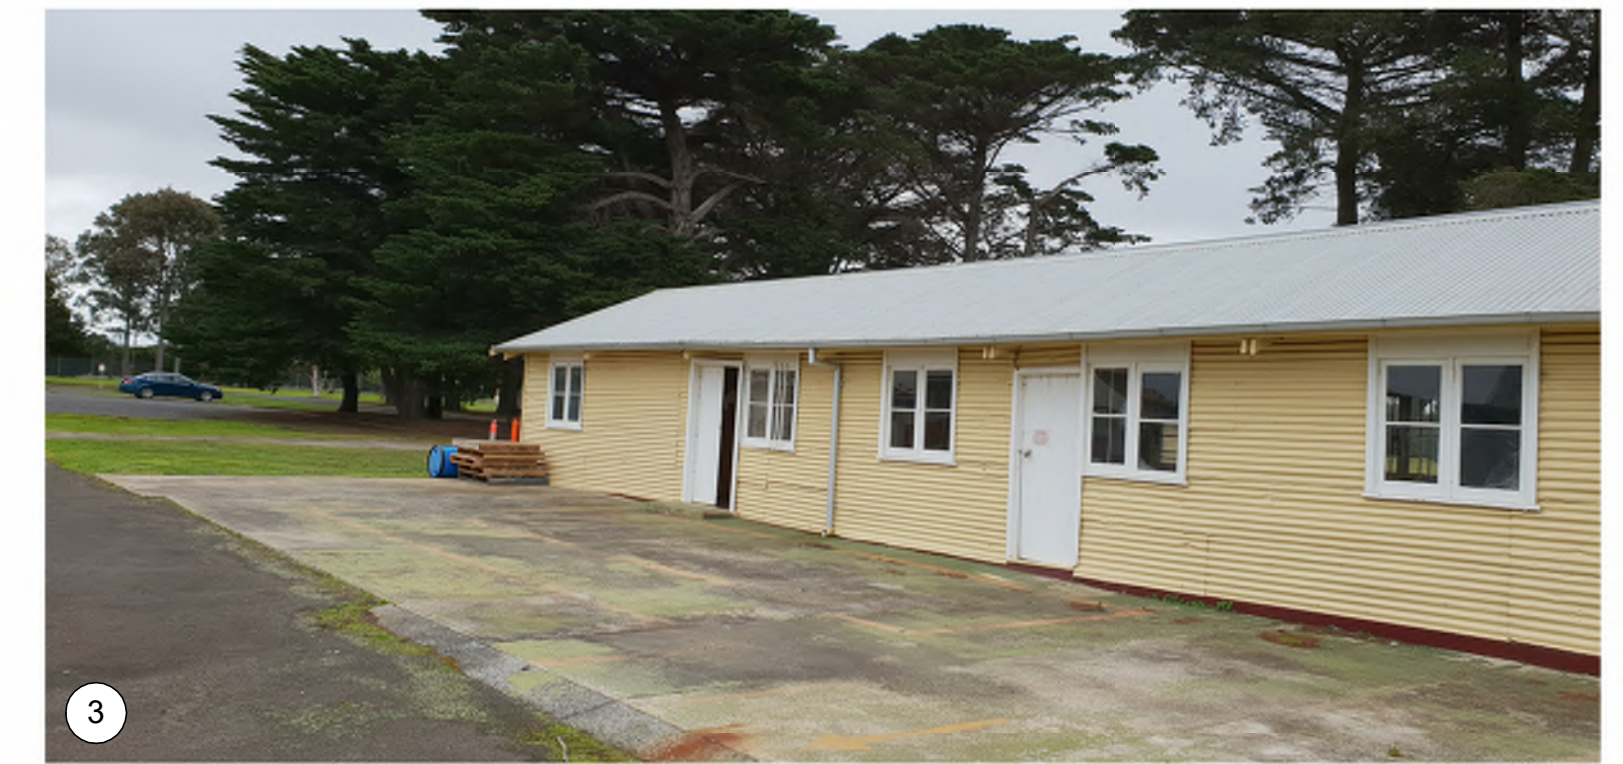
1 BUILDING A0125 - EXISTING CONDITIONS / DEMOLITION PLAN

- EXISTING EXTERNAL METAL WALL SHEETING IS DAMAGED AND THE INTERNAL TIMBER WALLS STUDS WHICH ARE NOT STRAIGHT AND PLUMB MAKES THE METAL SHEETING LOOK DISTORTED AND NOT STRAIGHT.
- THE METAL SHEETING HAS BEEN PAINTED NUMEROUS TIMES AND IS PEELING AND FLAKING, WHICH WOULD NEED TO BE REPLACED.
- THE EXTERNAL TIMBER WINDOWS ARE UNABLE TO BE OPEN DUE TO THE EXISTING WALLS MOVEMENT, AND WHILE THEY ARE IN GOOD CONDITION, THE BUILDING WOULD NEED TO BE RESTUMPED AND WALLS JACKED UP TO PROVIDE A LEVEL SURFACE WHICH WOULD ALLOW OPERATION OF THE WINDOWS.

- EXISTING METAL ROOFING, GUTTERS AND DOWNPIPES ARE IN GOOD CONDITION, AND COULD BE SALVAGED FOR REUSE.
- TIMBER FASCIAS, SOFFIT LININGS ARE ROTTING AND DAMAGED. DUE TO THE DAMAGE AND FAILING OF THE BUILDING STRUCTURE THE STRUCTURAL INTEGRITY OF THE BUILDING SHOULD BE FURTHER PROOF THAT THE BUILDING SHOULD BE DEMOLISHED.

- THE BUILDING SHOULD BE TOTALLY DEMOLISHED AND REMOVED FROM SITE.
- CONTRACTORS SHOULD BE PROVIDED ACCESS TO EXISTING ASBESTOS REGISTERS FOR THE BUILDING. CONTRACTOR IS TO ENSURE ANY ASBESTOS PRESENT IS TO BE DISPOSED OF PROPERLY AND IN ACCORDANCE WITH REGULATIONS, AND COUNCIL GUIDELINES.
- THE EXISTING CONCRETE SLAB TO THE WEST SIDE OF THE BUILDING SHOULD BE BROKEN UP AND BE DISPOSED OF.
- ANY SERVICE PITS, PIPES, ETC SHOULD BE CAPPED AND DEMOLISHED.
- CONTRACTOR IS TO ALLOW TO LEVEL THE AREA AFTER REMOVAL OF THE BUILDING AND PROVIDE NEW SOIL AND SEEDING TO AREA.

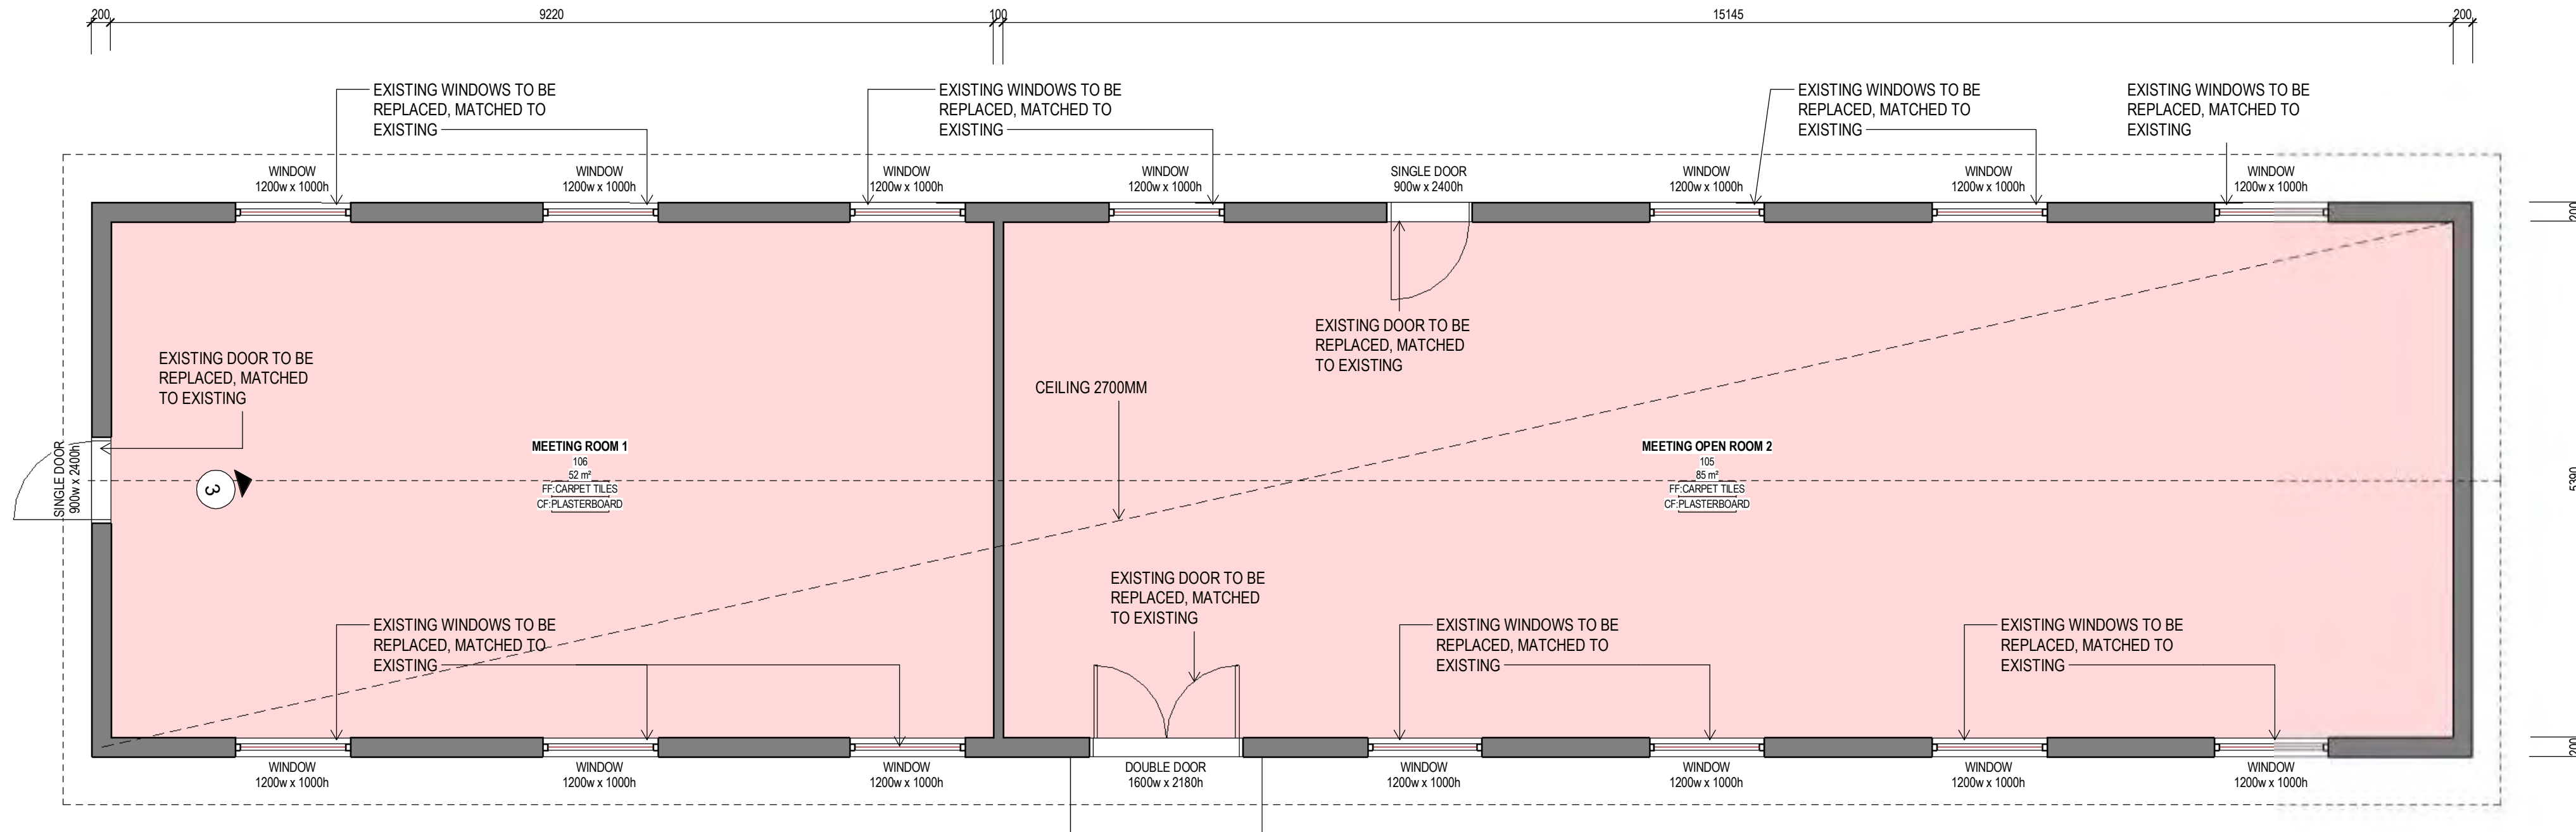
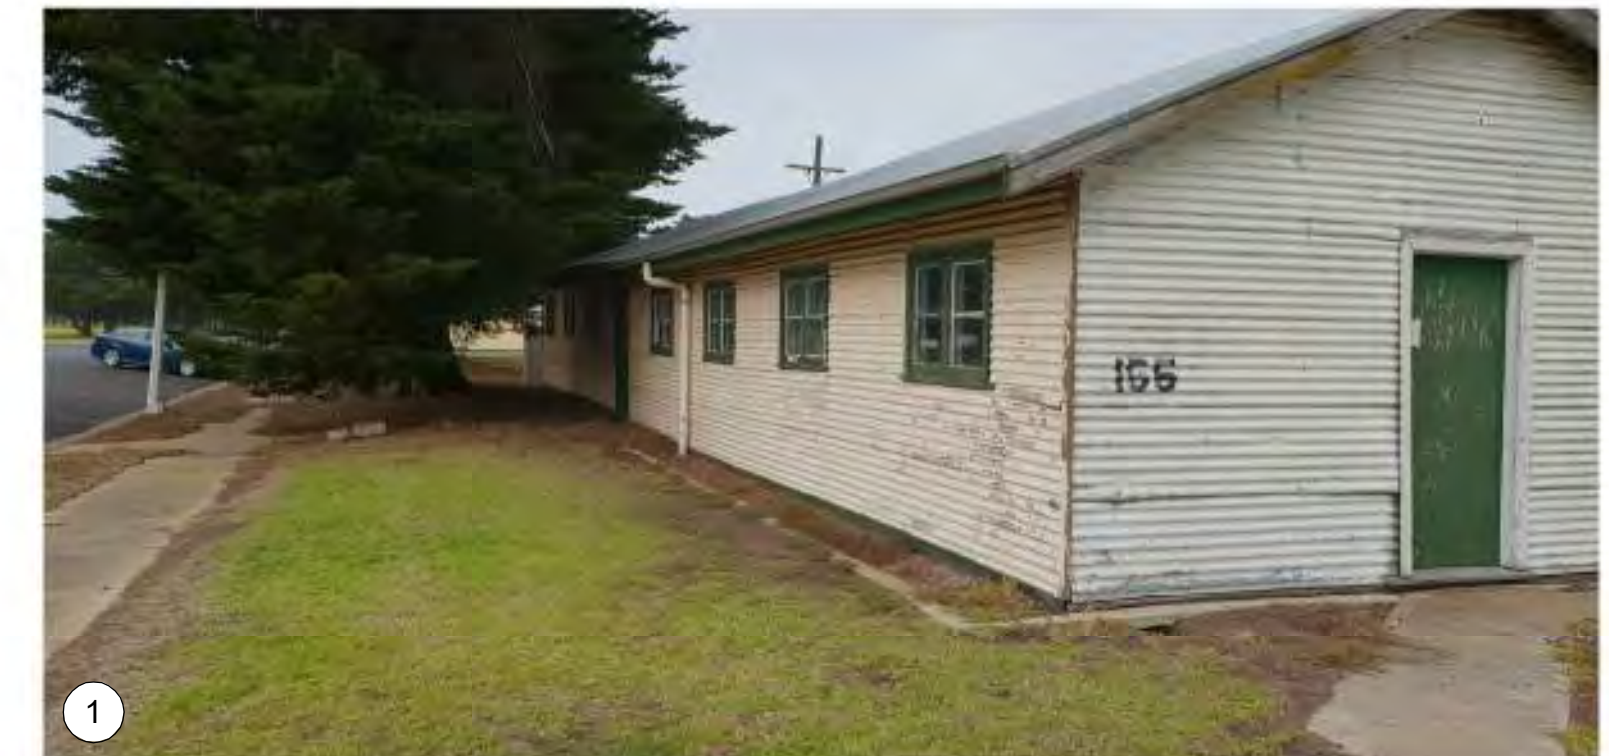
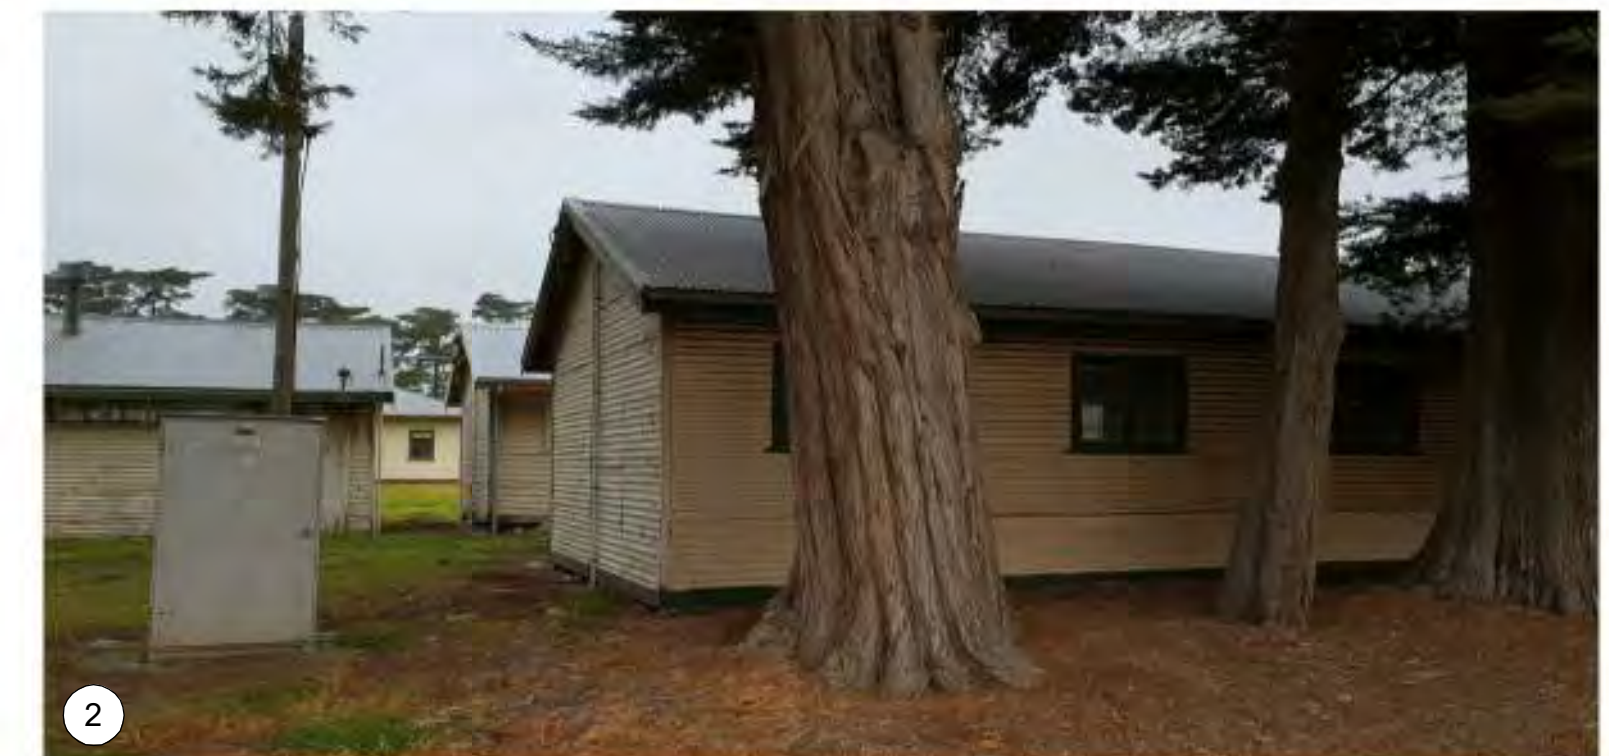
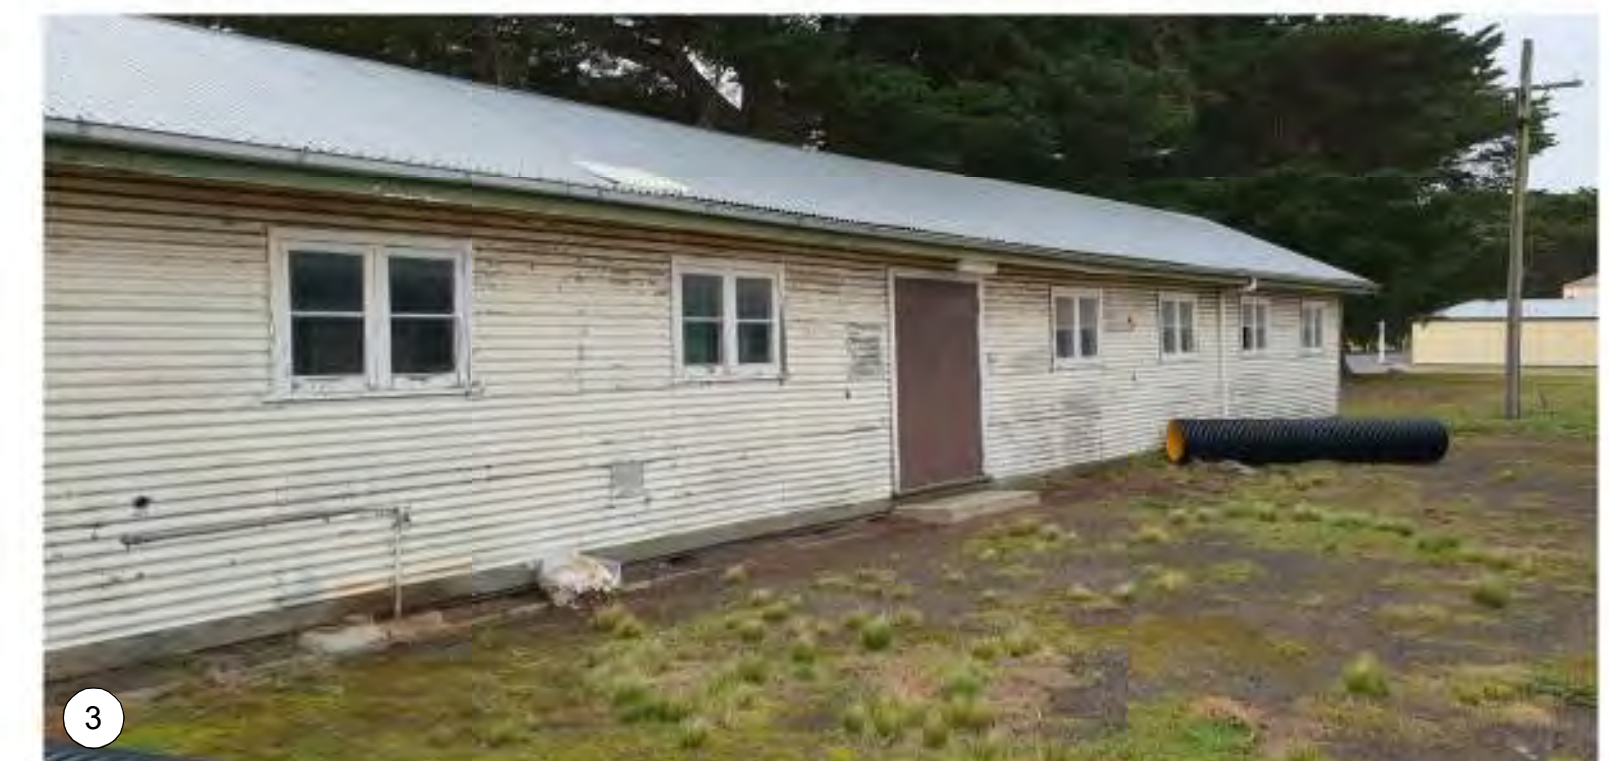
1 EXISTING CONDITIONS - REFURBISHMENT WORKS PLAN
1:50

- THE EXISTING EXTERNAL AND INTERNAL WALLS, WHICH WERE NOT PLUMB AND STRAIGHT, SHOULD BE SET LEVEL AFTER BUILDING IS RESTUMPED. EXTERNAL WALL LININGS, WHICH CONSIST OF PAINTED CORRUGATED SHEETING, SHOULD BE REPLACED.

- THE EXTERNAL TIMBER WINDOWS WHICH ARE UNABLE TO BE OPENED DUE TO ROT SHOULD BE REPLACED WITH NEW MATCHING DOUBLE HUNG WINDOWS, AND NEW WINDOW HARDWARE.

- INTERNAL WALL LININGS AND CEILING LININGS SHOULD BE REMOVED AND REPLACED WITH NEW PAINTED 10MM PLASTERBOARD LININGS TO THE WHOLE OF THE BUILDING AND ALLOW FOR NEW PAINTED TIMBER SKIRTINGS, ARCHITRAVES TO THE WHOLE OF THE BUILDING.

- REPLACE ALL SINGLE DOORS AND DOUBLE DOORS WITH NEW TIMBER DOORS, MATCHED TO EXISTING, INCLUDING NEW DOOR HARDWARE.

- EXISTING ROOF STRUCTURE WHICH CONSISTS OF TIMBER FRAMED ROOF TRUSSES, AND TIMBER ROOF BATTENS LOOK IN GOOD CONDITION.
- EXISTING TIMBER BARGE BOARDS, FASCIA BOARDS SHOULD BE REPLACED WITH NEW PRIMED AND PAINTED BOARD, SIZED TO MATCH EXISTING.
- EXISTING ZINCALUME CORRUGATED ROOF SHEETING IS IN VERY GOOD CONDITION AND DOES NOT NEED TO BE REPLACED.
- EXISTING METAL GUTTERS AND DOWNPIPES NEED TO BE REPLACED. GUTTERS SHOULD BE SET TO LINE AND TO FALL TO OUTLETS. NEW 90MM DIA DOWNPIPES SHOULD BE INSTALLED AND THEY SHOULD BE CONNECT INTO EXISTING STORMWATER DRAINAGE SYSTEM.
- REPLACE EXISTING SOFFIT LINING WITH NEW 9MM VILLABOARD LINING, PAINTED FINISH.

- ALL SERVICES TO THE BUILDING WOULD NEED TO BE CAPPED AND CUT TO THE BUILDING PRIOR TO ANY WORKS PROCEEDING.
- THIS WOULD INCLUDE ELECTRICAL, MECHANICAL, AND HYDRAULIC SERVICES TO THE BUILDING.
- FITTINGS WOULD ALSO NEED TO BE REMOVED AND THESE INCLUDE EXISTING SINK.
- OTHER SERVICES THAT NEED TO BE CUT WOULD INCLUDE STORMWATER DOWNPIPES, WATER PIPING AND ANY ELECTRICAL CONDUITS THAT SERVICE THE BUILDING AND THESE SHOULD BE REPLACED WITH NEW SERVICES.

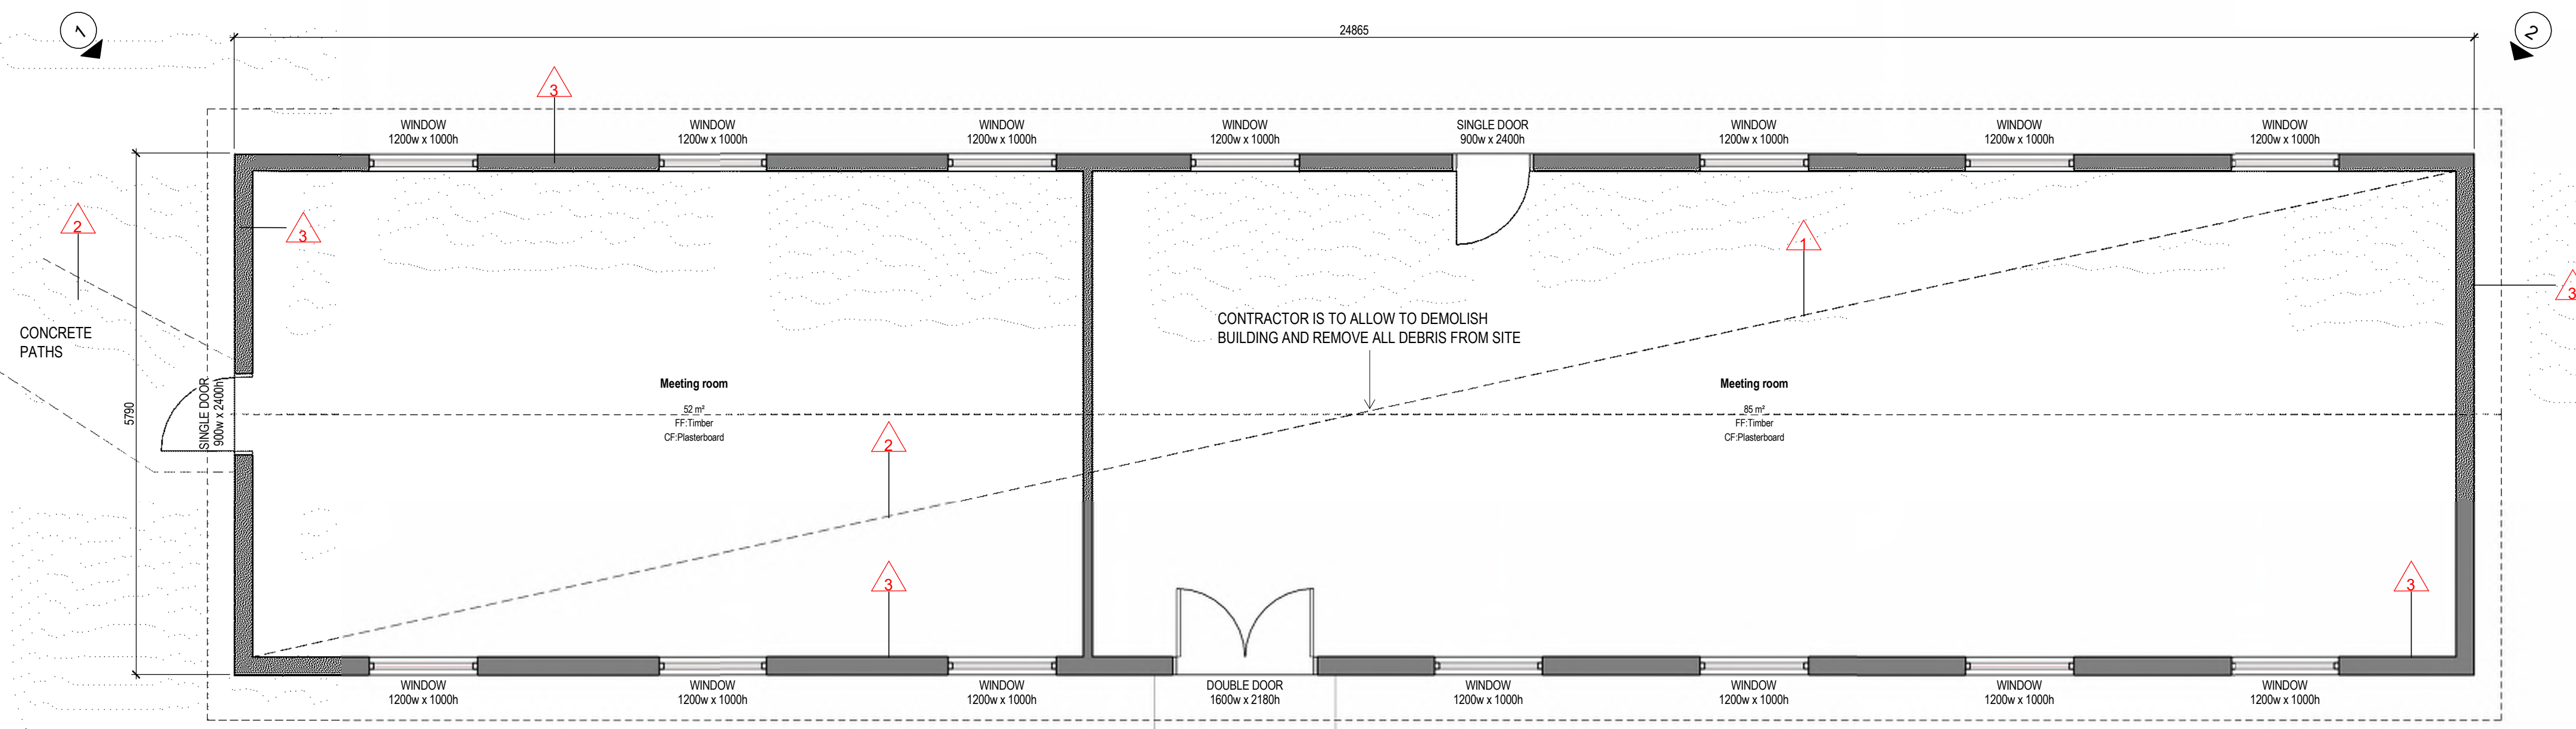
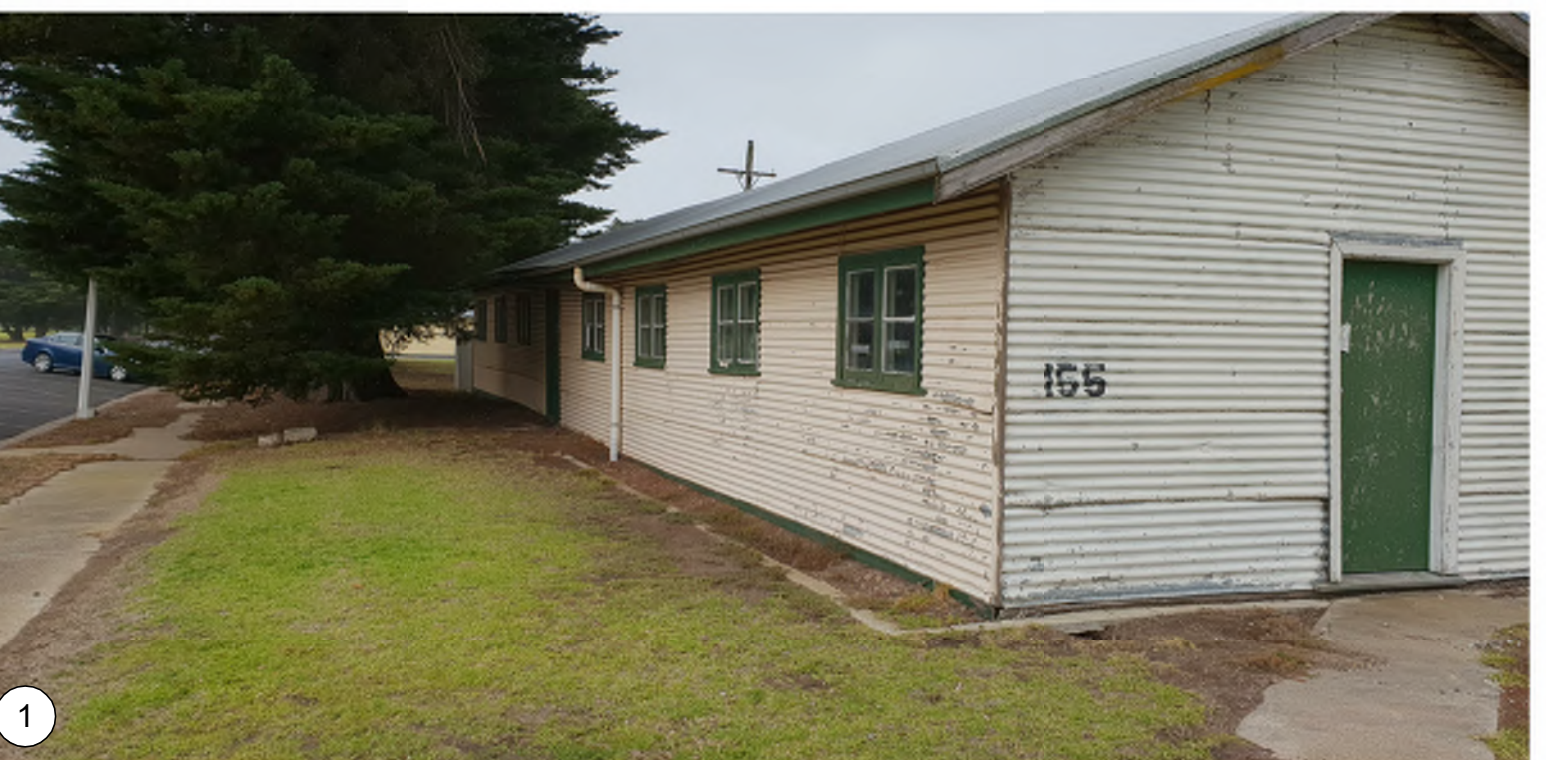
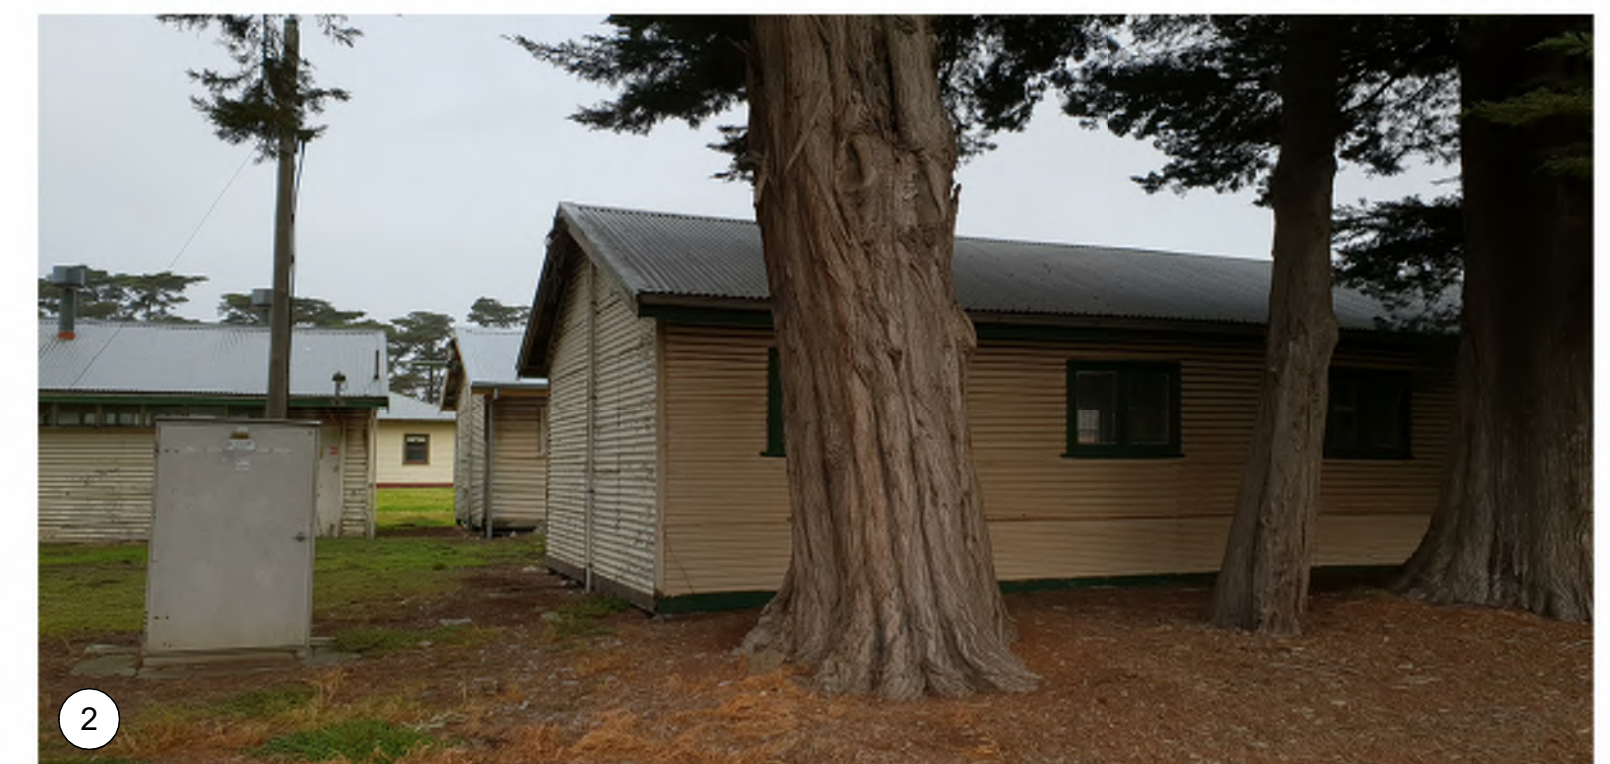
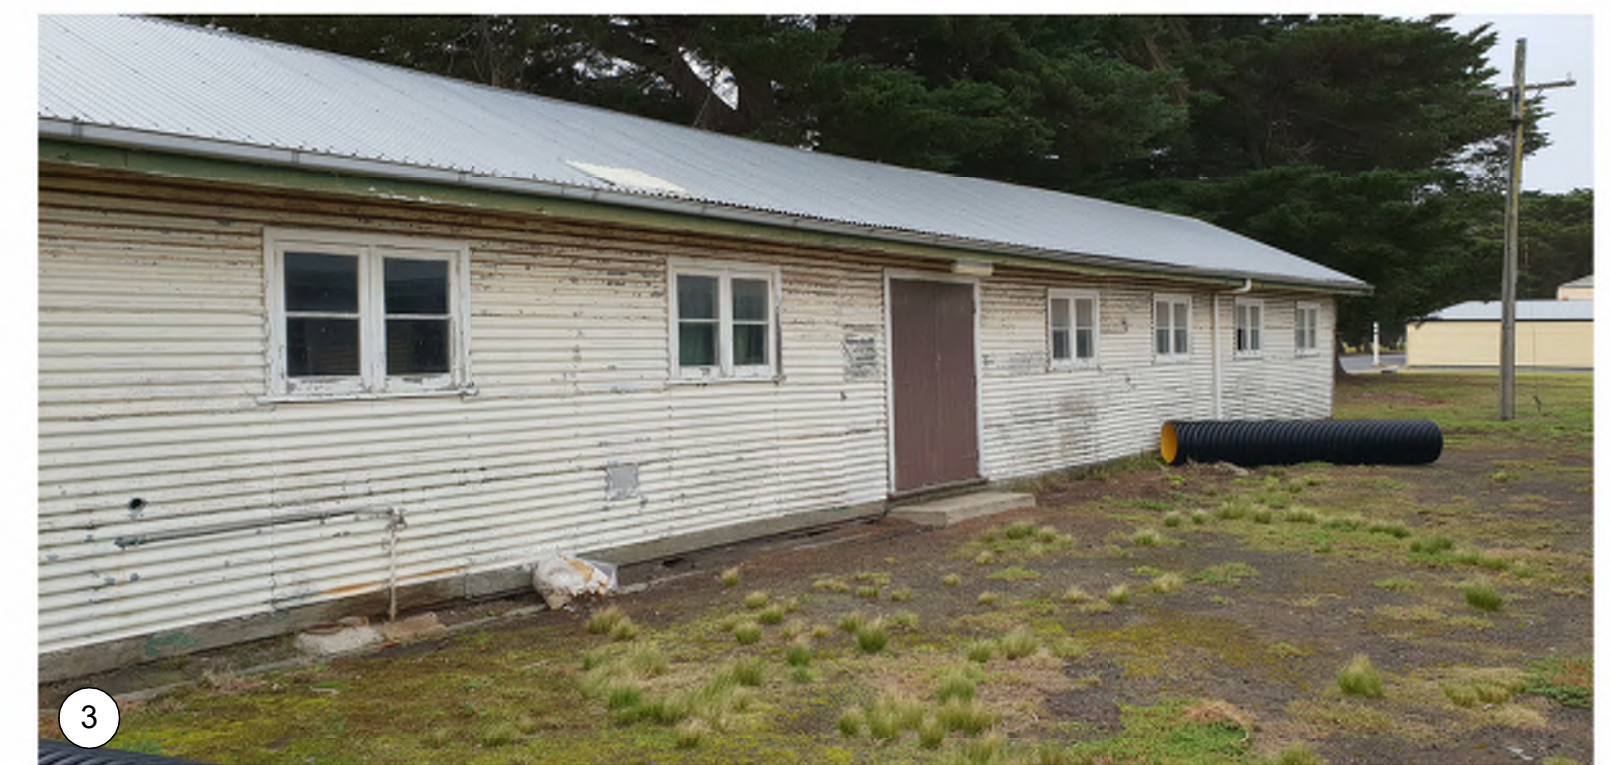
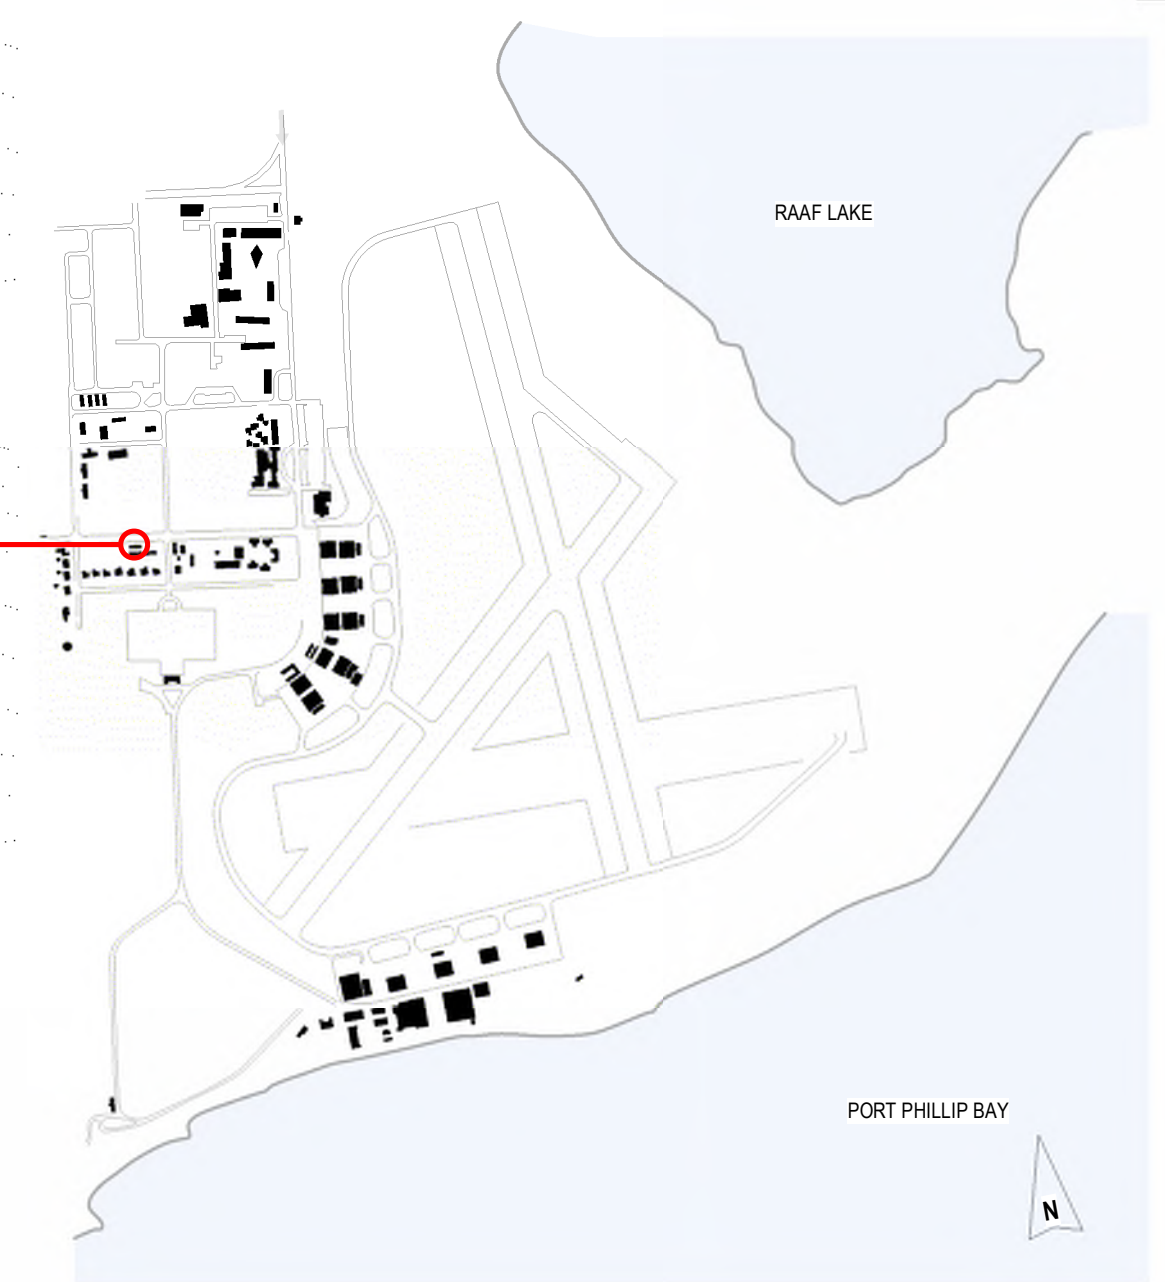
1 BUILDING 155 - EXISTING CONDITIONS/DEMOLITION PLAN
1:50

- EXISTING EXTERNAL METAL WALL SHEETING IS DAMAGED WITH MISSING SHEETS AND OTHER SHEETS ARE CORRODED, RUSTING AND PAINT IS FLAKING AND PEELING.
- THE SHEETING ITSELF HAS BEEN PAINTED OVER AND WOULD NEED TO BE REPLACED.
- THE EXTERNAL TIMBER SURFACES INCLUDING WINDOWS AND DOORS ARE UNABLE TO BE OPEN DUE TO THE EXISTING WALLS MOVEMENT, AND ARE IN NEED OF REPLACEMENT.
- THE BUILDING WOULD NEED TO BE RESTUMPED AND THE WALLS LIFTED UP TO ALLOW OPERATION OF THE WINDOWS AND DOORS.

- EXISTING METAL ROOFING IS IN GOOD CONDITION BUT THE BUILDING DOES NOT HAVE ANY GUTTERS OR DOWNPIPES.
- EXTERNAL TIMBER FASCIAS, ARE ROTTING AND DAMAGED DUE TO THE DAMAGE AND FAILING OF THE BUILDING STRUCTURE THE STRUCTURAL INTEGRITY OF THE BUILDING SHOULD BE FURTHER PROOF THAT THE BUILDING SHOULD BE DEMOLISHED.

- THE BUILDING SHOULD BE TOTALLY DEMOLISHED AND REMOVED FROM SITE.
- THE CONTRACTORS SHOULD BE PROVIDED ACCESS TO EXISTING ASBESTOS REPORTS FOR THIS BUILDING, TO ENSURE THAT ANY ASBESTOS PRESENT IS DISPOSED OF IN CORRECT MANNER AND IN COMPLIANCE WITH REGULATIONS.
- ANY SERVICE PITS, PIPES, ETC SHOULD BE CAPPED AND DEMOLISHED.
- AFTER REMOVAL OF ALL DEBRIS, SURFACE LEVELS SHOULD BE FILLED WITH CLEAN SOIL AND SEEDING TO PROVIDE A LEVEL SURFACE AROUND WHERE THE DEMOLISHED BUILDING FOOTPRINT WAS.
