PRELIMINARY DOCUMENTATION REPORT

Demolition of Structures at RAAF Williams – Point Cook, Victoria

(EPBC 2019/8514)

November 2023

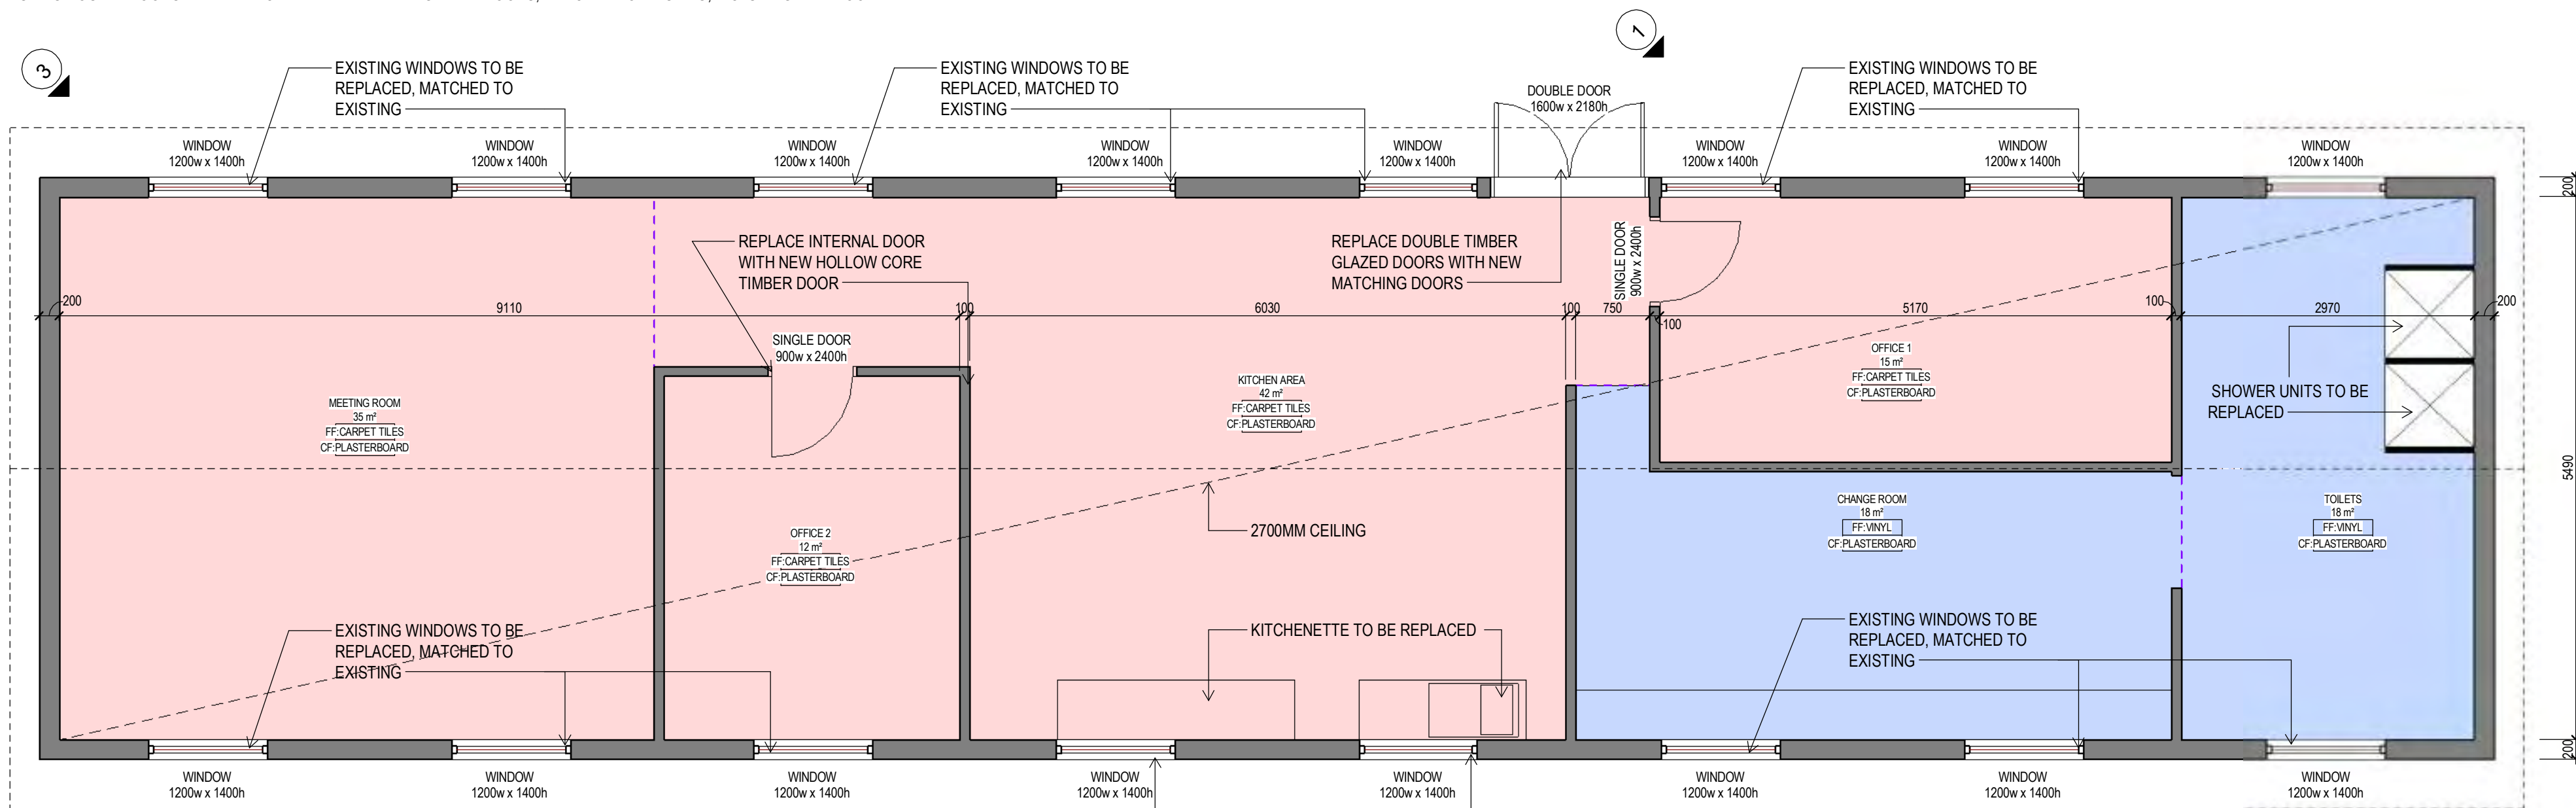
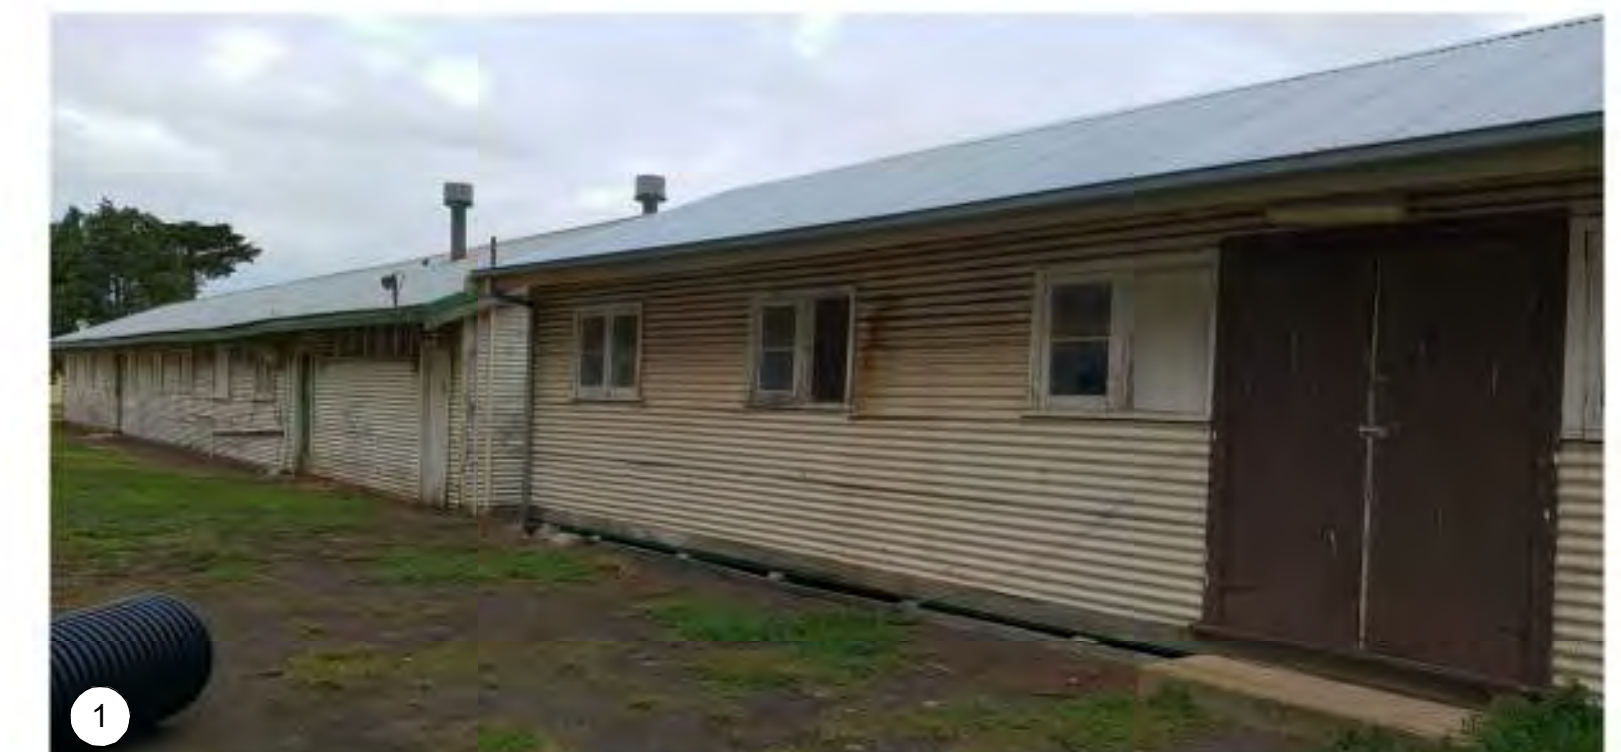
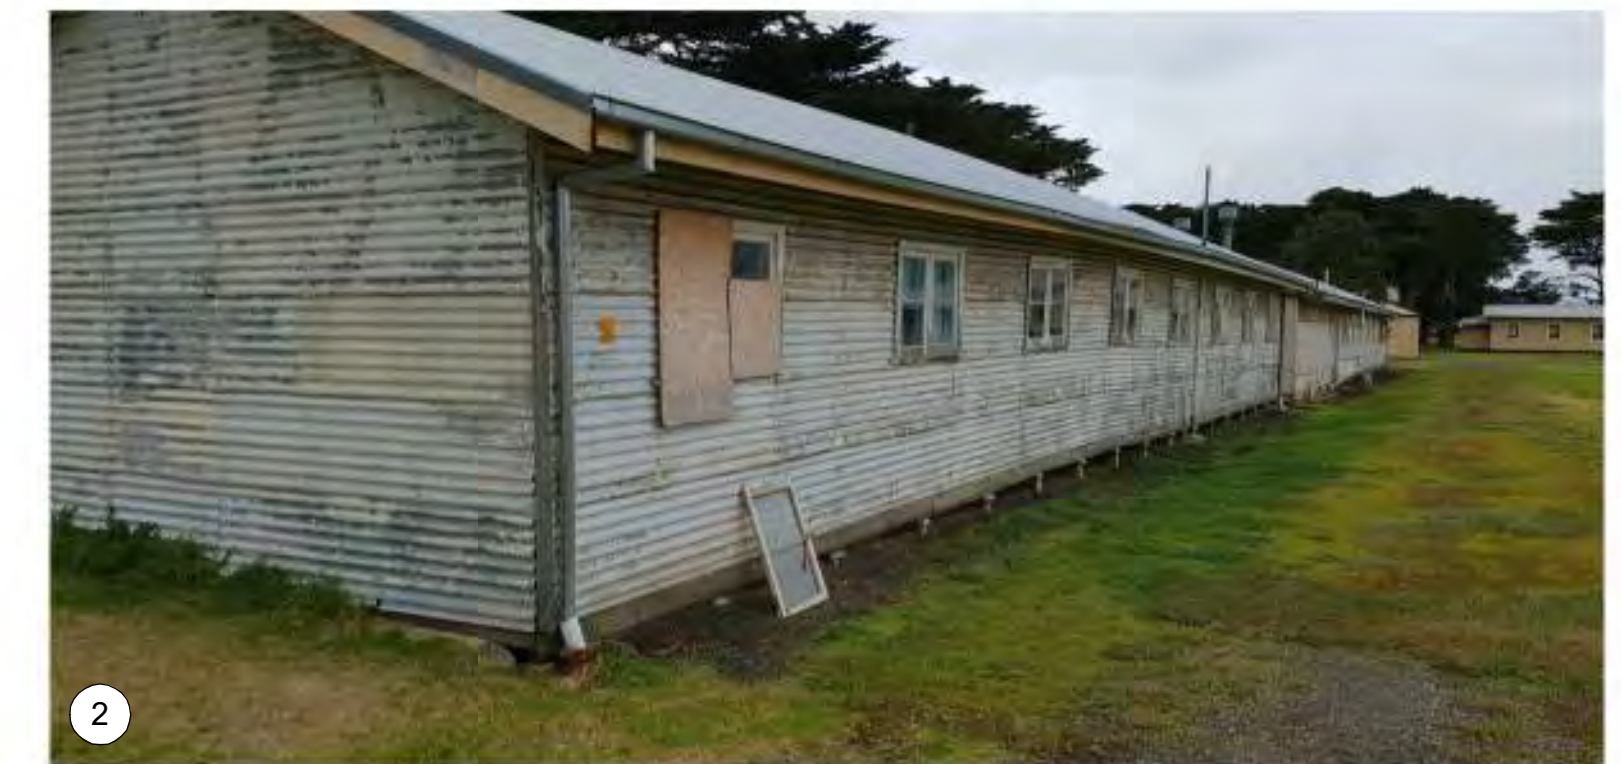
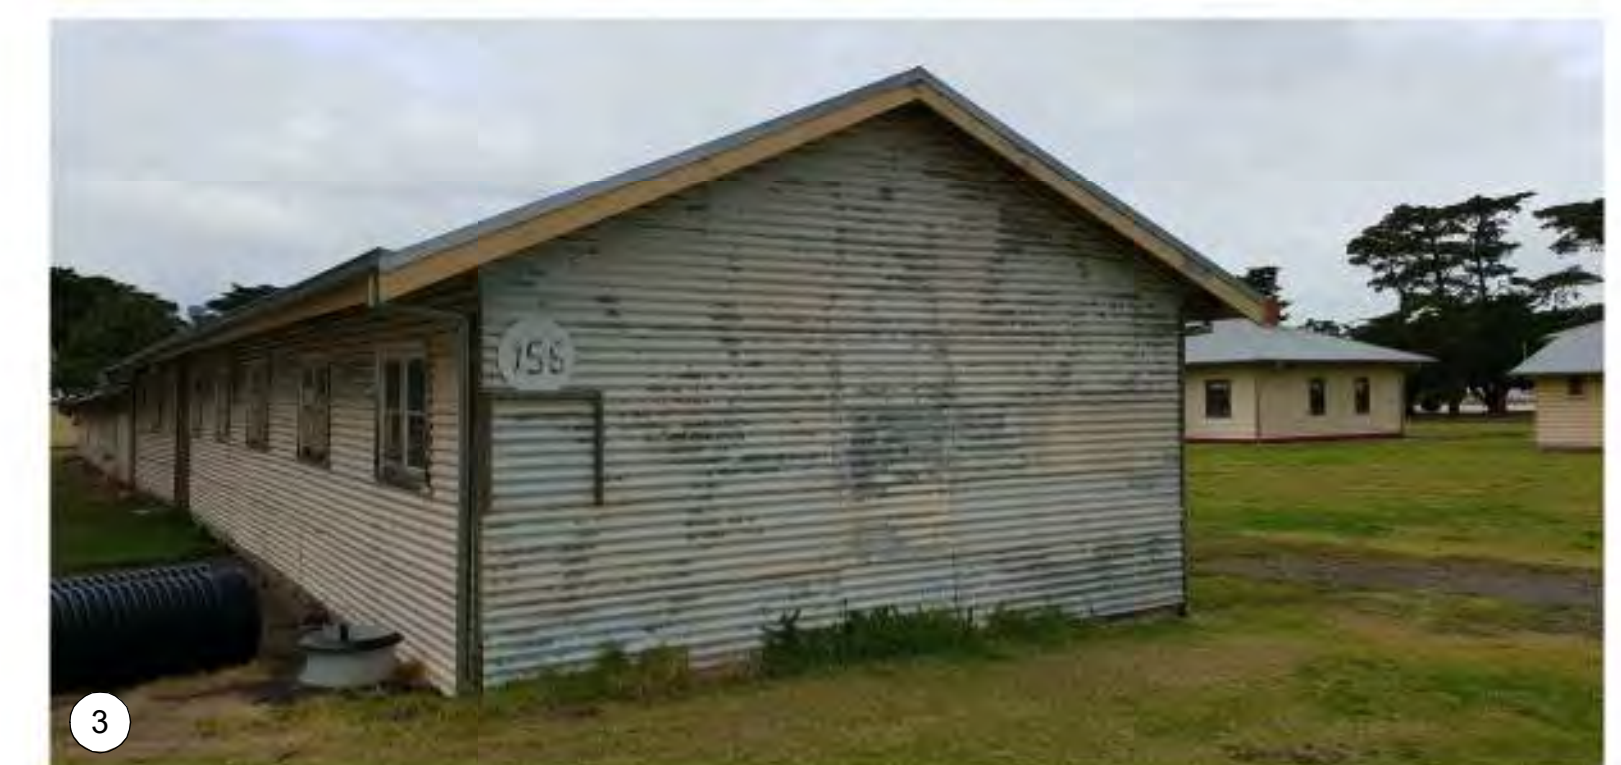
1 BUILDING A0156 - EXISTING CONDITIONS - NEW REFURBISHMENT WORKS
1:50

- THE EXISTING EXTERNAL AND INTERNAL WALLS, WHICH WERE NOT PLUMB AND STRAIGHT, SHOULD BE SET LEVEL AFTER THE BUILDING IS RESTUMPED. EXTERNAL WALL LININGS, WHICH CONSIST OF PAINTED CORRUGATED SHEETING SHOULD BE REPLACED WITH NEW MATCHING CORRUGATED SHEETING.

- THE EXTERNAL DOUBLE HUNG TIMBER WINDOWS SHOULD BE REPLACED WITH NEW MATCHING TYPE WINDOWS.
- REPLACE INTERIOR AND EXTERIOR CASINGS TO WINDOWS AS WELL AS TIMBER SILLS.

- INTERNAL WALL LININGS AND CEILING LININGS SHOULD BE REMOVED AND REPLACED WITH NEW PAINTED 10MM PLASTERBOARD LININGS TO THE WHOLE OF THE BUILDING AND ALLOW FOR NEW PAINTED TIMBER SKIRTINGS, ARCHITRAVES TO THE WHOLE OF THE BUILDING.

- REMOVE EXISTING DOUBLE DOORS AND REPLACE WITH NEW TIMBER GLAZED DOORS, MATCHED TO EXISTING, INCLUDING NEW DOOR HARDWARE.

- EXISTING ROOF STRUCTURE WHICH CONSISTS OF TIMBER FRAMED ROOF TRUSSES, AND TIMBER ROOF BATTENS ARE IN GOOD CONDITION.
- EXISTING ZINCALUME CORRUGATED ROOF SHEETING IS IN VERY GOOD CONDITION AND DOES NOT NEED TO BE REPLACED
- EXISTING METAL GUTTERS AND DOWNPIPES ARE IN GOOD CONDITION AND SHOULD BE RETAINED.
- REPLACE EXISTING SOFFIT LINING WITH NEW 9MM VILLABOARD LINING, PAINTED FINISH.
- EXISTING TIMBER BARGE BOARDS, AND FASCIA'S, NEED TO BE PRIMED AND PAINTED

- EXISTING INTERNAL KITCHENETTE SHOULD BE DEMOLISHED AND REMOVED FROM SITE AND REPLACED WITH NEW KITCHENETTE IN SAME CONFIGURATION, WITH NEW SINGLE STAINLESS STEEL SINK AND TAPS, AND NEW CABINETRY.
- ALLOW TO PROVIDE HOT AND COLD WATER TO SINK WITH NEW UNDERBENCH HOT WATER UNIT.

- DEMOLISH AND REMOVE EXISTING SHOWER UNITS AND REPLACE WITH NEW SHOWER UNITS, COMPLETE WITH NEW SHOWER ROSE, FLOOR WASTE, ETC
- PROVIDE NEW HOT WATER SERVICE UNIT TO PROVIDE WATER TO SHOWERS.
- INSTALL NEW VINYL SHEETING TO FLOOR IN CHANGE ROOM AND TOILETS.

- ALL SERVICES TO THE BUILDING WOULD NEED TO BE CAPPED AND CUT TO THE BUILDING PRIOR TO ANY WORKS PROCEEDING.
- THIS WOULD INCLUDE ELECTRICAL, MECHANICAL, AND HYDRAULIC SERVICES TO THE BUILDING.
- FITTINGS WOULD ALSO NEED TO BE REMOVED AND THESE INCLUDE EXISTING SINK.
- OTHER SERVICES THAT NEED TO BE CUT WOULD INCLUDE STORMWATER DOWNPIPES, WATER PIPING AND ANY ELECTRICAL CONDUITS THAT SERVICE THE BUILDING AND THESE SHOULD BE REPLACED WITH NEW SERVICES.

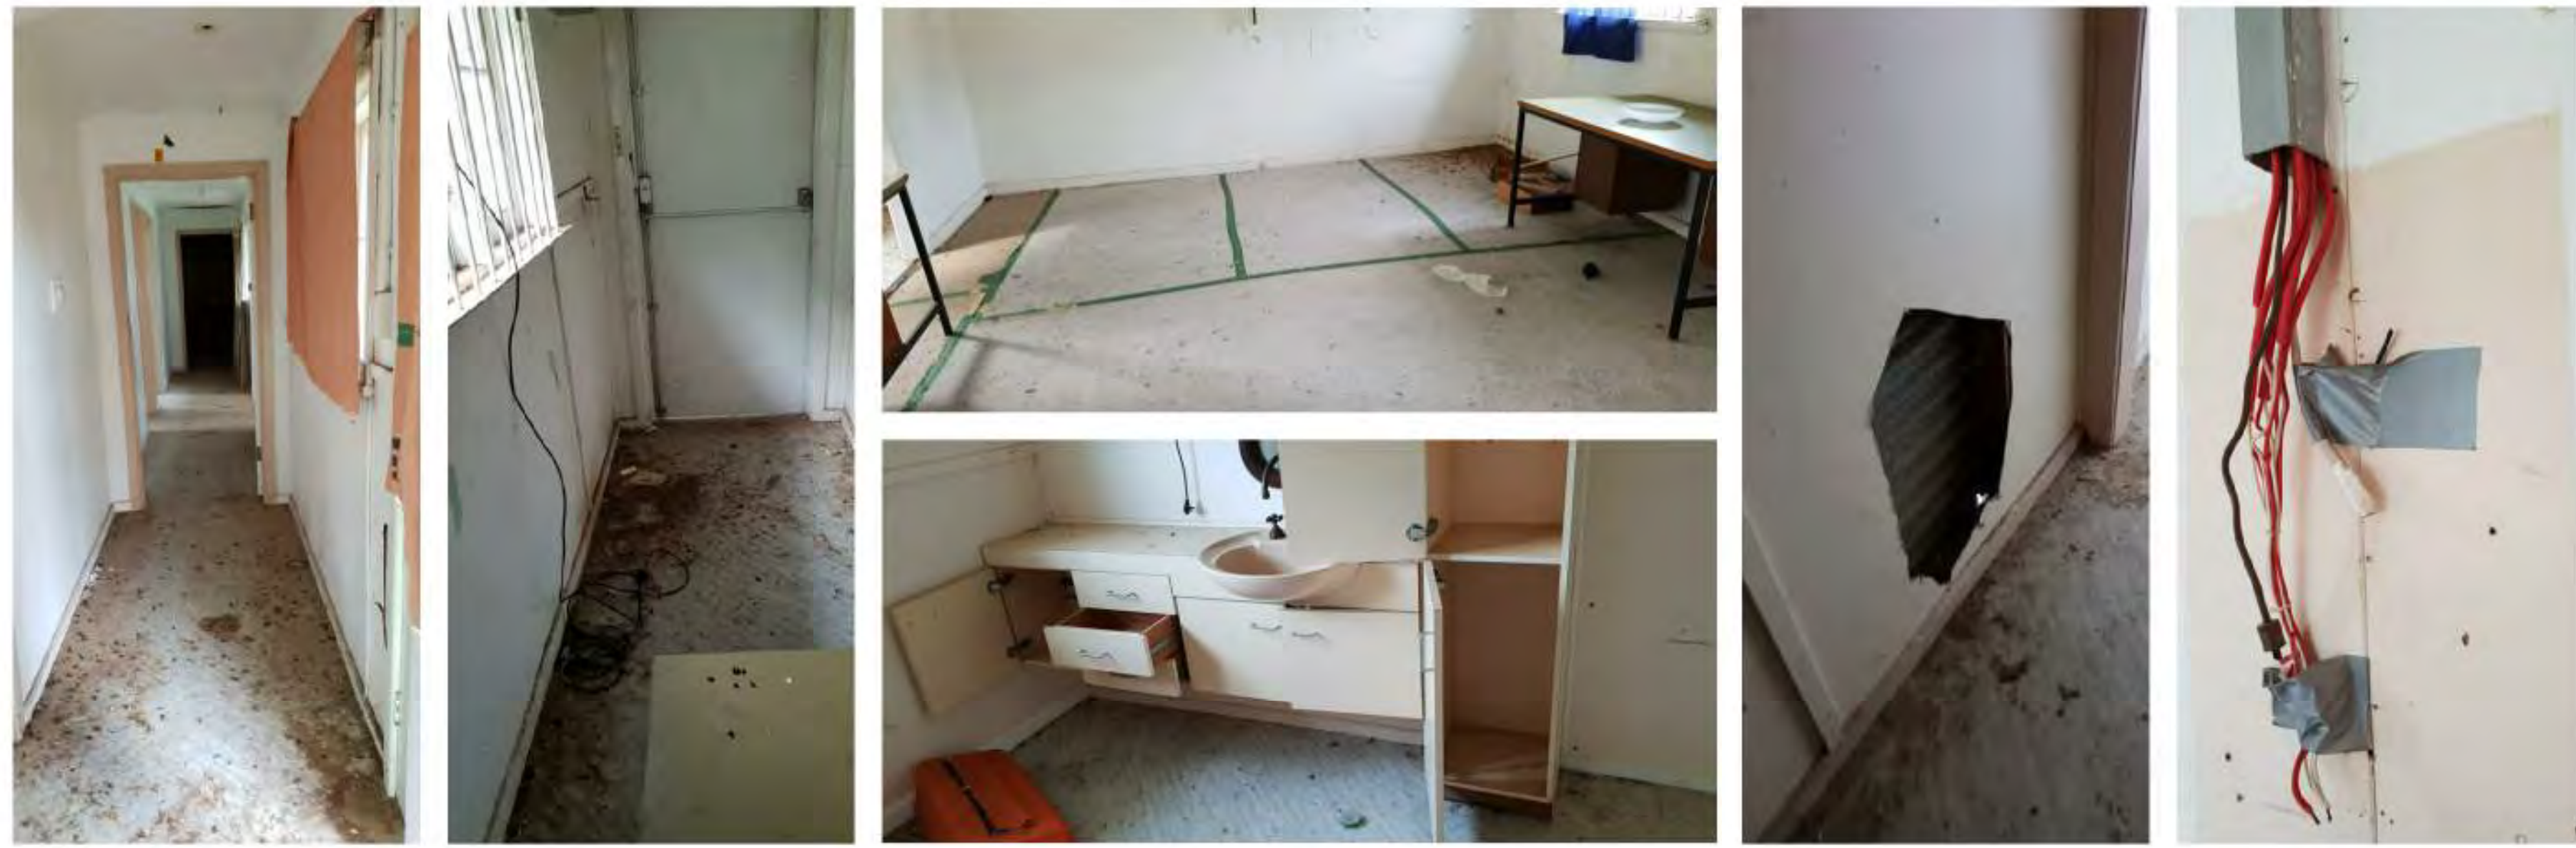
IMAGES OF TYPICAL DETERIORATION

- THE EXISTING EXTERNAL AND INTERNAL WALLS, WHICH WERE NOT PLUMB AND STRAIGHT, SHOULD BE SET LEVEL AFTER THE BUILDING IS RESTUMPED. EXTERNAL WALL LININGS, WHICH CONSIST OF PAINTED CORRUGATED SHEETING SHOULD BE REPLACED WITH NEW MATCHING CORRUGATED SHEETING.

- EXISTING ROOF STRUCTURE WHICH CONSISTS OF TIMBER FRAMED ROOF TRUSSES, AND TIMBER ROOF BATTENS ARE IN GOOD CONDITION.
- EXISTING ZINCALUME CORRUGATED ROOF SHEETING IS IN VERY GOOD CONDITION AND DOES NOT NEED TO BE REPLACED
- INSTALL NEW METAL GUTTERS AND DOWNPIPES AND ALLOW TO CONNECT INTO EXISTING STORMWATER DRAINAGE SYSTEM.
- REPLACE EXISTING SOFFIT LINING WITH NEW 9MM VILLABOARD LINING, PAINTED FINISH.
- REPLACE EXISTING TIMBER BARGE BOARDS, AND FASCIAS.

- THE EXTERNAL DOUBLE HUNG TIMBER WINDOWS SHOULD BE REPLACED WITH NEW MATCHING TYPE WINDOWS.
- REPLACE INTERIOR AND EXTERIOR CASINGS TO WINDOWS AS WELL AS TIMBER SILLS.

- INTERNAL WALL LININGS AND CEILING LININGS SHOULD BE REMOVED AND REPLACED WITH NEW PAINTED 10MM PLASTERBOARD LININGS TO THE WHOLE OF THE BUILDING AND ALLOW FOR NEW PAINTED TIMBER SKIRTINGS, ARCHITRAVES TO THE WHOLE OF THE BUILDING.

- REMOVE EXISTING SINGLE DOORS TO BUILDING AND REPLACE WITH NEW TIMBER DOORS, MATCHED TO EXISTING, INCLUDING NEW DOOR HARDWARE.

- ALL SERVICES TO THE BUILDING WOULD NEED TO BE CAPPED AND CUT TO THE BUILDING PRIOR TO ANY WORKS PROCEEDING.
- THIS WOULD INCLUDE ELECTRICAL, MECHANICAL, AND HYDRAULIC SERVICES TO THE BUILDING.
- FITTINGS WOULD ALSO NEED TO BE REMOVED AND THESE INCLUDE EXISTING SINK.
- OTHER SERVICES THAT NEED TO BE CUT WOULD INCLUDE STORMWATER DOWNPIPES, WATER PIPING AND ANY ELECTRICAL CONDUITS THAT SERVICE THE BUILDING AND THESE SHOULD BE REPLACED WITH NEW SERVICES.

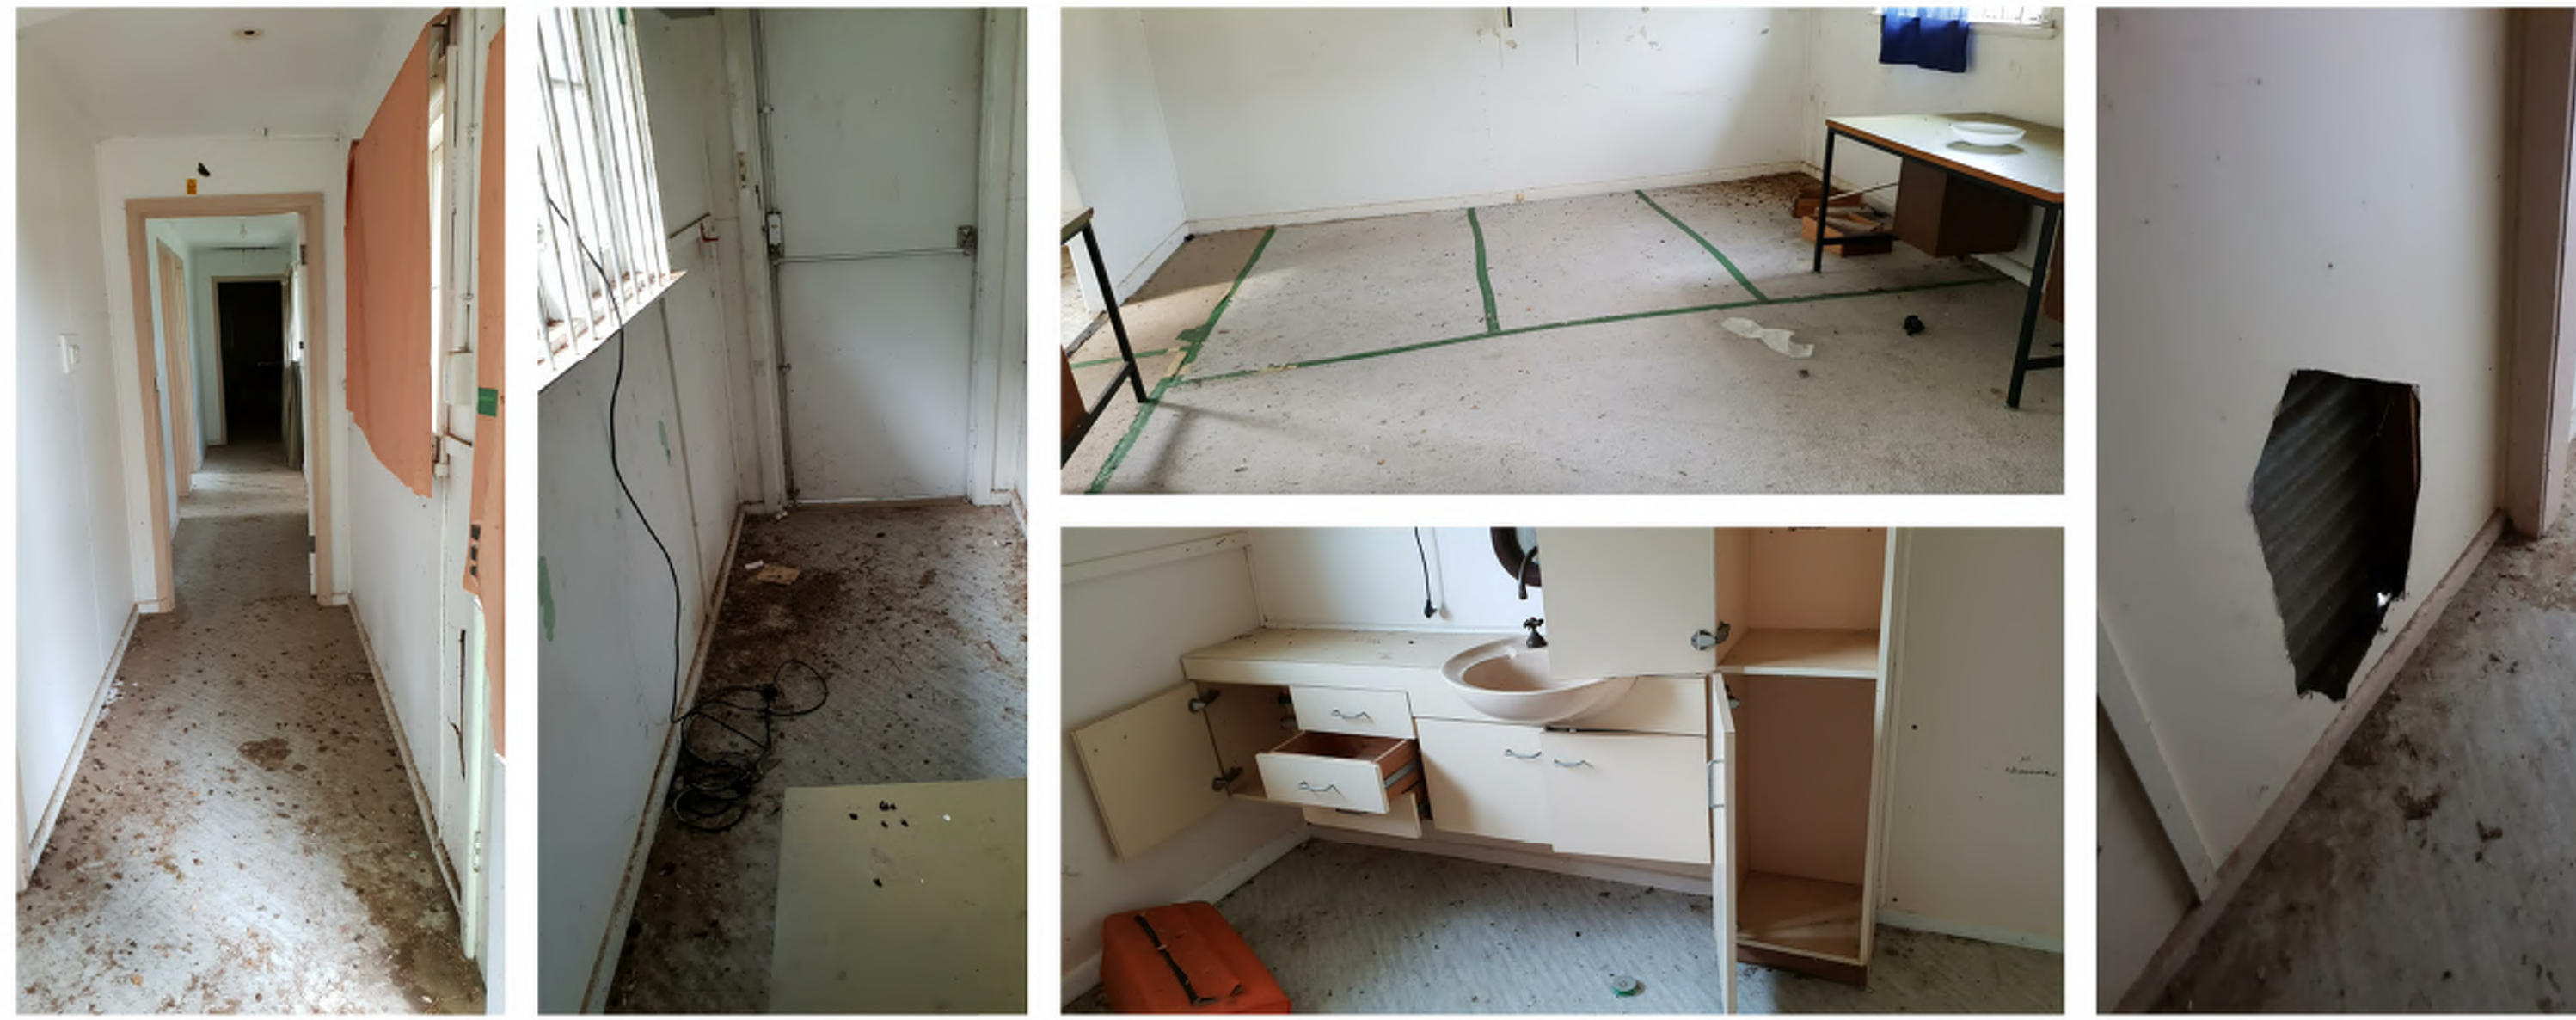
IMAGES OF TYPICAL DETERIORATION

- EXISTING EXTERNAL METAL WALL SHEETING IS DAMAGED WITH MISSING SHEETS AND OTHER SHEETS ARE CORRODED, RUSTING AND PAINT IS FLAKING AND PEELING.
- THE SHEETING ITSELF HAS BEEN PAINTED OVER AND WOULD NEED TO BE REPLACED.
- THE EXTERNAL TIMBER SURFACES INCLUDING WINDOWS AND DOORS ARE UNABLE TO BE OPEN DUE TO THE EXISTING WALLS MOVEMENT, AND ARE IN NEED OF REPLACEMENT.
- THE BUILDING WOULD NEED TO BE RESTUMPED AND THE WALLS LIFTED UP TO ALLOW OPERATION OF THE WINDOWS AND DOORS.

- EXISTING METAL ROOFING IS IN GOOD CONDITION BUT THE BUILDING DOES NOT HAVE ANY GUTTERS OR DOWNPIPES.
- EXTERNAL TIMBER FASCIAS, ARE ROTTING AND DAMAGED DUE TO THE DAMAGE AND FAILING OF THE BUILDING STRUCTURE THE STRUCTURAL INTEGRITY OF THE BUILDING SHOULD BE FURTHER PROOF THAT THE BUILDING SHOULD BE DEMOLISHED.

- THE BUILDING SHOULD BE TOTALLY DEMOLISHED AND REMOVED FROM SITE.
- THE CONTRACTORS SHOULD BE PROVIDED ACCESS TO EXISTING ASBESTOS REPORTS FOR THIS BUILDING, TO ENSURE THAT ANY ASBESTOS PRESENT IS DISPOSED OF IN CORRECT MANNER AND IN COMPLIANCE WITH REGULATIONS.
- ANY SERVICE PITS, PIPES, ETC SHOULD BE CAPPED AND DEMOLISHED.
- AFTER REMOVAL OF ALL DEBRIS, SURFACE LEVELS SHOULD BE FILLED WITH CLEAN SOIL AND MATCH ADJOINING GROUND LEVELS.

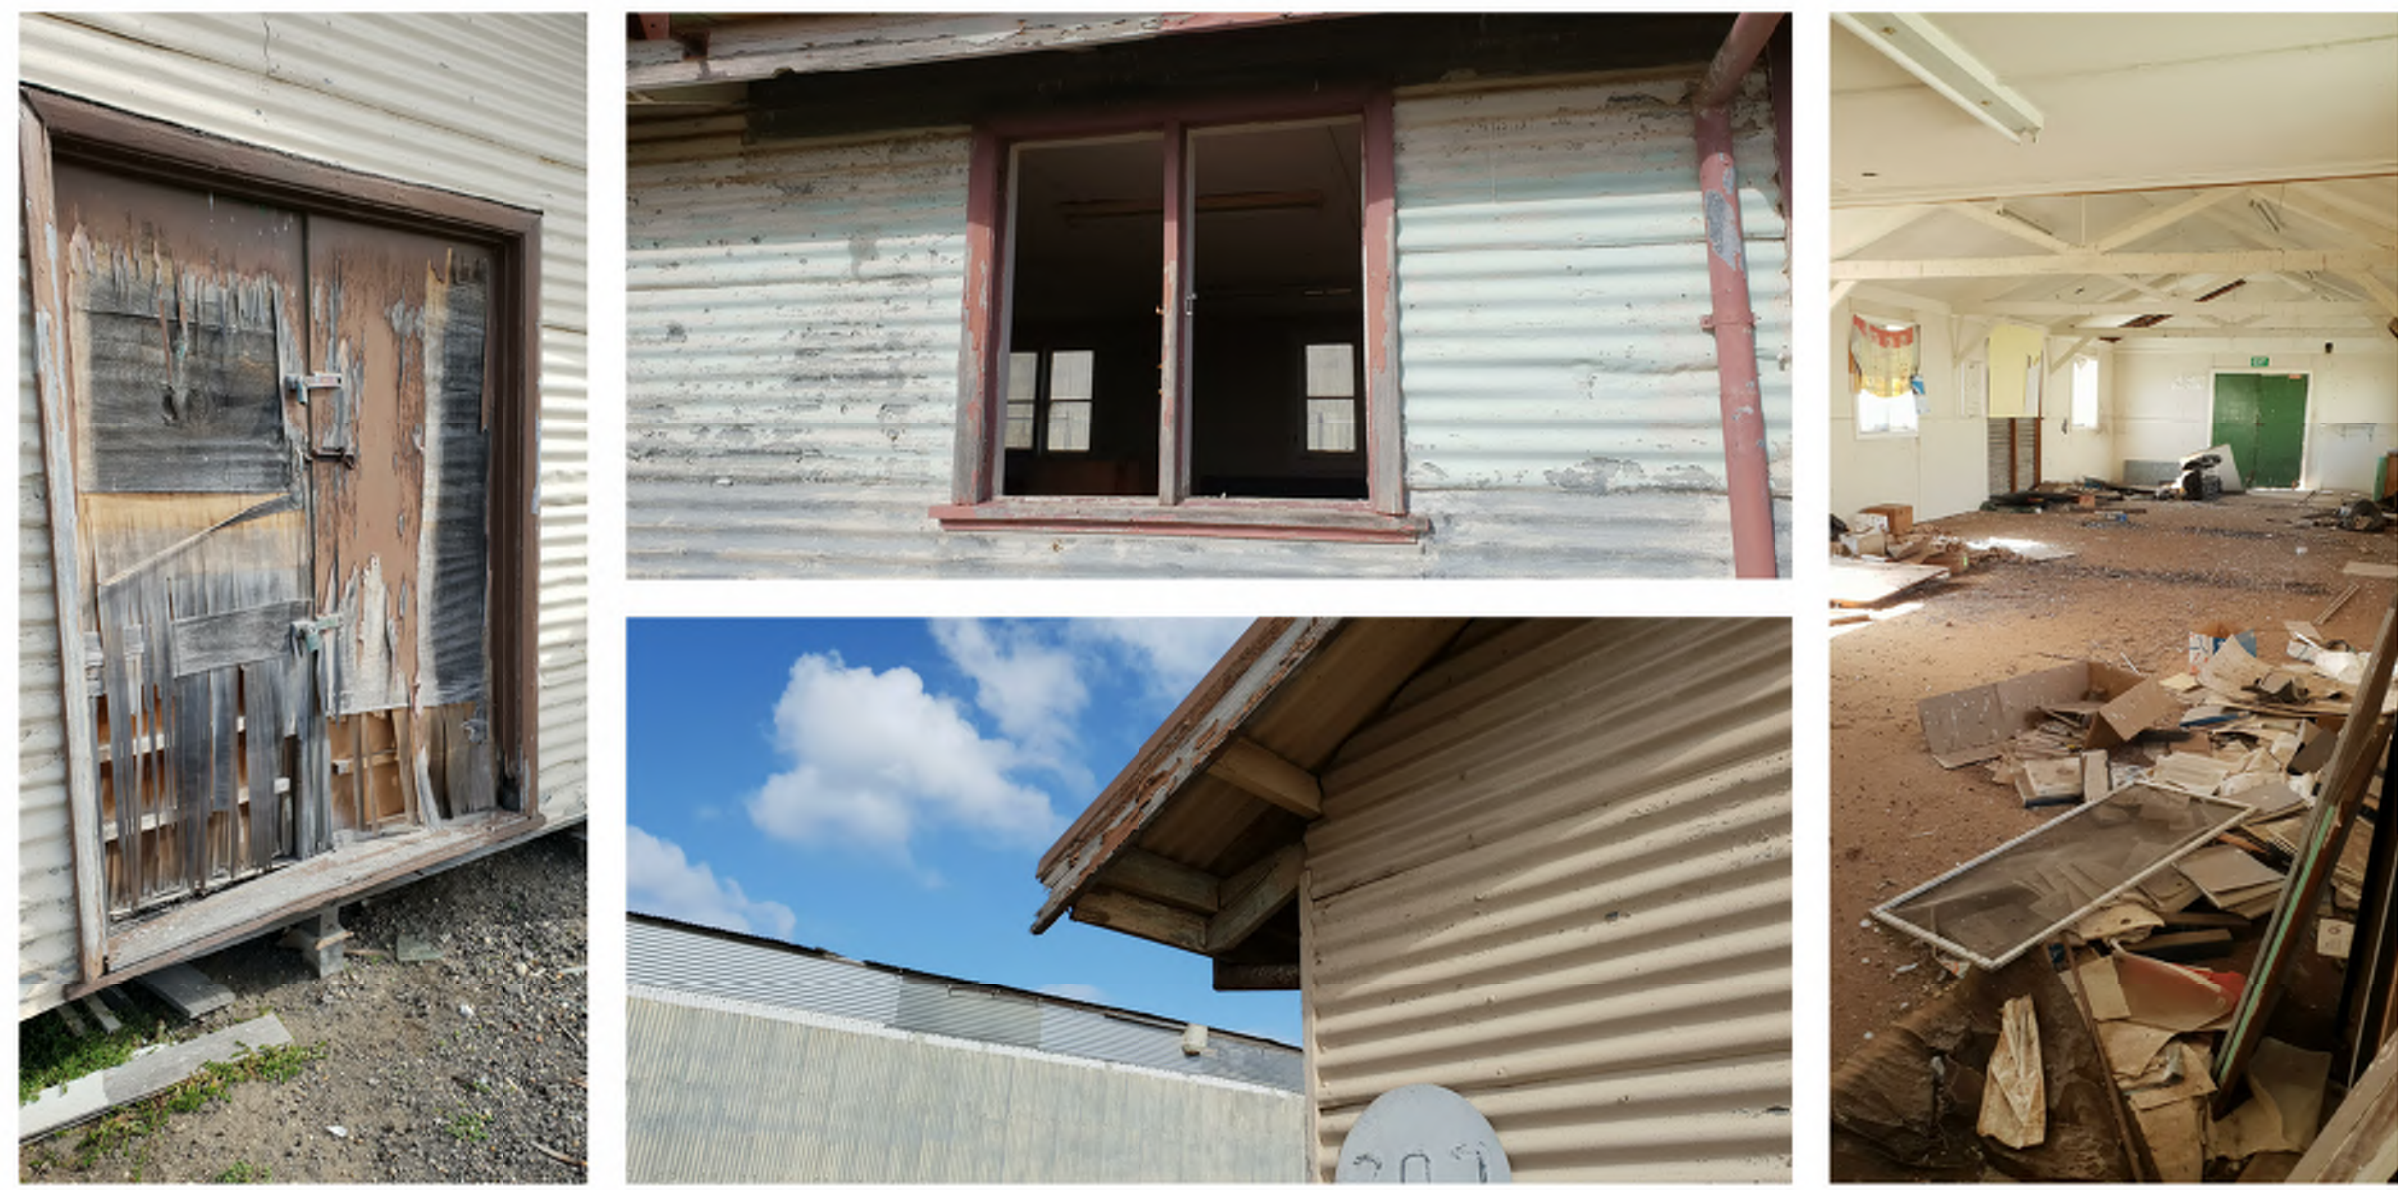
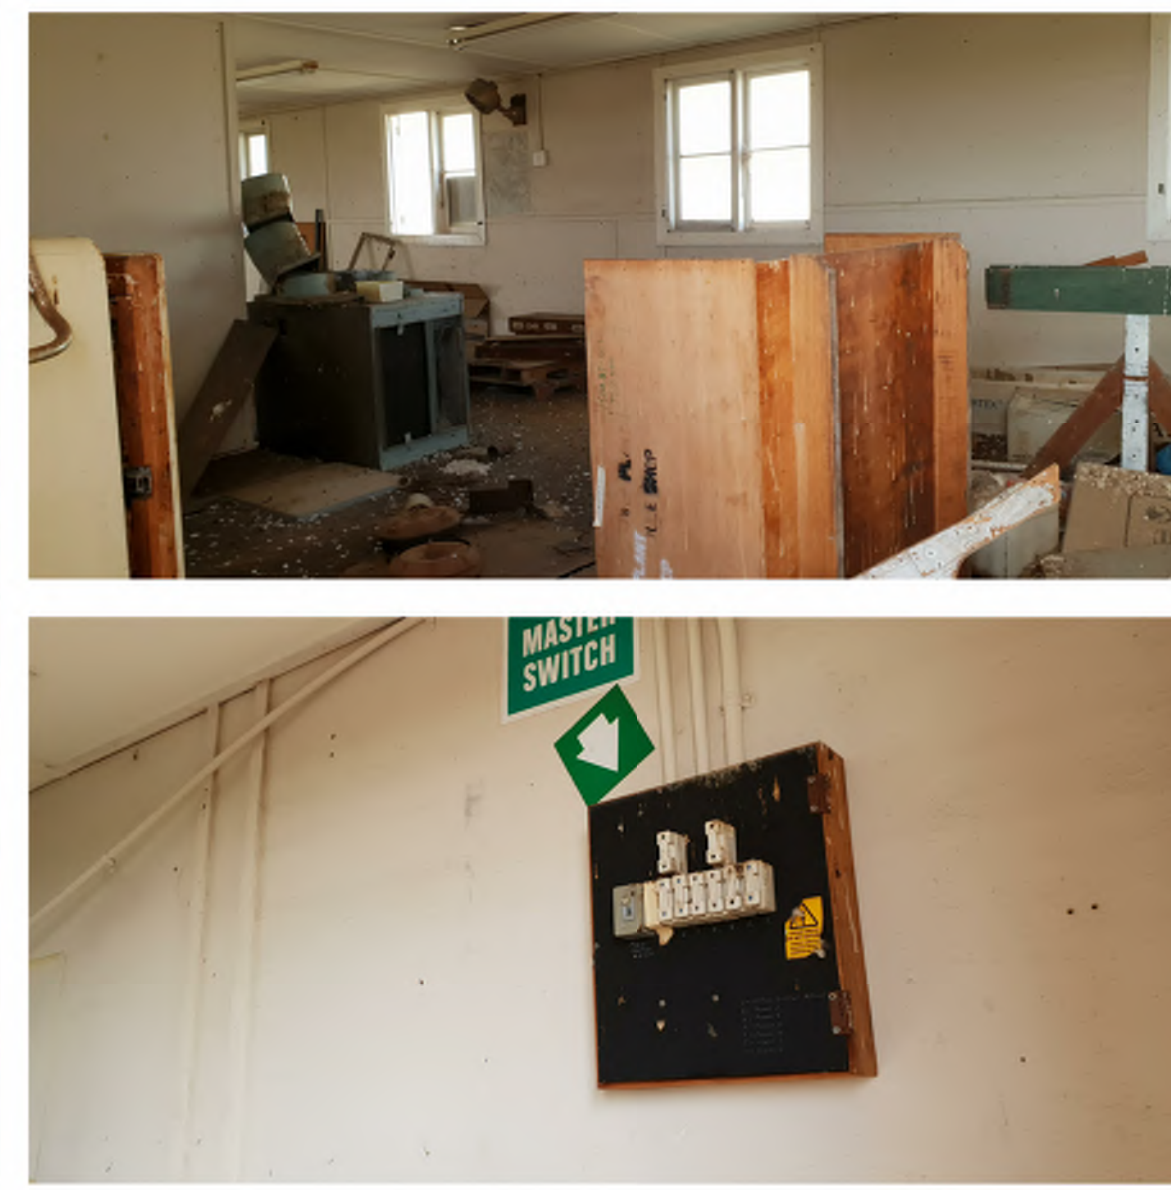
IMAGES OF TYPICAL DETERIORATION

- EXISTING EXTERNAL METAL WALL SHEETING IS DAMAGED WITH MISSING SHEETS AND OTHER SHEETS ARE CORRODED, RUSTING AND PAINT IS FLAKING AND PEELING.
- THE SHEETING ITSELF HAS BEEN PAINTED OVER AND WOULD NEED TO BE REPLACED.
- THE EXTERNAL TIMBER SURFACES INCLUDING WINDOWS AND DOORS ARE UNABLE TO BE OPEN DUE TO THE EXISTING WALLS MOVEMENT, AND ARE IN NEED OF REPLACEMENT.
- THE BUILDING WOULD NEED TO BE RESTUMPED AND THE WALLS LIFTED UP TO ALLOW OPERATION OF THE WINDOWS AND DOORS.

- EXISTING METAL ROOFING IS IN GOOD CONDITION BUT THE BUILDING DOES NOT HAVE ANY GUTTERS OR DOWNPIPES.
- EXTERNAL TIMBER FASCIAS, ARE ROTTING AND DAMAGED DUE TO THE DAMAGE AND FAILING OF THE BUILDING STRUCTURE THE STRUCTURAL INTEGRITY OF THE BUILDING SHOULD BE FURTHER PROOF THAT THE BUILDING SHOULD BE DEMOLISHED.

- THE BUILDING SHOULD BE TOTALLY DEMOLISHED AND REMOVED FROM SITE.
- THE CONTRACTORS SHOULD BE PROVIDED ACCESS TO EXISTING ASBESTOS REPORTS FOR THIS BUILDING, TO ENSURE THAT ANY ASBESTOS PRESENT IS DISPOSED OF IN CORRECT MANNER AND IN COMPLIANCE WITH REGULATIONS.
- ANY SERVICE PITS, PIPES, ETC SHOULD BE CAPPED AND DEMOLISHED.
- AFTER REMOVAL OF ALL DEBRIS, SURFACE LEVELS SHOULD BE FILLED WITH CLEAN SOIL AND SEEDING TO PROVIDE A LEVEL SURFACE AROUND WHERE THE DEMOLISHED BUILDING FOOTPRINT WAS.

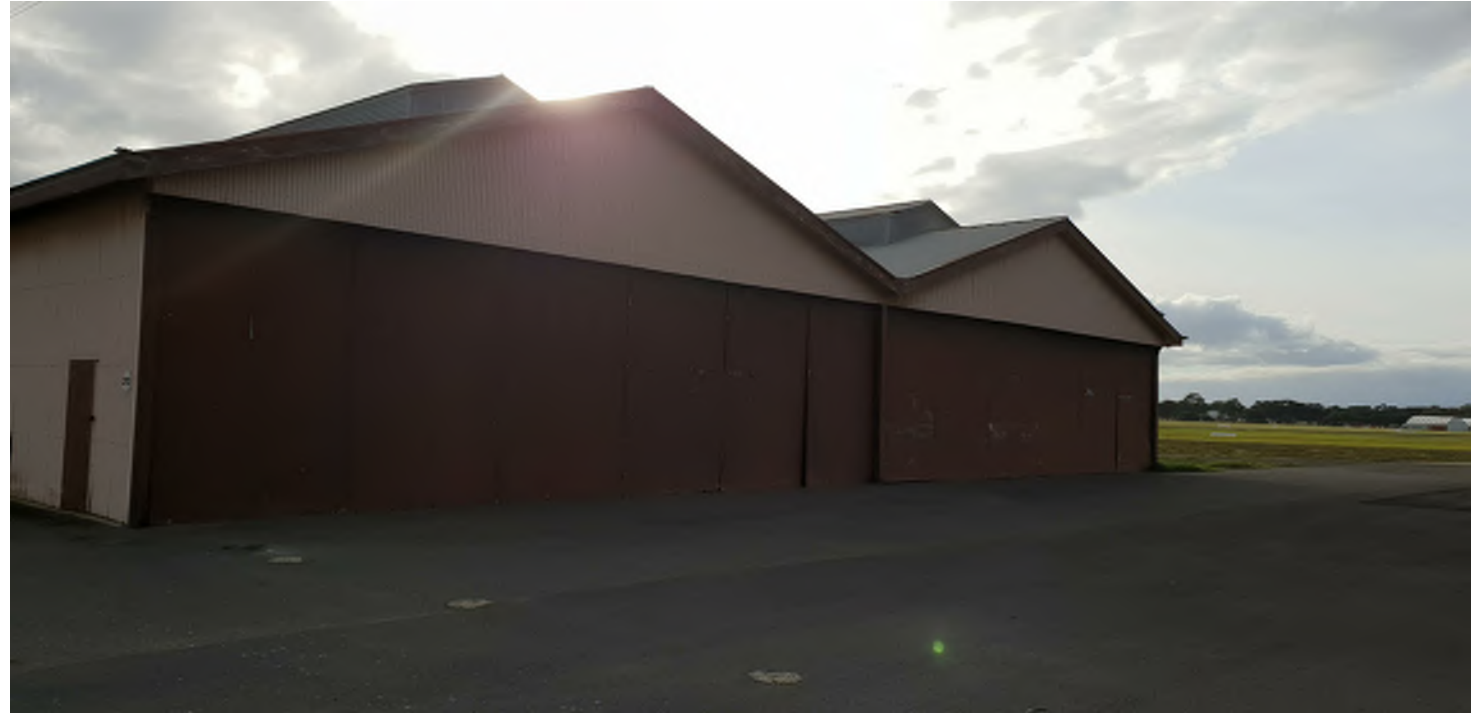
TYPICAL IMAGES - EXTERNAL

- EXTERNAL BUILDING SURFACES**
- EXISTING METAL WALL SHEETING IS SHOWING VISIBLE SIGNS OF CORROSION IN AREAS WHERE THE SHEETS HAVE BEEN PAINTED OVER. THE PAINT IS PEELING AND FLAKING. THE FIXINGS ARE ALL RUSTED AND IN SOME AREAS MISSING THE EXISTING SHEETING SHOULD BE REPLACED WITH NEW COLORBOND CORRUGATED WALL LININGS IN COLOURS TO MATCH EXISTING AND THE CONTRACTOR SHOULD ALLOW FOR MIN R2.5 RATED INSULATION TO ALL WALLS.

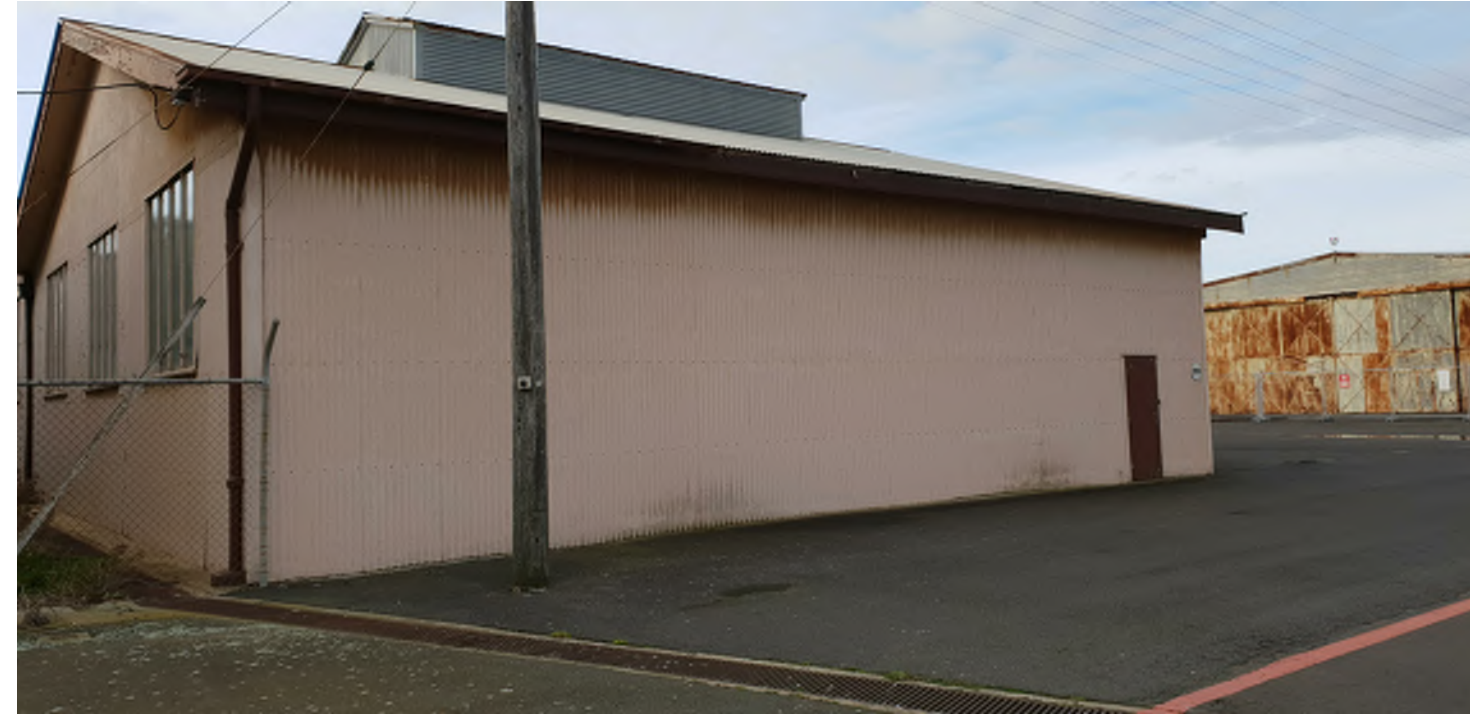
TYPICAL IMAGES - EXTERNAL

- THE EXTERNAL TIMBER BOARDS TO THE SOFFIT ARE DAMAGED, MISSING AND SHOW SIGNS OF WATER DAMAGE AND SHOULD BE REPLACED WITH NEW PAINTED TIMBER BOARDS WITH COLOUR TO MATCH EXISTING. THE EXISTING FASCIA GUTTERS AND PVC DOWNPIPES ARE MISSING, DAMAGED AND BEYOND REPLACEMENT AND SHOULD BE REPLACED WITH NEW MATCHING DOWNPIPES AND GUTTERS. EXTERNAL TIMBER FASCIA'S, ARE ROTTING AND DAMAGED AND REQUIRE TO BE REPLACED WITH NEW MATCHING PRIME AND PAINTED FASCIA'S.

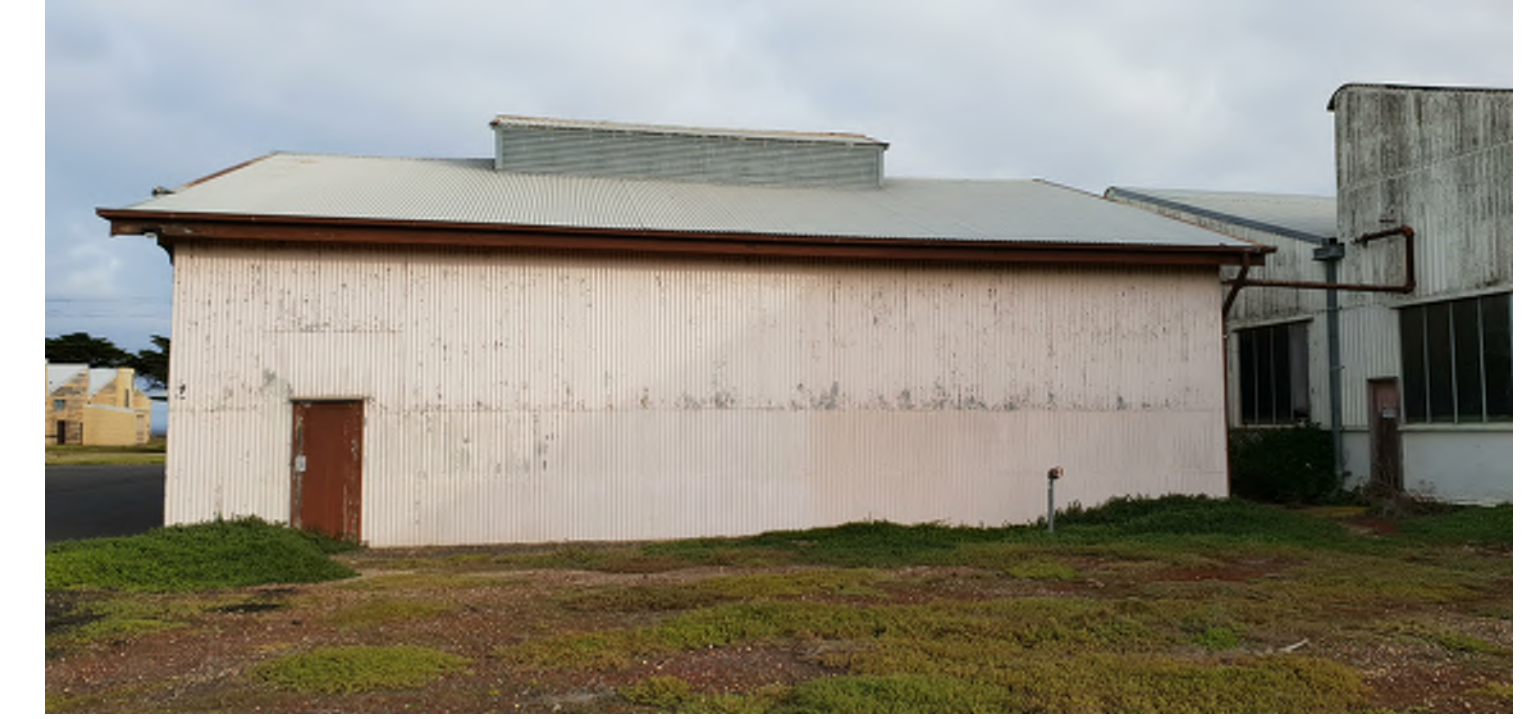
TYPICAL IMAGES - EXTERNAL

- INTERNALLY THE BOX GUTTERS WILL NEED TO BE REPLACED WITH NEW GUTTER BOARDS, METAL TRAY AND FLASHINGS AND BE SET TO LINE AND TO FALL TO OUTLETS.
 - THE LARGE EXTERNAL SLIDING DOORS HAS PEELING PAINT, DAMAGE TO THE BOTTOM AND SIDES. THE EXISTING DOORS CANNOT OPEN DUE TO DAMAGE TO THE BOTTOM TRACKS AND WHEELS. THE STEEL STRUCTURE IS RUSTING AND NEEDS TO BE CLEANED WITH WIRE BRUSH TO REMOVE CORROSION, PRIOR TO BE PRIMED AND PAINTED. IN RELOCATING THE BUILDING, NEW STEEL TRACKS TO BOTTOM AND THE TOP TRACKS WILL NEED TO BE SERVICED AND CLEANED TO ALLOW FOR EASY MOVEMENT OF THE DOORS.

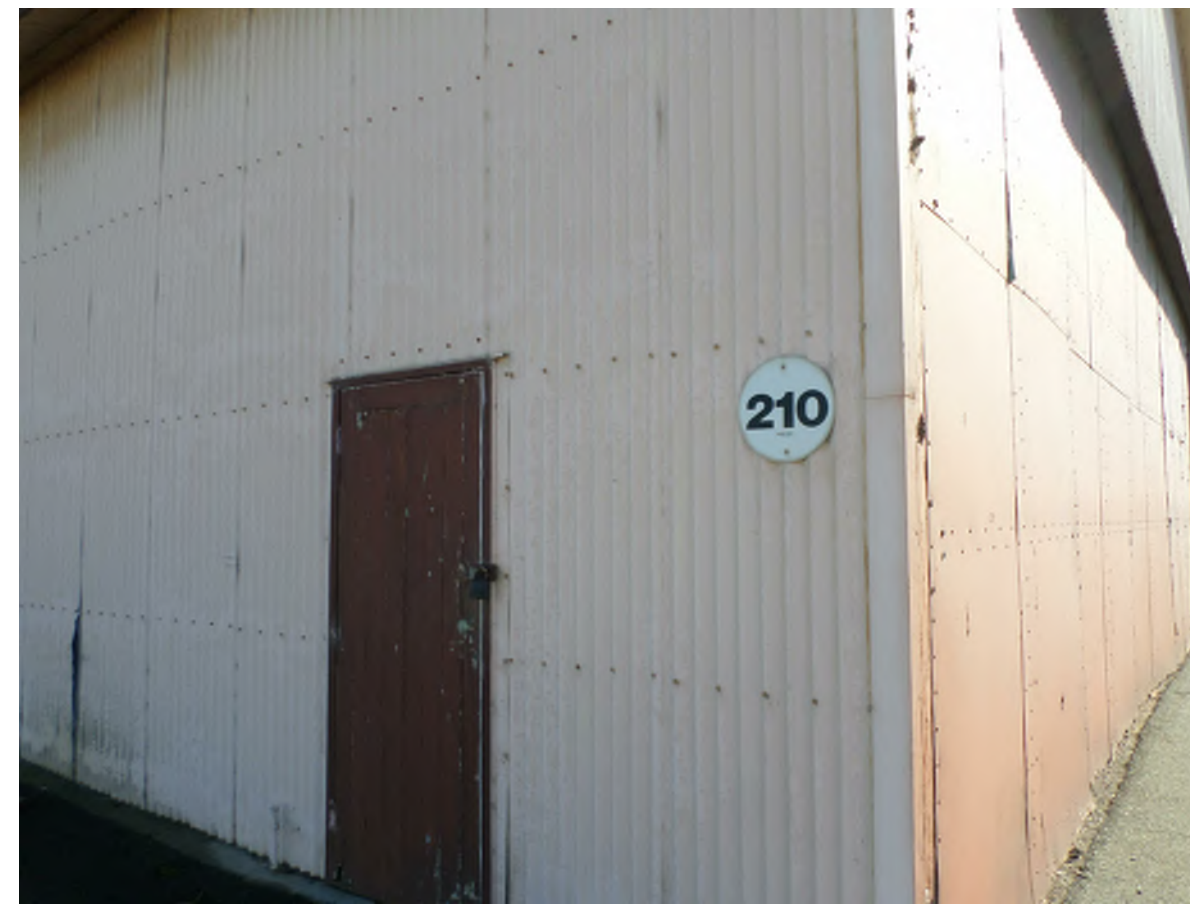
TYPICAL IMAGES - EXTERNAL

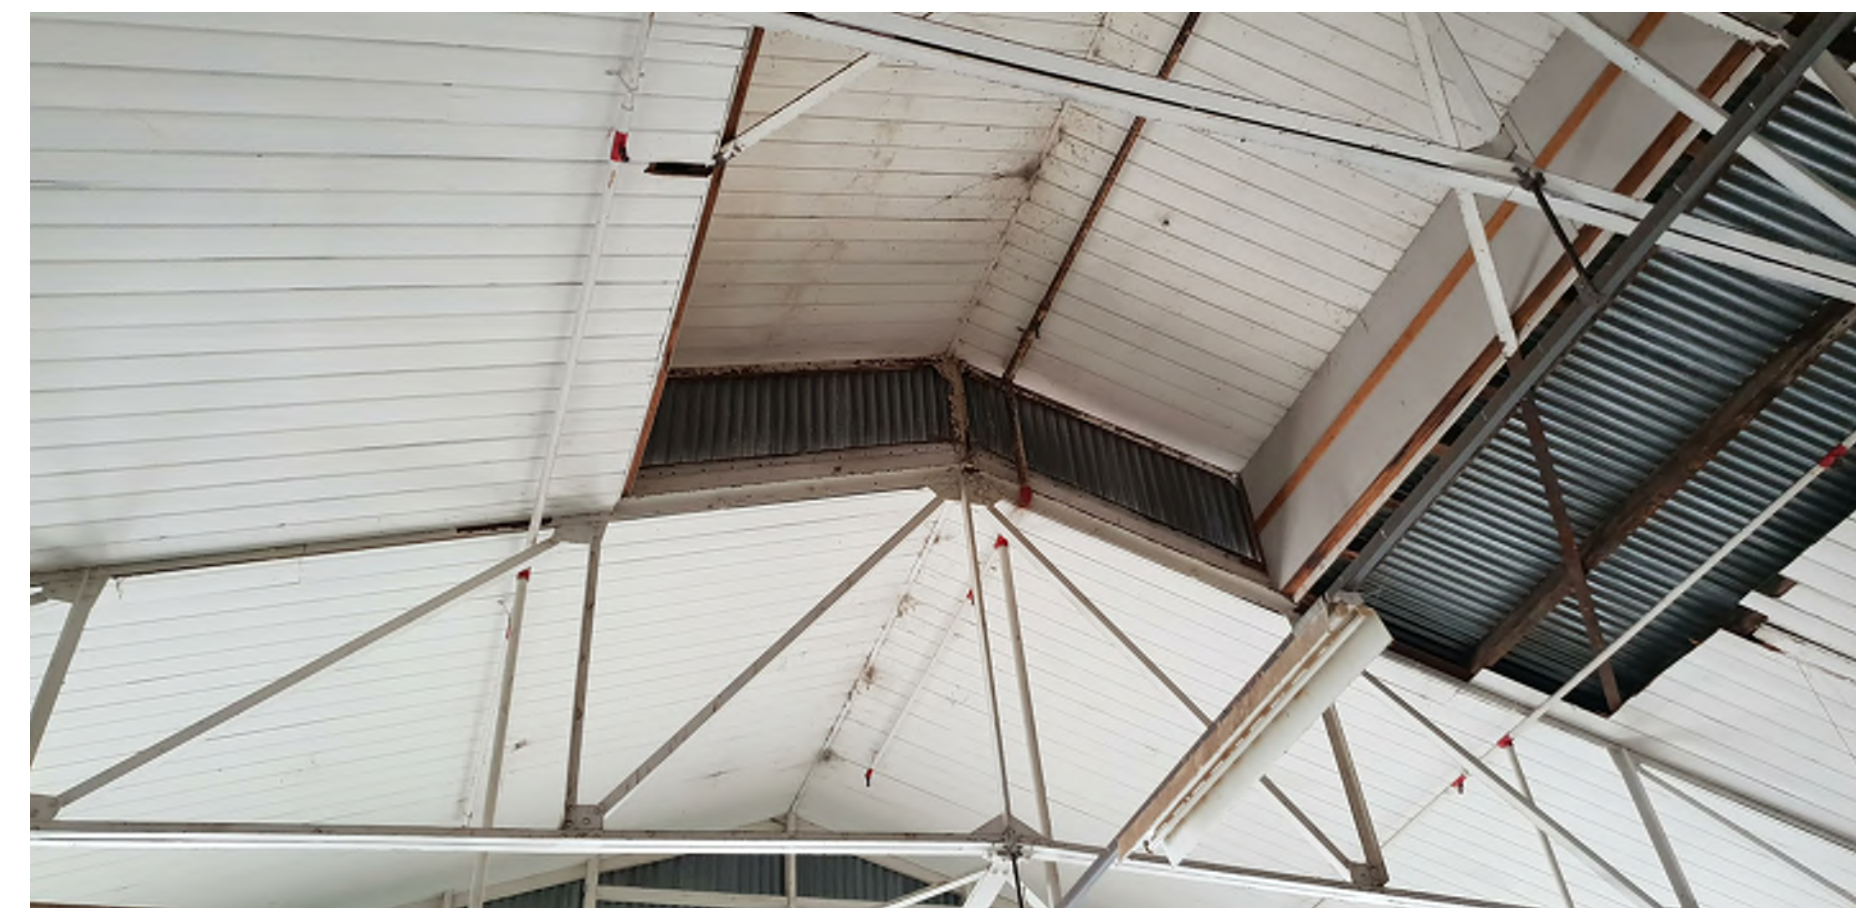
TYPICAL IMAGES - CEILING LININGS
