PRELIMINARY DOCUMENTATION REPORT

Demolition of Structures at RAAF Williams – Point Cook, Victoria

(EPBC 2019/8514)

November 2023

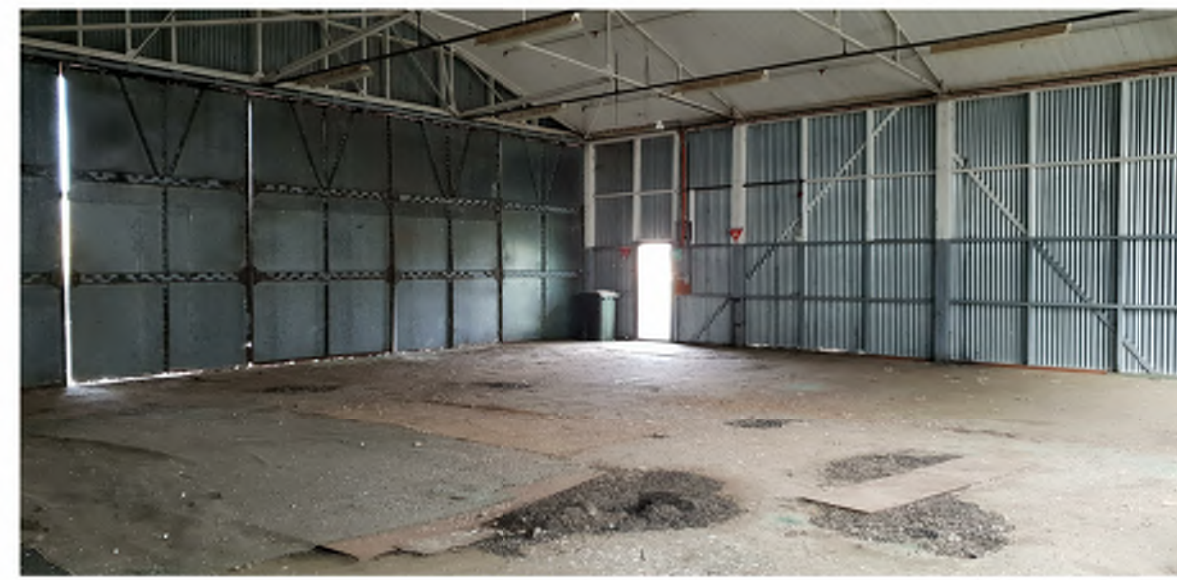
TYPICAL IMAGES - CONCRETE SLAB

- EXISTING STEEL WINDOWS, WILL BE REQUIRED TO BE REPLACED WITH NEW MATCHING TYPE WINDOWS.
 - THE EXISTING CONCRETE SURFACES INTERNALLY ARE DAMAGED AND CRACKED IN SOME AREAS WHERE THERE WERE ORIGINALLY PITS (TO SERVICE UNDERNEATH VEHICLES). THESE PITS HAVE BEEN FILLED WITH GRAVEL AND COVERED WITH CARPET AFTER THE BUILDING HAS BEEN TAKEN DOWN. THE CONCRETE INCLUDING PITS SHOULD BE BROKEN UP AND REMOVED FROM SITE. CONTAMINATION TO SOIL WILL NEED TO BE LOOKED AT AS OVER THE YEARS THE AREA WOULD HAVE BEEN EXPOSED TO CONTAMINATION FROM DIESEL, OIL, AND OTHER LIQUIDS. THE SOIL WILL NEED TO BE REMOVED AND ADDITIONAL SOIL BROUGHT IN WITH SEEDING TO LEAVE THE SITE IN THOSE AREAS.

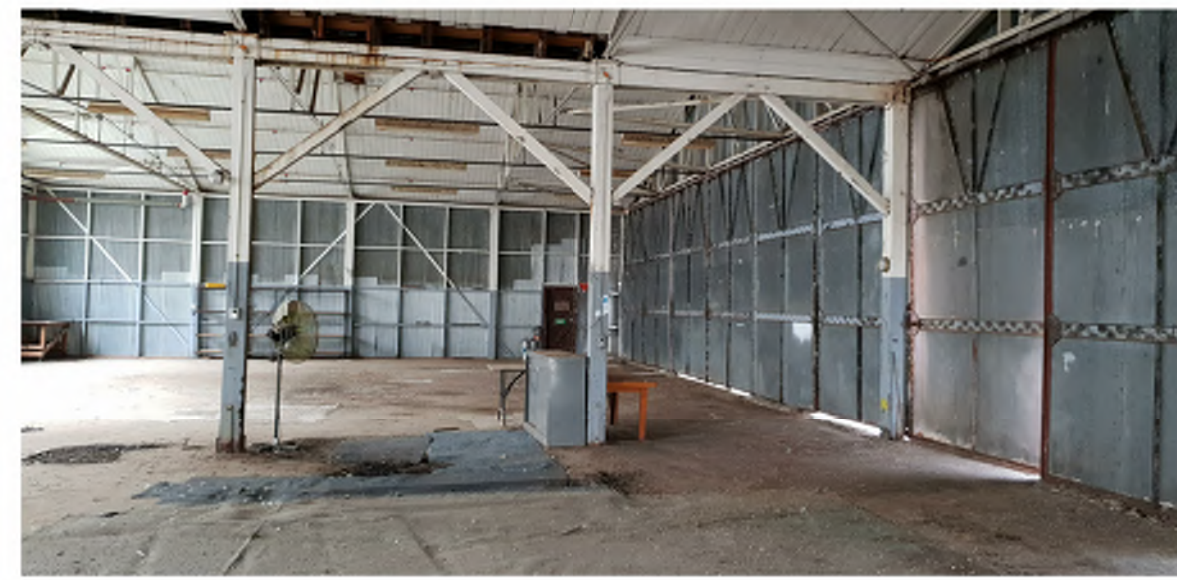
TYPICAL IMAGES - CONCRETE SLAB/
BUILDING STRUCTURE

- EXISTING TIMBER COLUMNS AND STEEL TRUSSES ETC ARE IN GOOD CONDITION AND CAN BE REUSED. TIMBER SURFACES SHOULD BE SANDED BACK AND PRIMED AND PAINTED. STEEL TRUSSES, SHOULD BE CLEANED AND ANY RUST REMOVED, PRIOR TO BEEN PRIMED AND PAINTED.

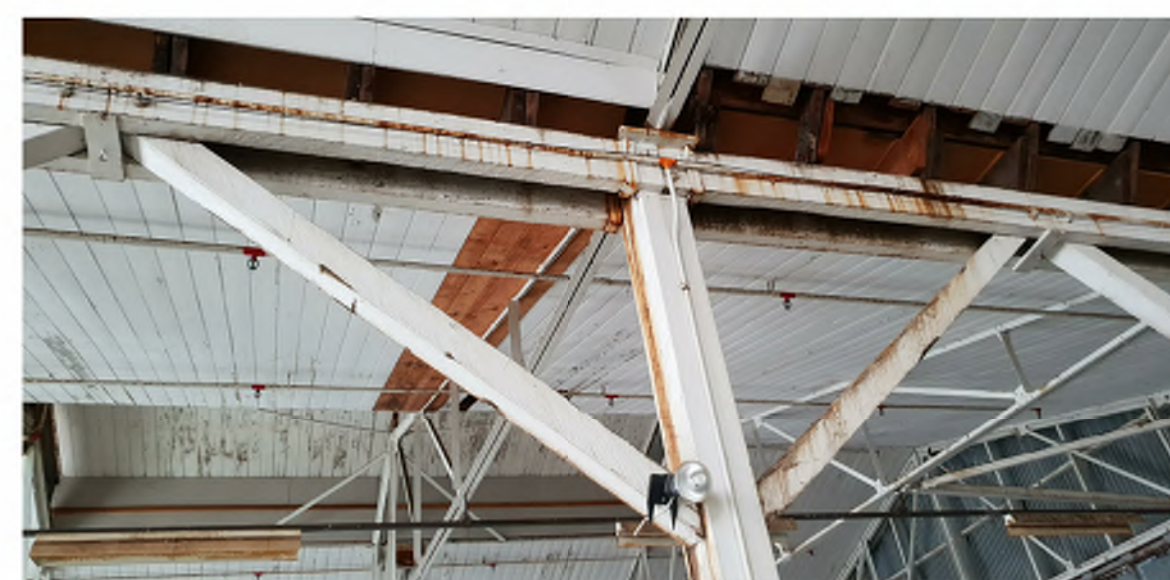
TYPICAL IMAGES - CEILING LININGS

- EXISTING INTERNAL CEILING LININGS ARE VAULTED PAINTED TIMBER PANELLING, WHICH IS IN GOOD CONDITION. THEY TIMBER PANELLING COULD BE REUSED IN THE NEW BUILDING, BUT CARE NEEDS TO BE TAKING REMOVING THE TIMBER BOARDS AND DURING REINSTALLATION PRIOR TO FIXING THE BOARDS SHOULD BE SANDED BACK, PRIMED AND PAINTED IN COLOURS TO MATCH EXISTING.

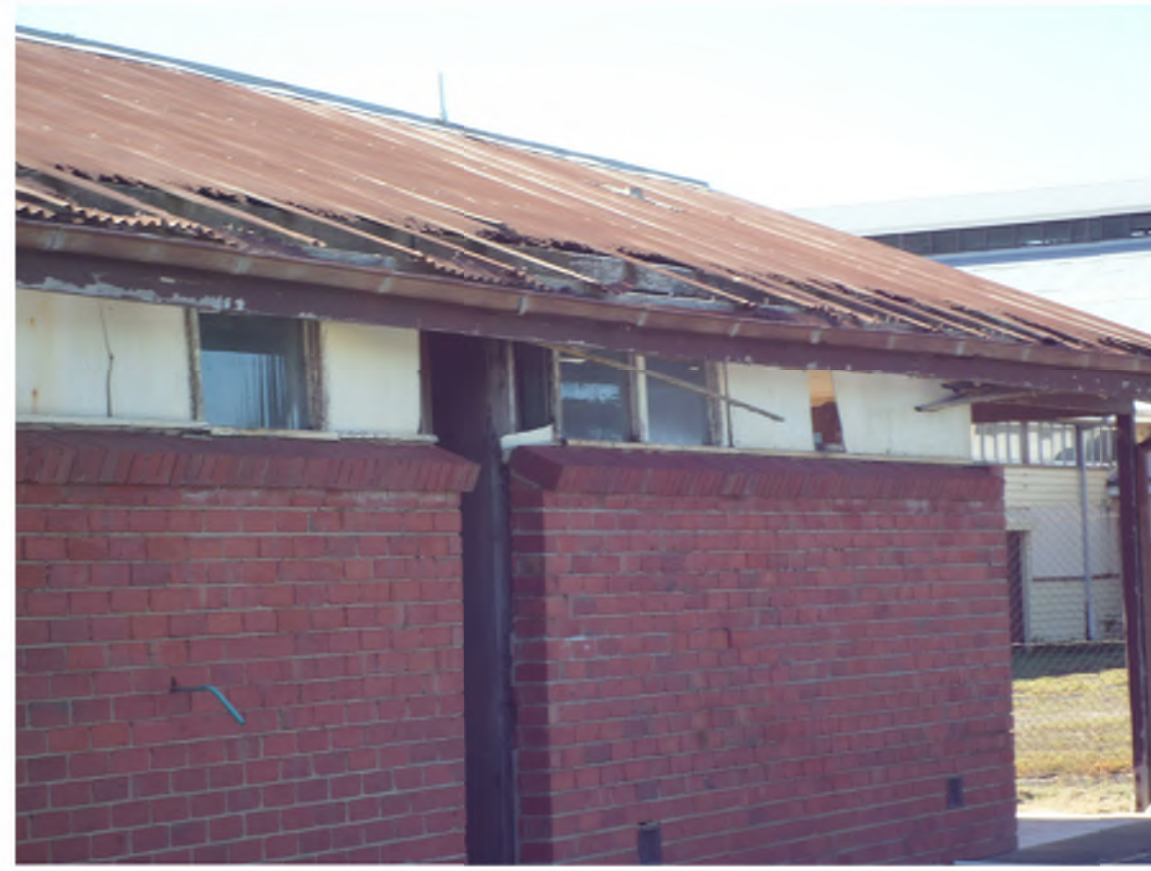
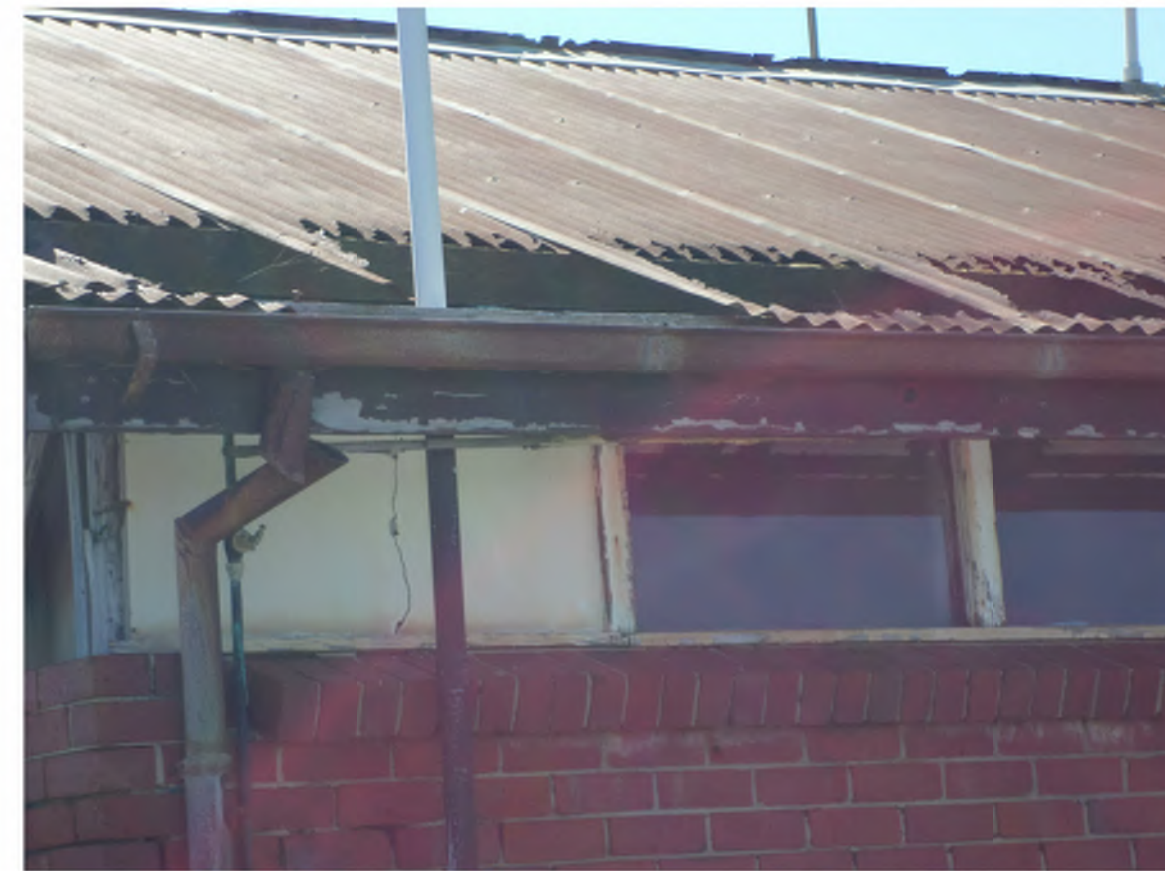
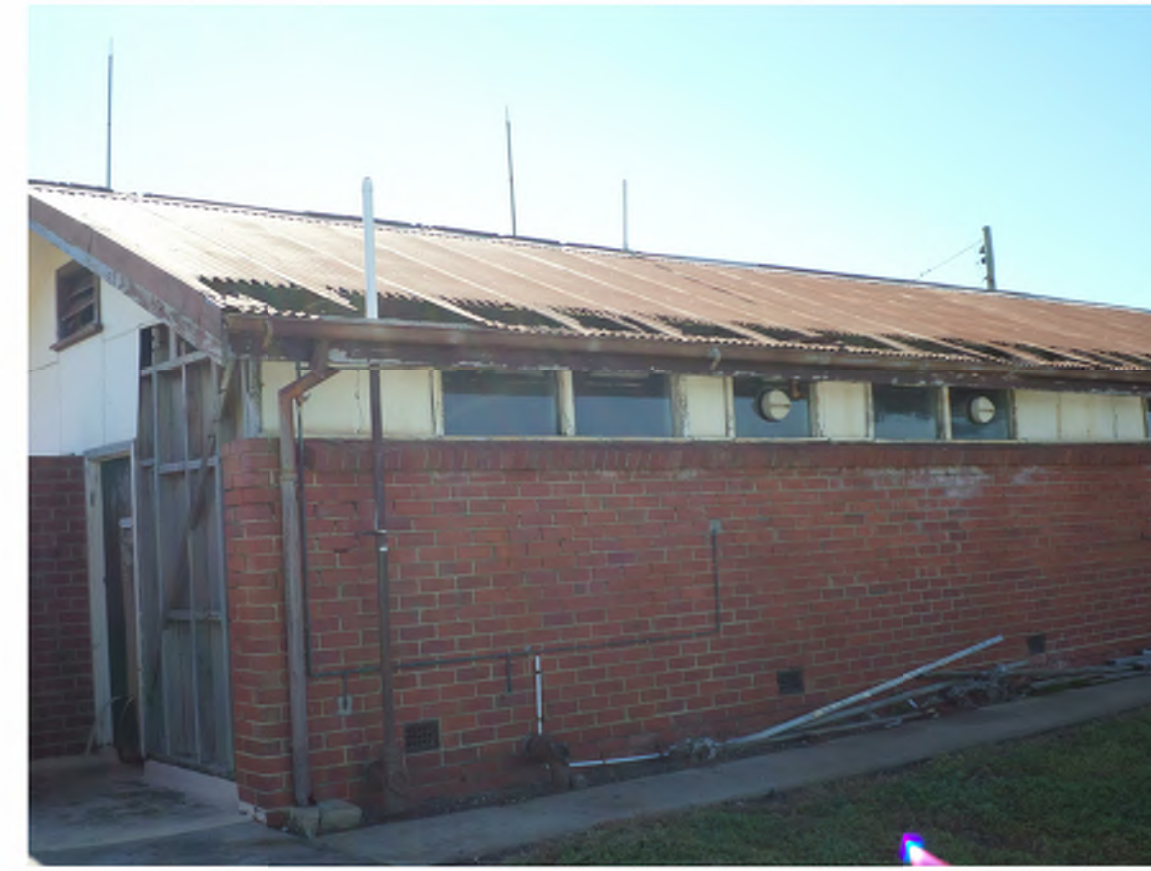
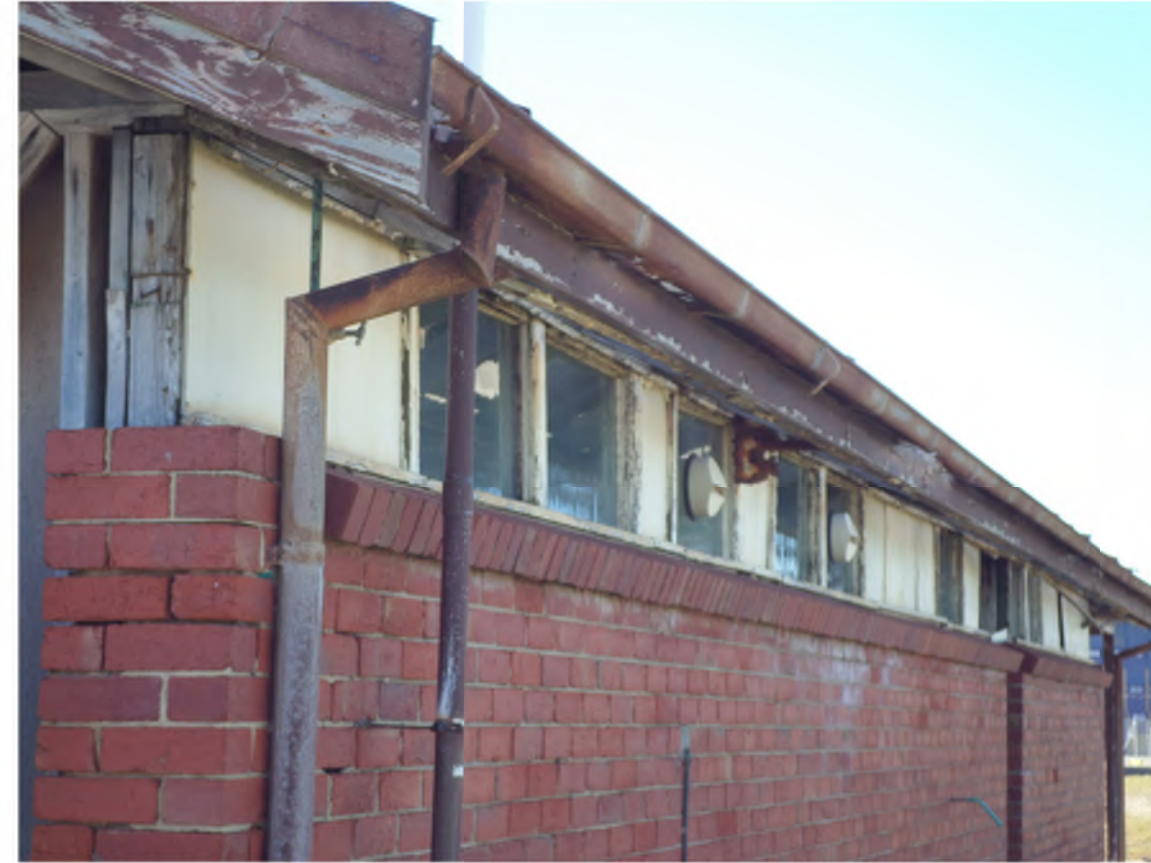
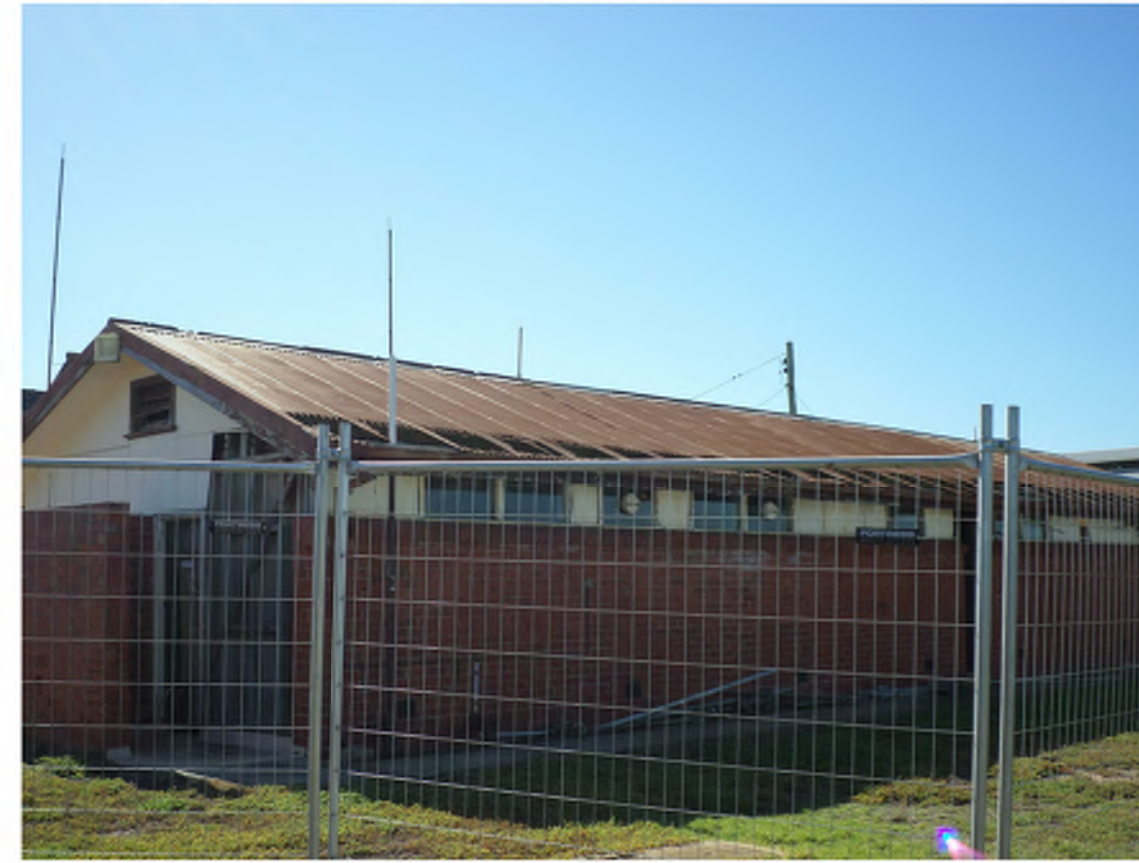
TOILET BLOCK SHOWING SIGNS OF DETERIORATION.

- EXISTING BRICK WALLS ARE IN GOOD CONDITION, BUT THE CLADDING ABOVE THEM HAS DETERIORATED AND IS DAMAGED WITH SOME MISSING PANELS.
- EXISTING TIMBER WINDOWS ARE DAMAGED, ROTTING, WITH SOME BROKEN GLAZING.
- THE EXISTING ROOF SHEETING IS RUSTED, WITH LARGE SECTION MISSING AND THE SHEETING IS LOOSE AND NOT SECURELY FIXED TO ROOF STRUCTURE.
- THE EXISTING TIMBER ROOF FRAMING IS ALSO DAMAGED AND WITH THE MISSING SHEETING IS SHOWING SIGNS OF WEATHERING.
- THE EXISTING GUTTERS AND DOWNPIPES ARE MISSING, DAMAGED AND BEYOND REPLACEMENT.
- EXTERNAL TIMBER FASCIAS, ARE ROTTING AND DAMAGED DUE TO THE DAMAGE AND FAILING OF THE BUILDING STRUCTURE
- THE STRUCTURAL INTEGRITY OF THE BUILDING SHOULD BE FURTHER PROOF THAT THE BUILDING SHOULD BE DEMOLISHED.

- INTERNAL SURFACES ARE DAMAGED, WITH BROKEN SHEETS, MISSING SHEETS AND THE CEILING HAS FALLEN DOWN IN A LOT OF AREAS.
- THE EXISTING TOILET FITTINGS ARE OLD, DAMAGED AND WOULD NEED REPLACEMENT. EXISTING INTERNAL DOORS ARE MISSING, DELAMINATING AND BADLY DAMAGED.

- THE BUILDING SHOULD BE TOTALLY DEMOLISHED AND REMOVED FROM SITE.
- THE CONTRACTORS SHOULD CONFER WITH ASBESTOS REGISTER FOR THIS BUILDING, TO ENSURE THAT ANY ASBESTOS PRESENT IS DISPOSED OF IN CORRECT MANNER AND IN COMPLIANCE WITH REGULATIONS.
- THE EXISTING CONCRETE SLAB TO THE WEST SIDE OF THE BUILDING SHOULD BE BROKEN UP AND BE DISPOSED OF.
- ANY SERVICE PITS, PIPES, ETC SHOULD BE CAPPED AND DEMOLISHED.
- CONTRACTOR IS TO ALLOW TO LEVEL THE AREA AFTER REMOVAL OF THE BUILDING AND PROVIDE NEW SOIL AND SEEDING TO AREA.

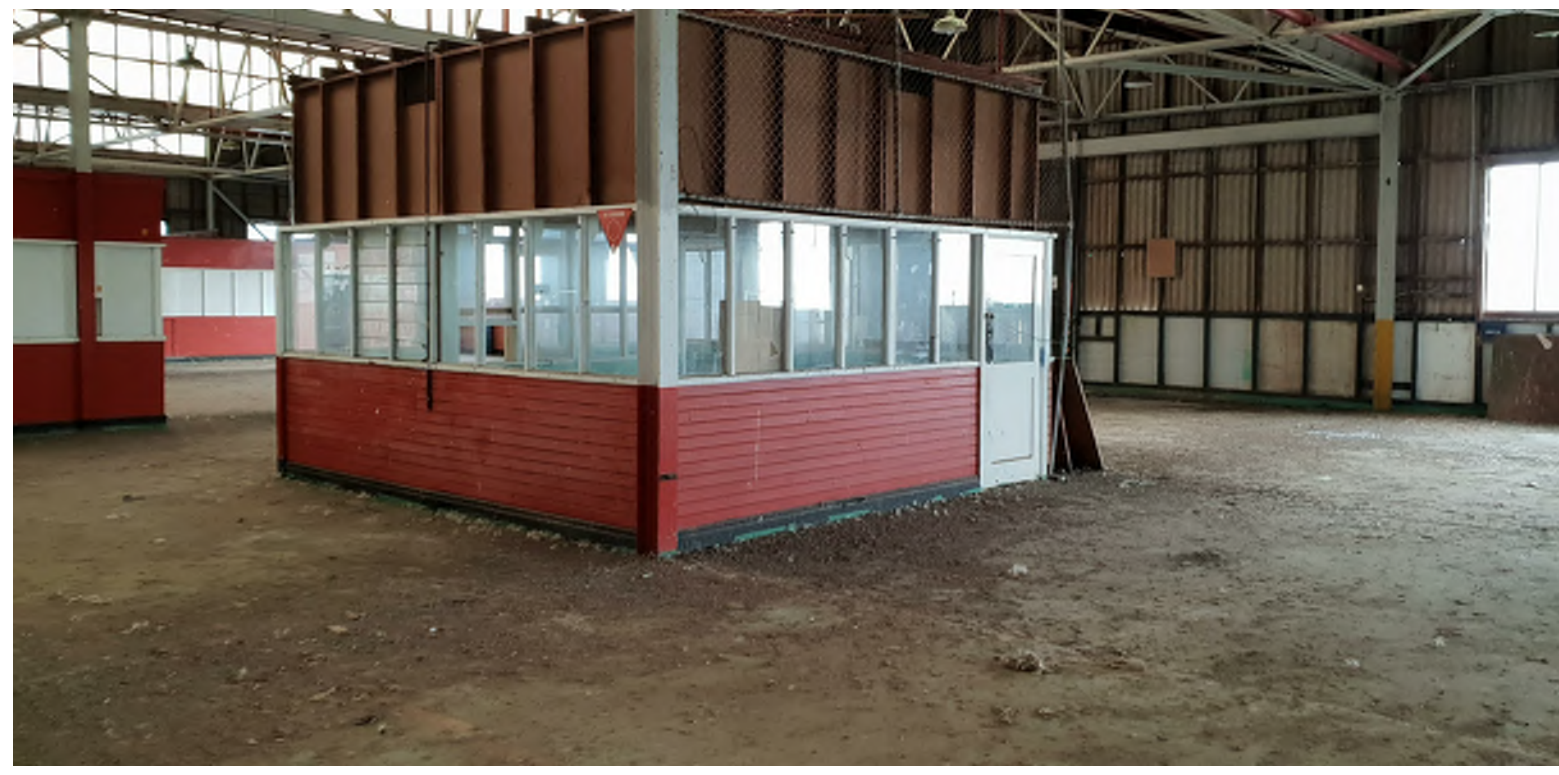
TYPICAL INTERNAL OFFICE TO BE DEMOLISHED

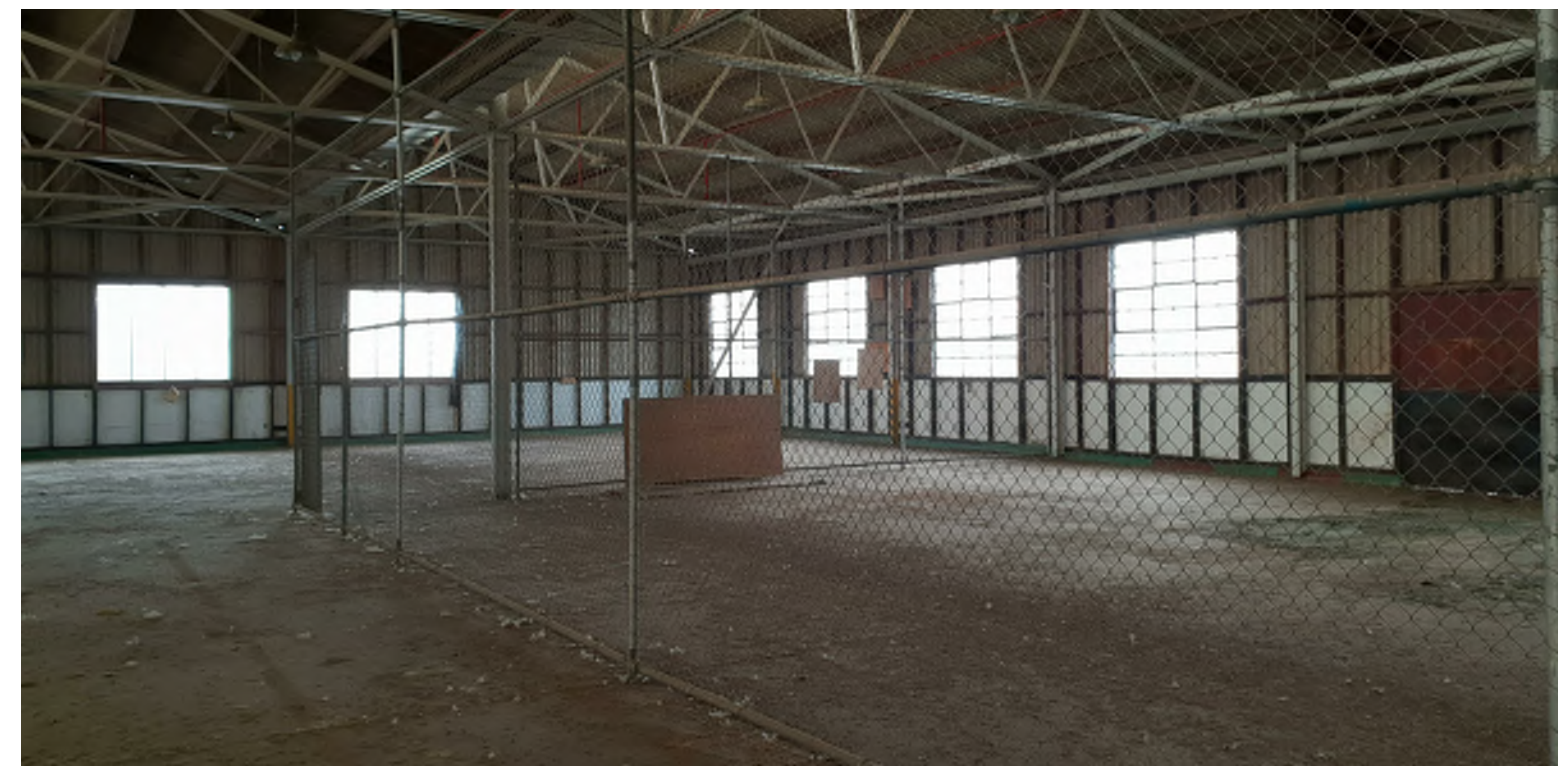
INTERNAL CAGED STORE AREA TO BE DEMOLISHED

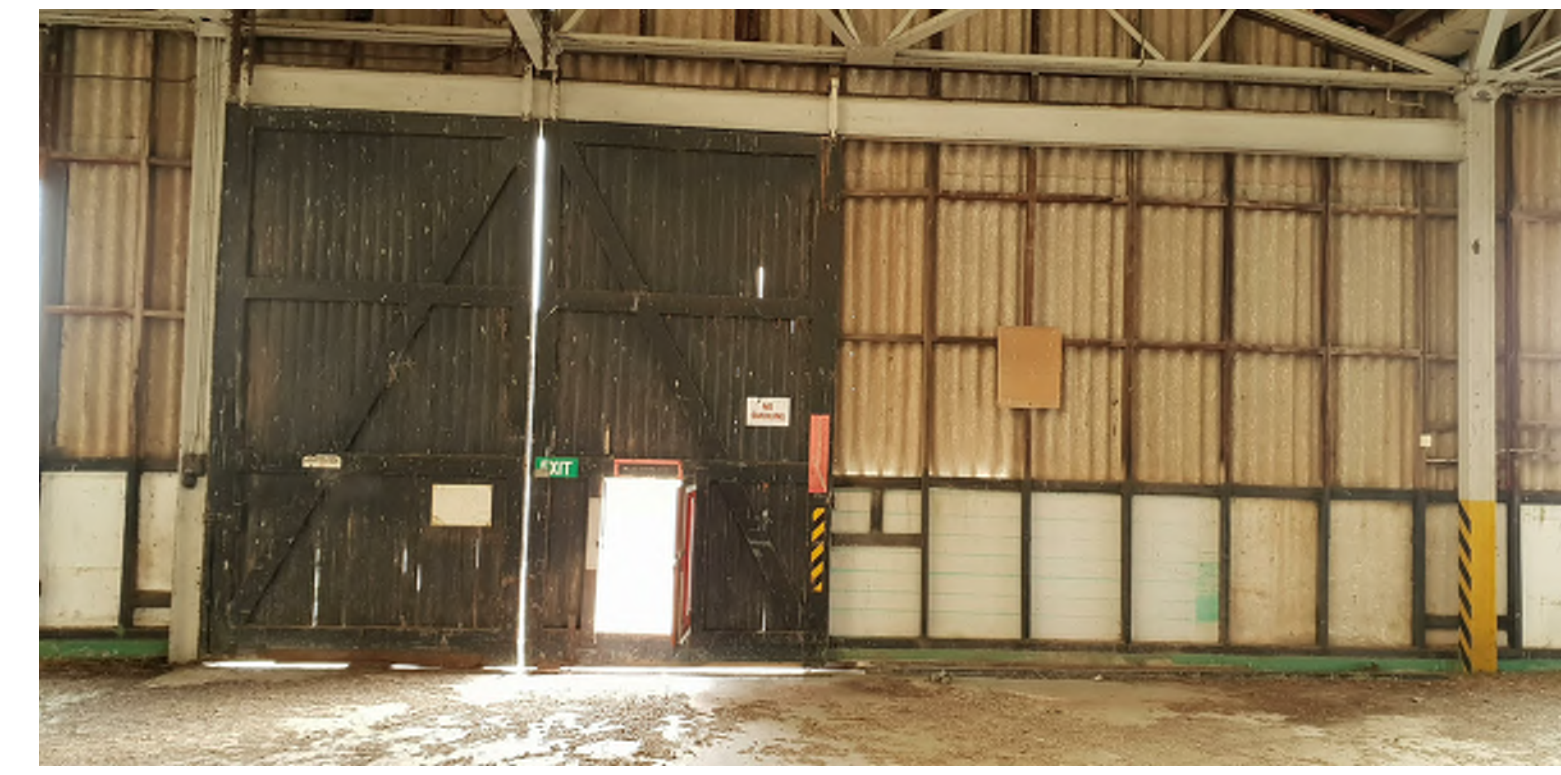
EXISTING LARGE TIMBER DOORS TO BE REPLACED

- REPLACE EXISTING EXTERNAL TIMBER DOORS AND REPLACE WITH NEW SOLID PANEL TIMBER DOORS INCLUDING NEW DDA COMPLIANT DOOR HARDWARE AND WEATHER SEALS TO BOTTOM OF DOORS.

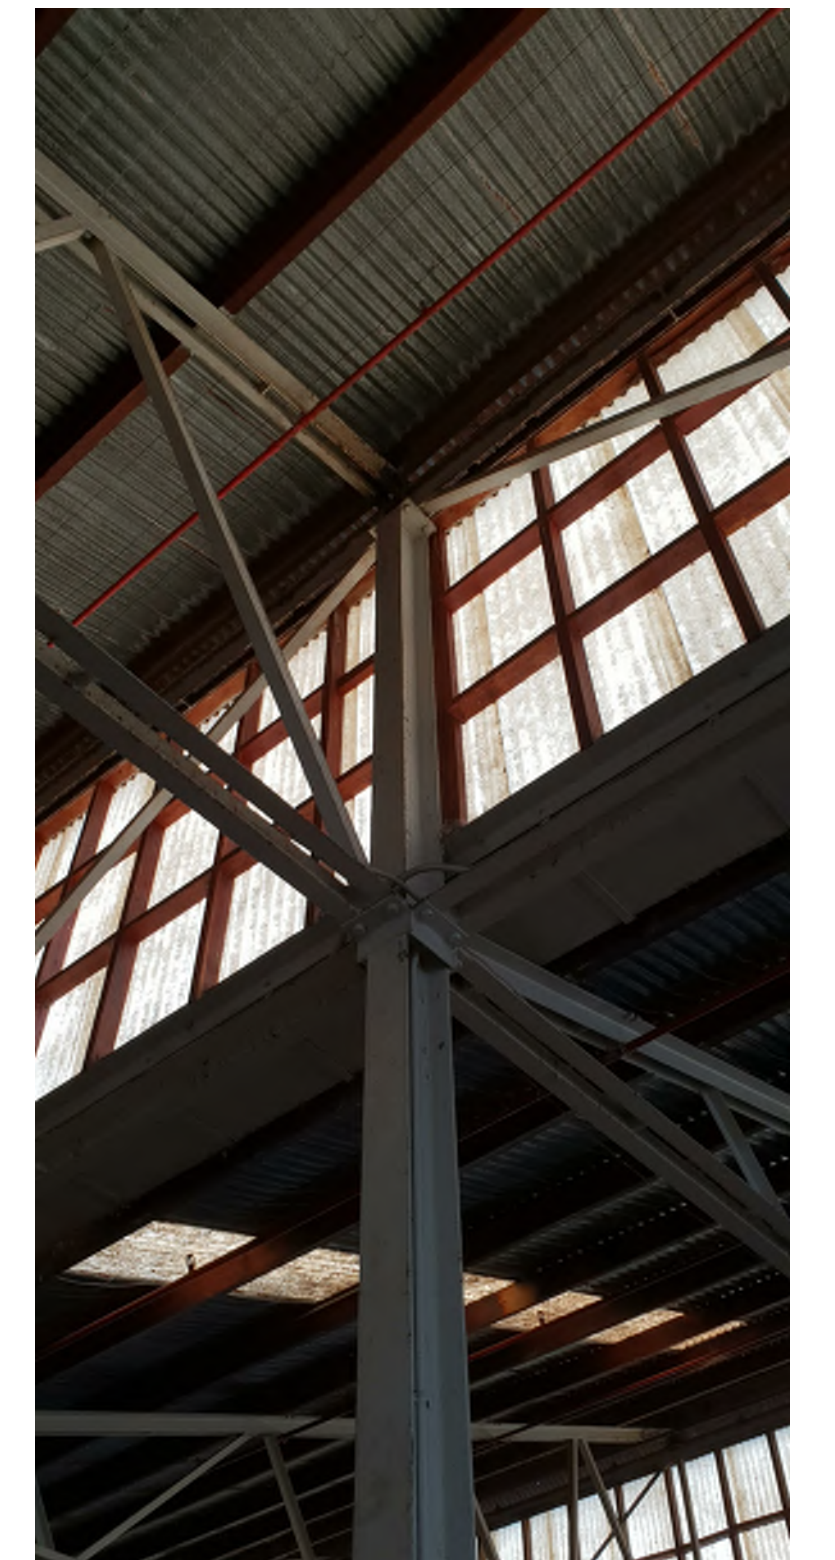
EXISTING STEEL STRUCTURE - PRIME AND REPAINT

- EXISTING STEEL STRUCTURE, SHOWS SIGNS OF RUSTING AND CORROSION AND NEEDS TO BE CLEANED AND RUSTING REMOVED AND PRIMED AND PAINTED.
 - EXISTING OFFICES, TOILETS, ADMINISTRATION AREAS TO NEW BUILDING REFURBISHMENTS SHOULD BE ASSESSED AFTER BUILDING CLASSIFICATION HAS BEEN DETERMINED. ANY NEW AMENITIES WILL BE REQUIRED TO COMPLY WITH CURRENT DDA STANDARDS.

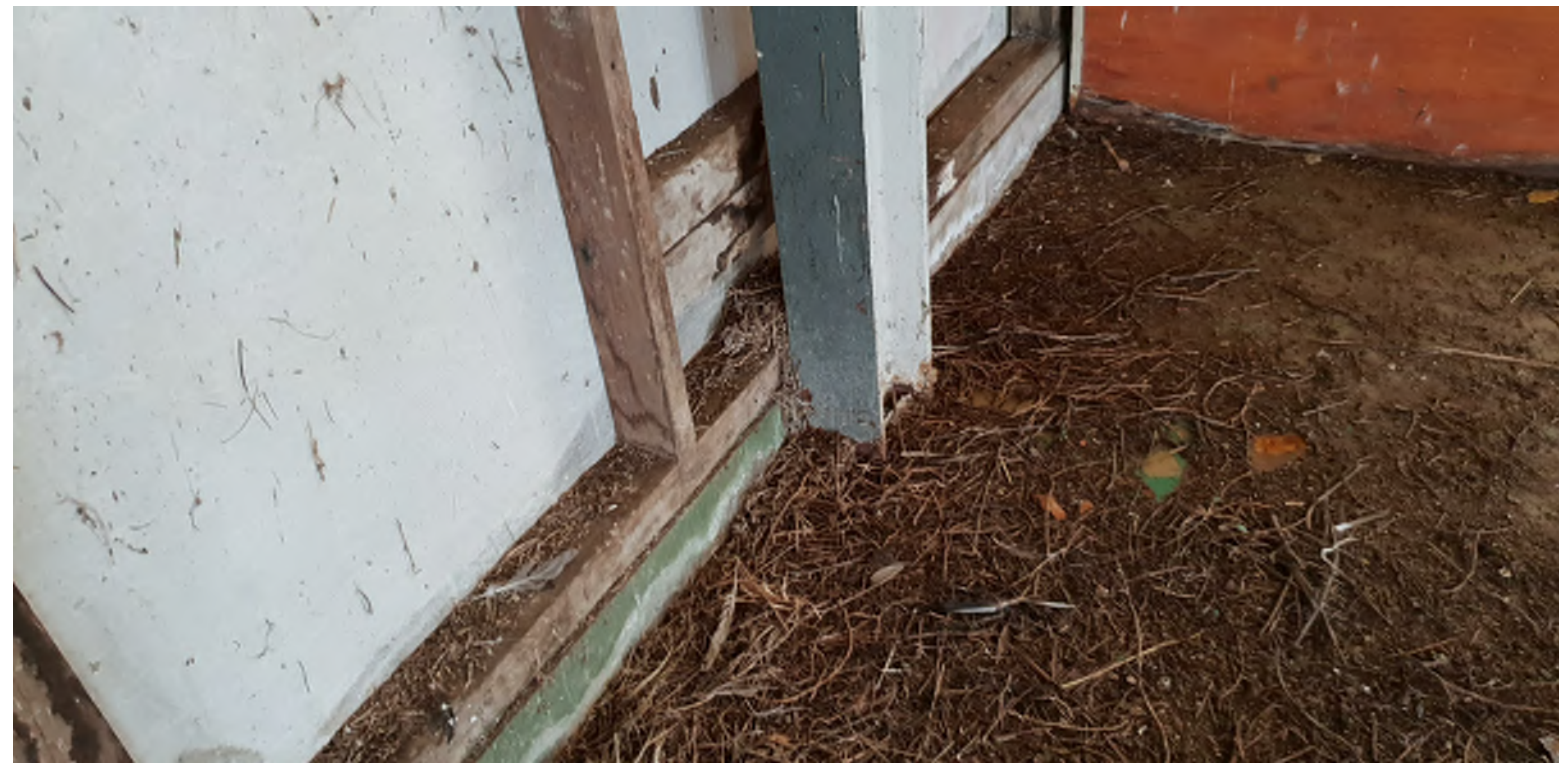
TYPICAL RUBBISH, LEAVES TO BE REMOVED FROM BUILDING

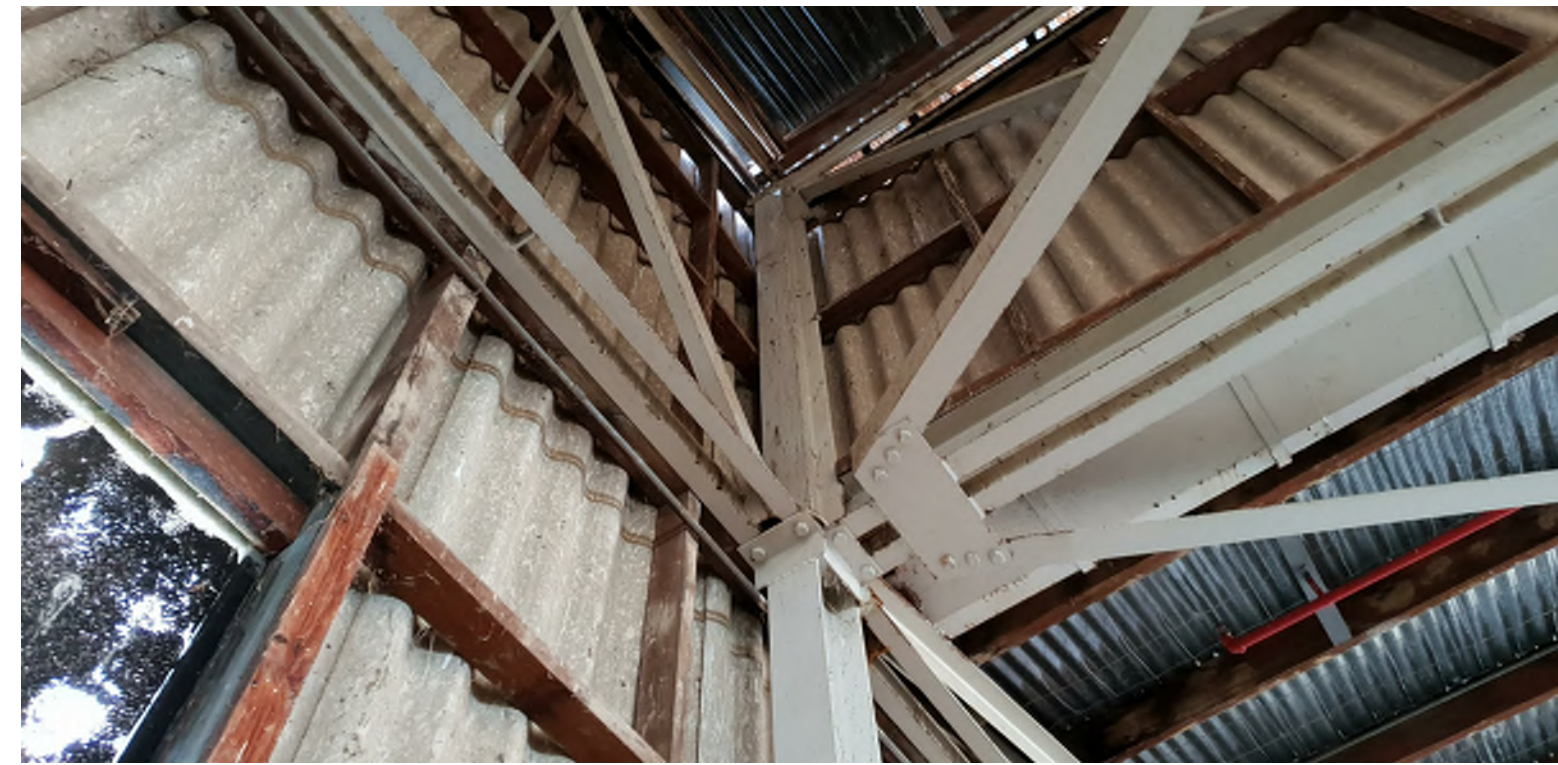
EXTERNAL LININGS TO BE REMOVED AND REPLACED WITH NEW

- SCOPE OF WORKS**
- EXTERNAL METAL CLADDING IS A MIXTURE OF ASBESTOS FIBRE CEMENT SHEETING IN BOTH RIB PANEL AND FLAT SHEETS, WHICH SHOULD BE REMOVED AND REPLACED WITH NEW COLORBOND METAL CLADDING, INCLUDING ALL FLASHINGS, CAPPINGS, R2.5 RATED INSULATION, ETC.

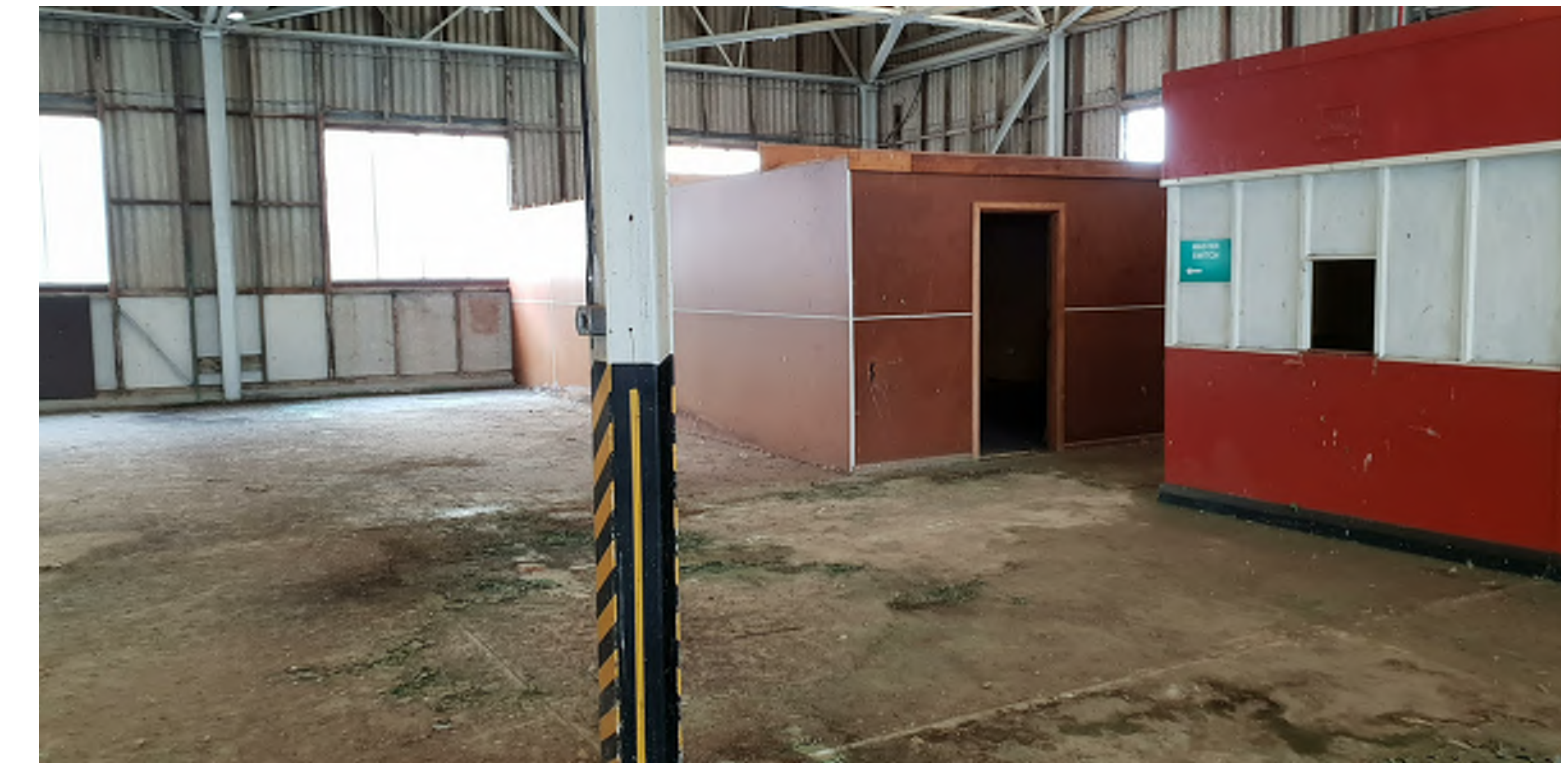
INTERNAL OFFICES TO BE DEMOLISHED

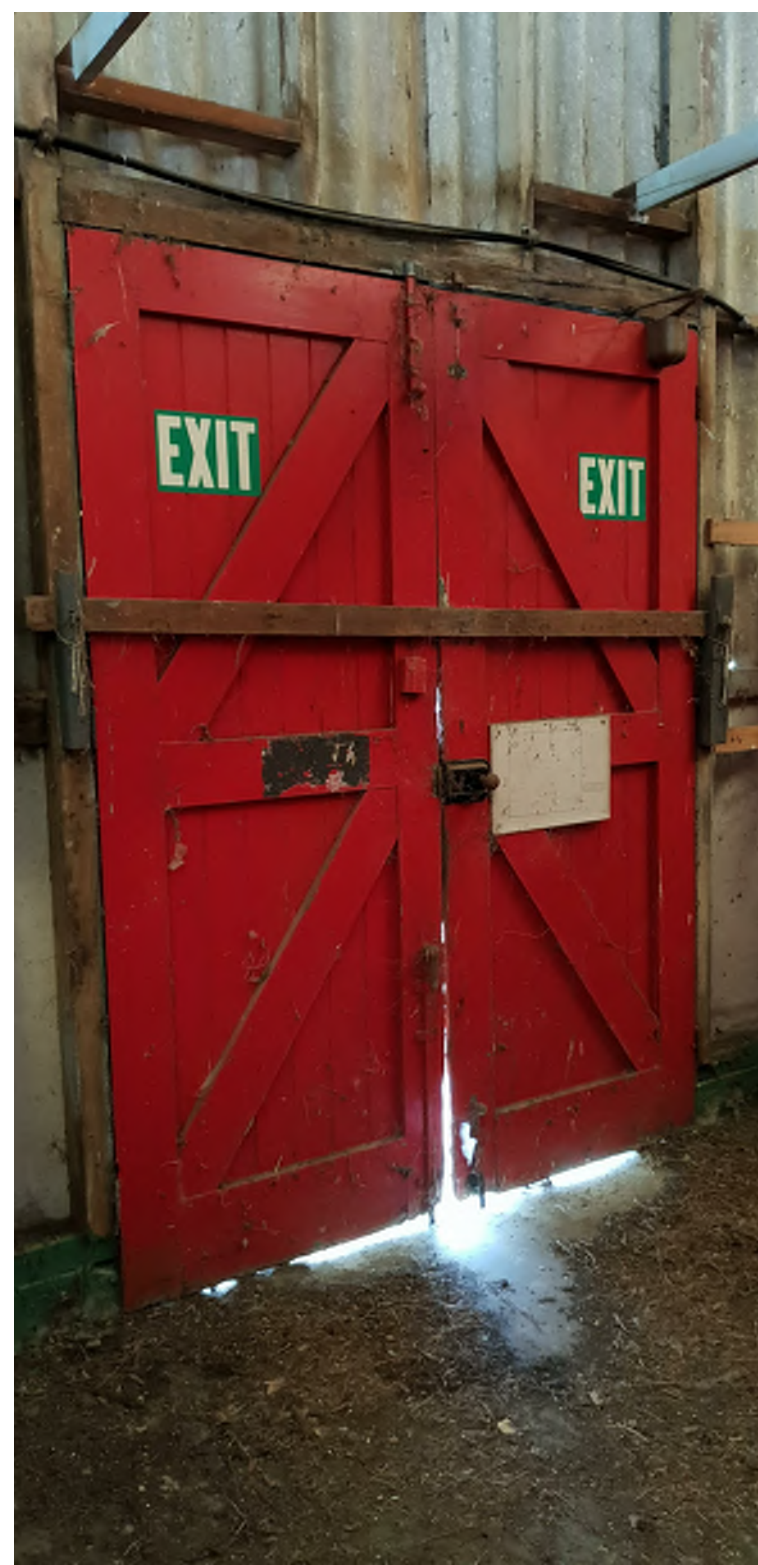
EXISTING DOORS TO BE REPLACED

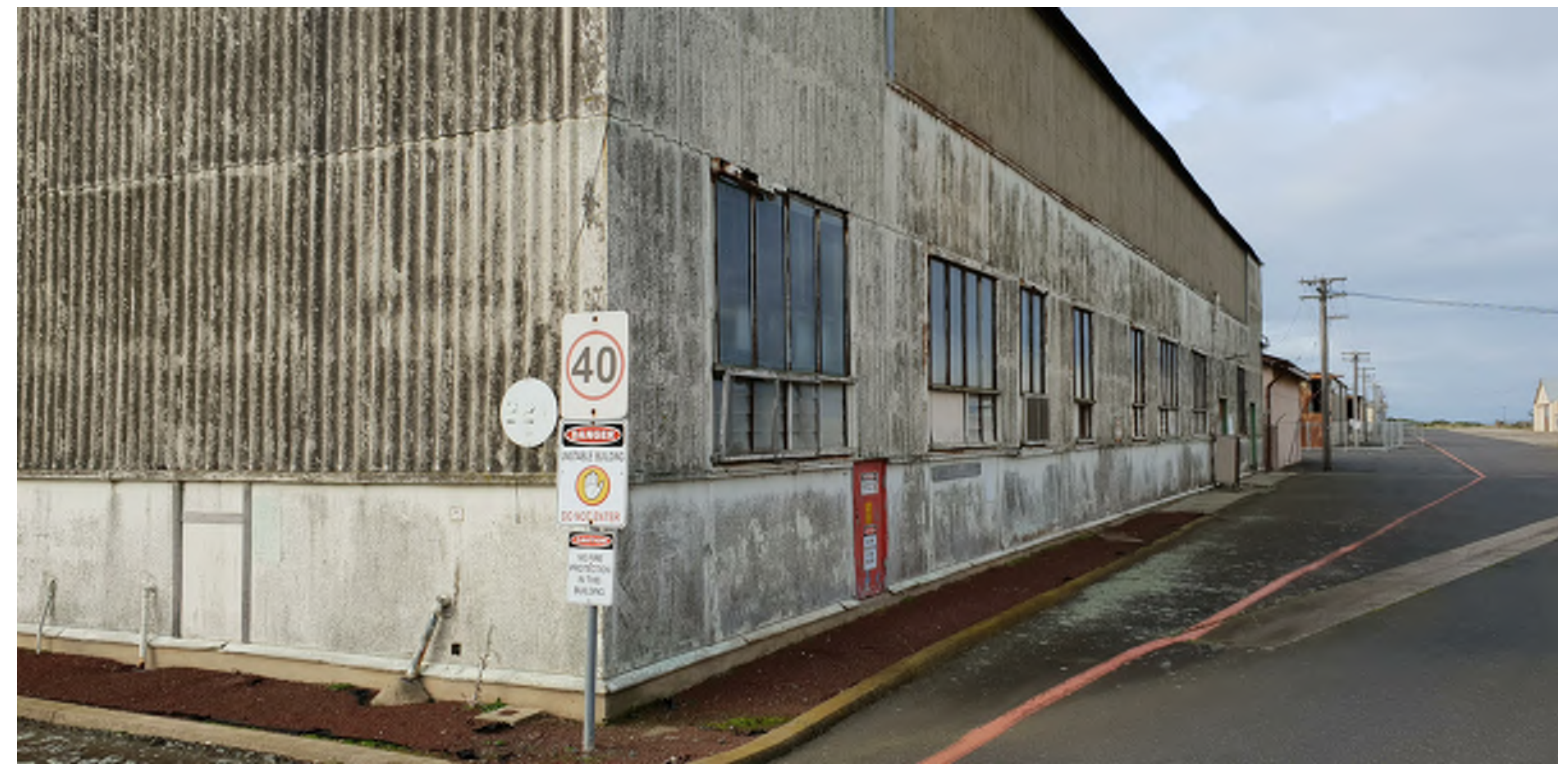
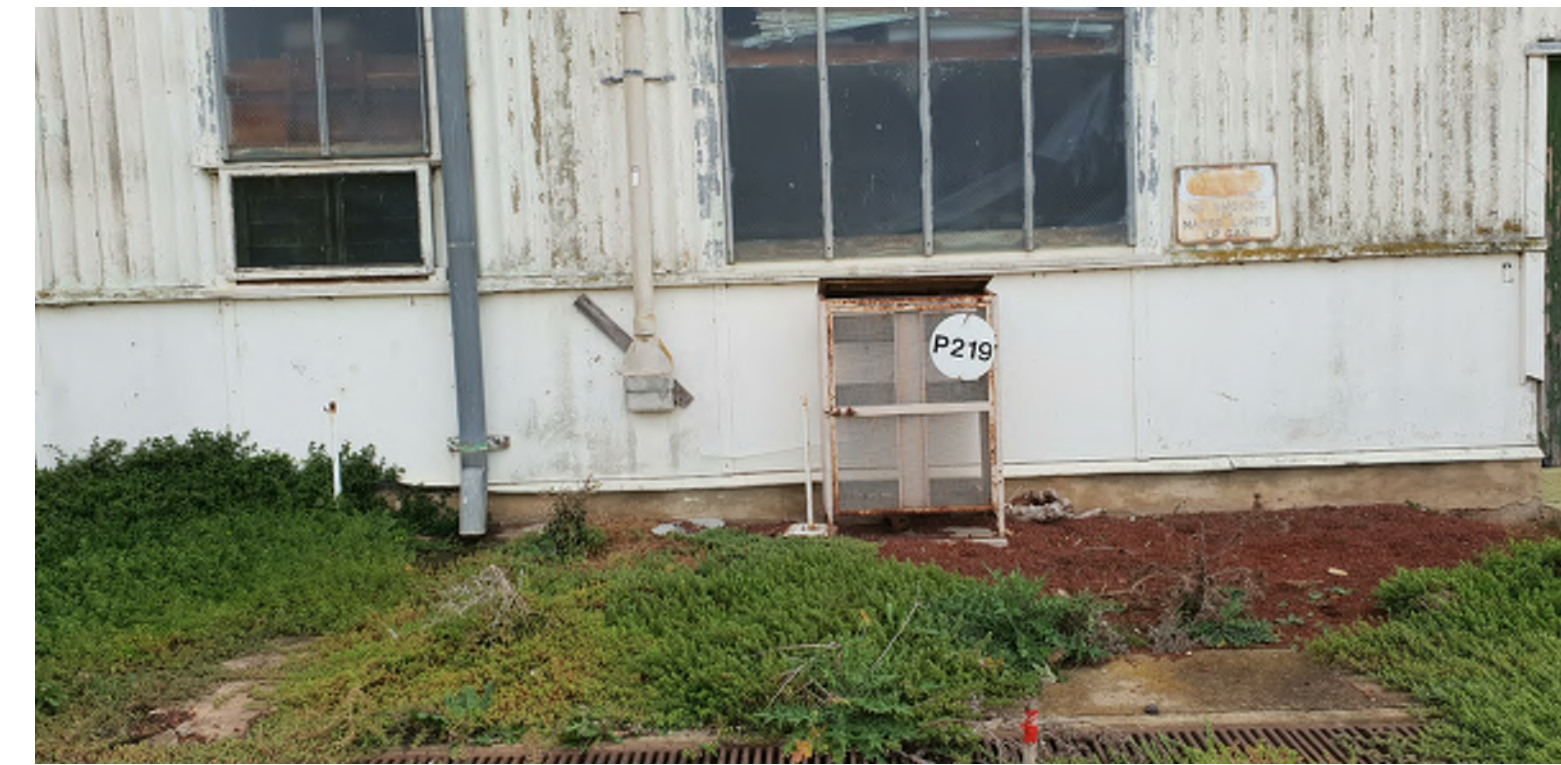
DETERIORATION OF EXTERNAL CLADDING - TYPICAL

TYPICAL DETERIORATION OF EXTERNAL CLADDING

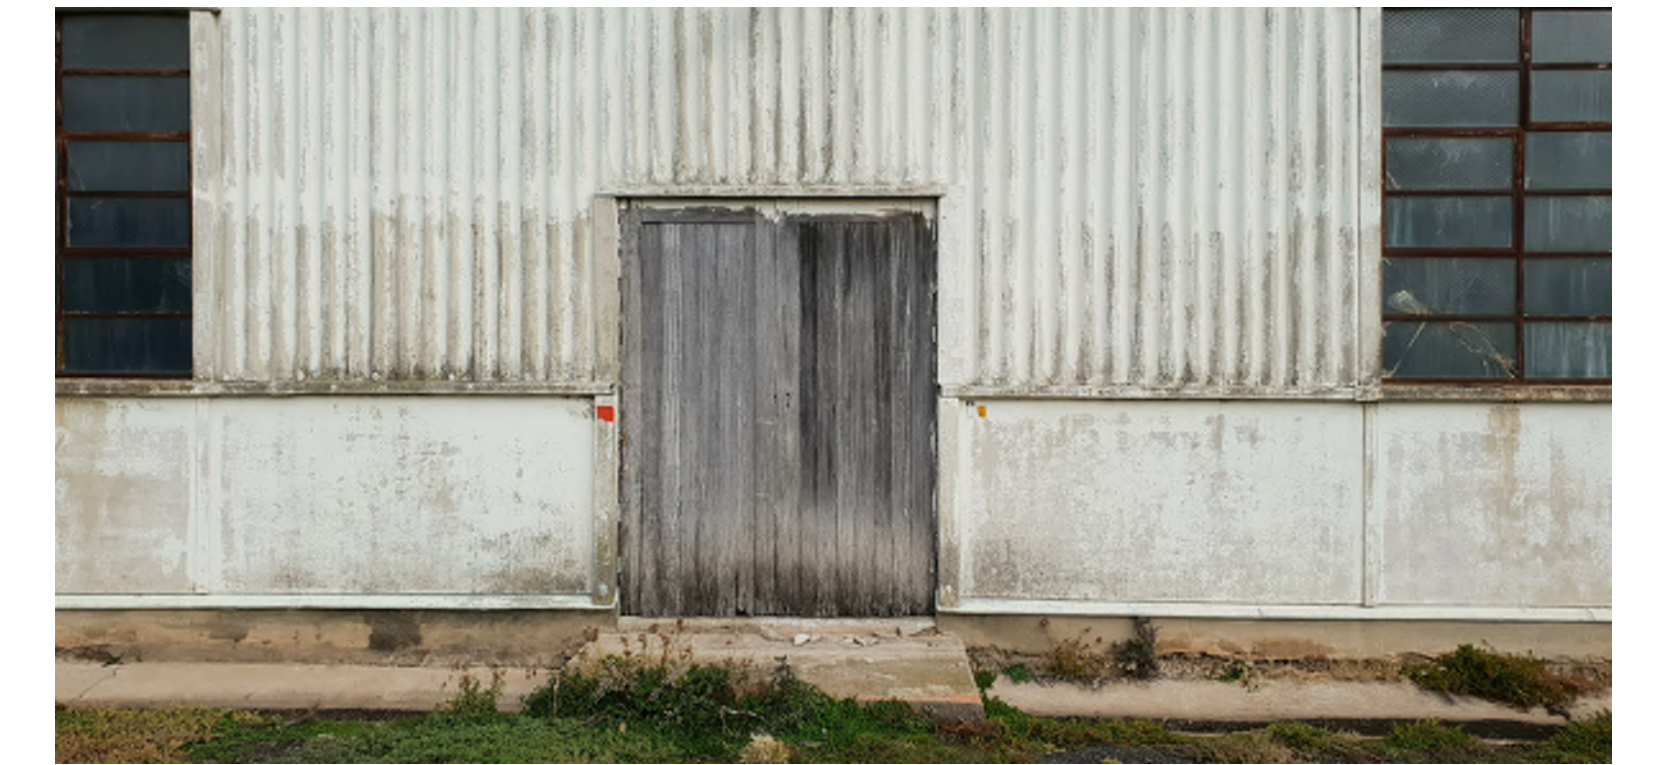
TYPICAL DETERIORATION OF EXTERNAL CLADDING AND TIMBER DOOR TO BE REPLACED

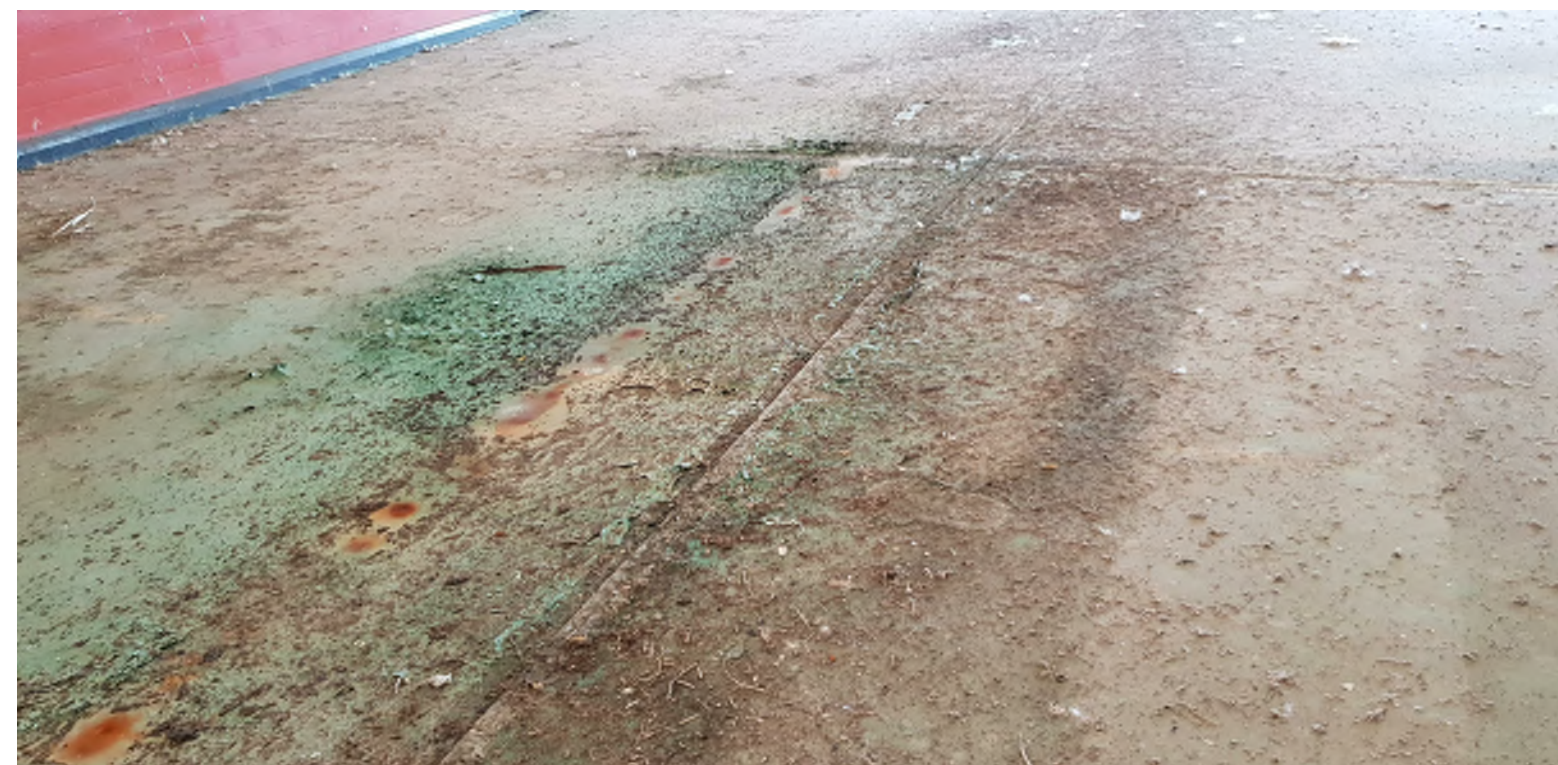
TYPICAL CONCRETE SLAB - SHOWING EXTENT OF DIRT BUILD UP TO BE REMOVED
