PRELIMINARY DOCUMENTATION REPORT

Demolition of Structures at RAAF Williams – Point Cook, Victoria

(EPBC 2019/8514)

November 2023

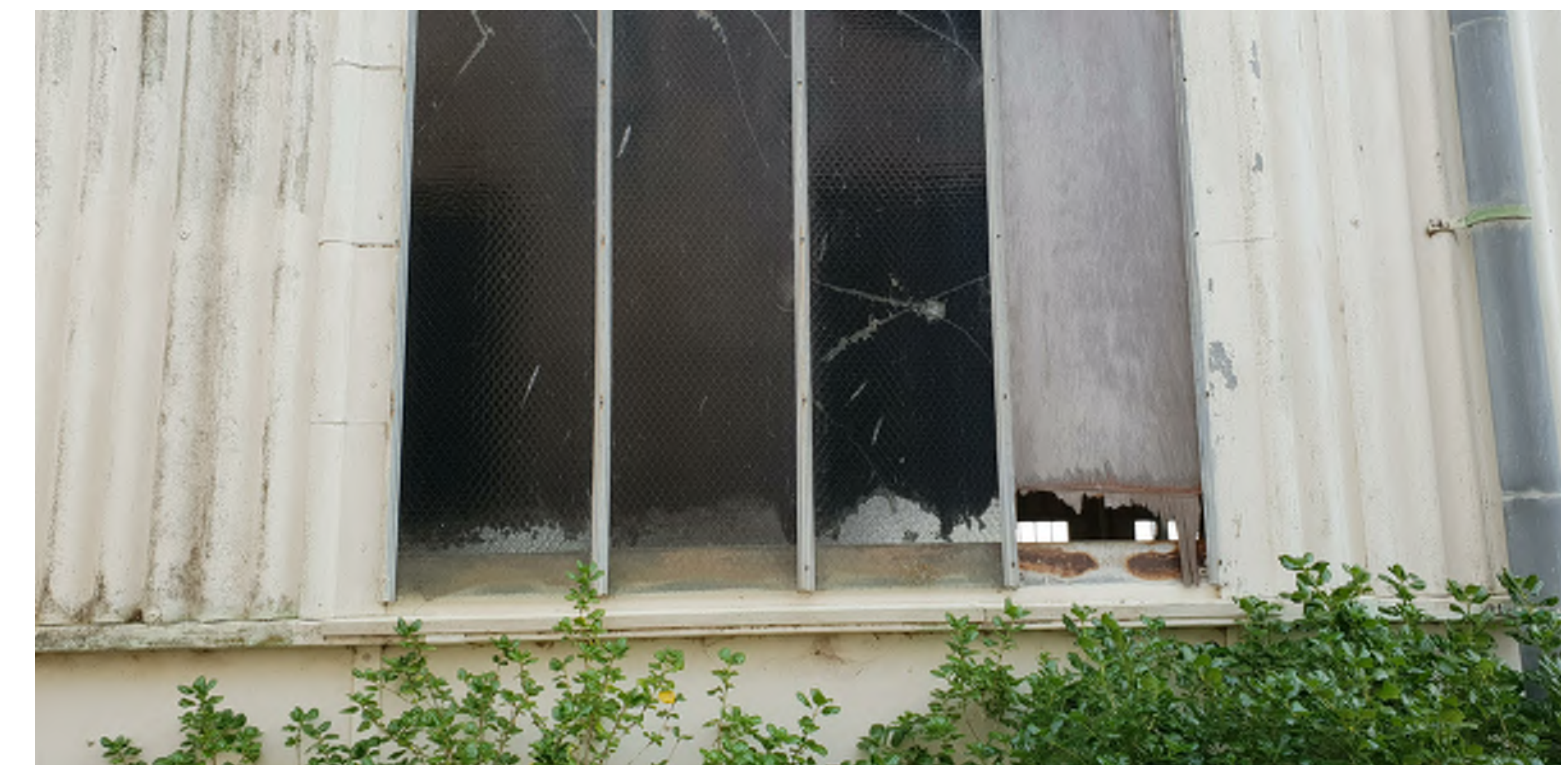
EXISTING STEEL FRAMED WINDOWS TO BE REPLACED

- EXISTING STEEL WINDOWS FRAMES ARE DAMAGED, RUSTING AND CORRODED AND SHOULD BE REPLACED WITH NEW POWDERCOATED ALUMINIUM WINDOWS, INCLUDING ALL FLASHINGS, CAPPINGS.

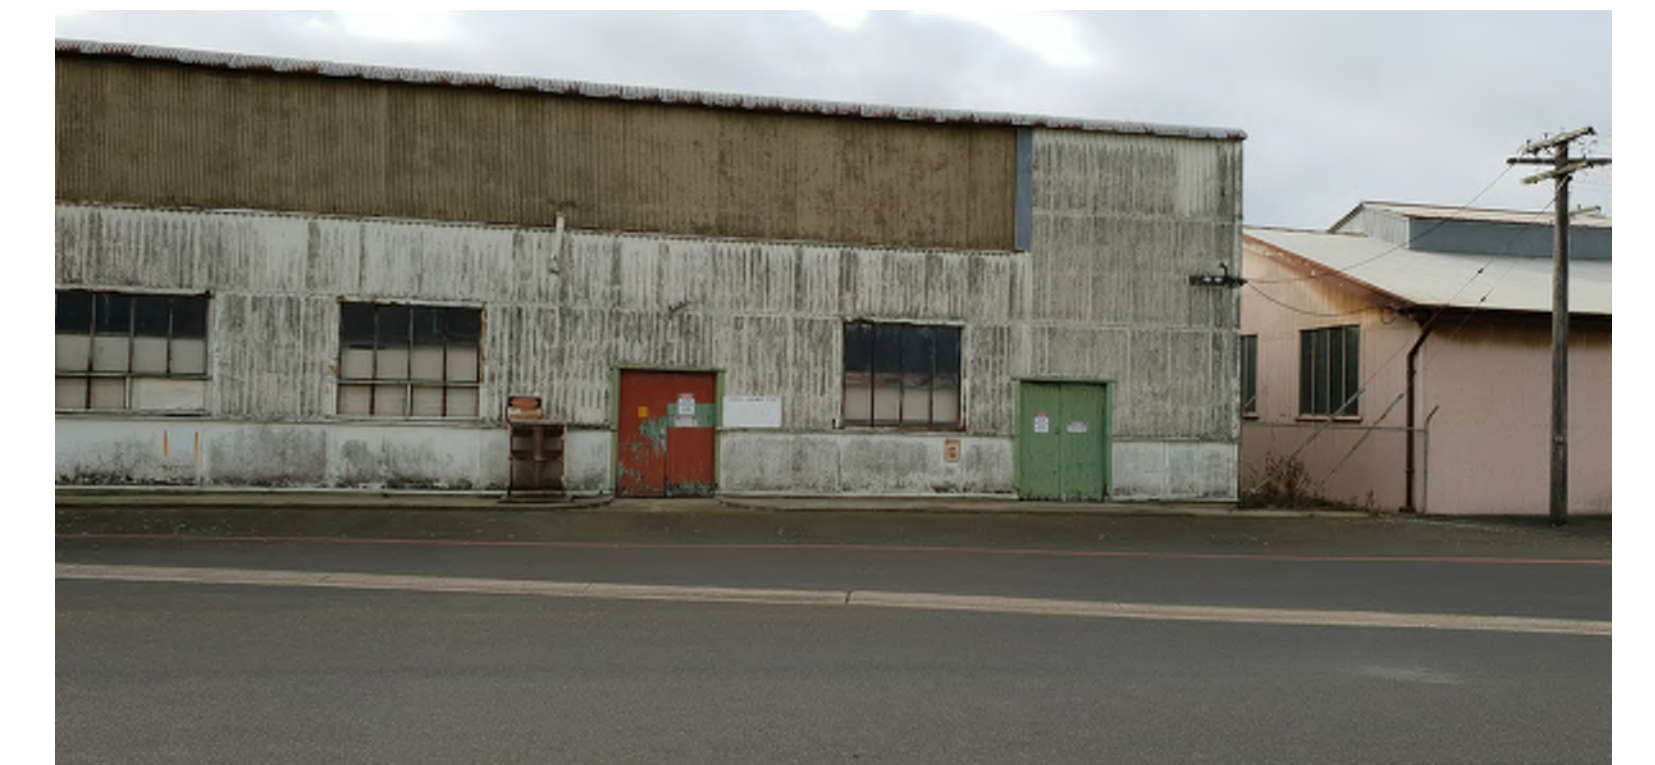
TYPICAL EXTERNAL ELEVATION - SHOWING EXTENT OF CLADDING TO BE REPLACED

- SCOPE OF WORKS**
- EXTERNAL METAL CLADDING IS A MIXTURE OF ASBESTOS FIBRE CEMENT SHEETING IN BOTH RIB PANEL AND FLAT SHEETS, WHICH SHOULD BE REMOVED AND REPLACED WITH NEW COLORBOND METAL CLADDING, INCLUDING ALL FLASHINGS, CAPPINGS, R2.5 RATED INSULATION, ETC.

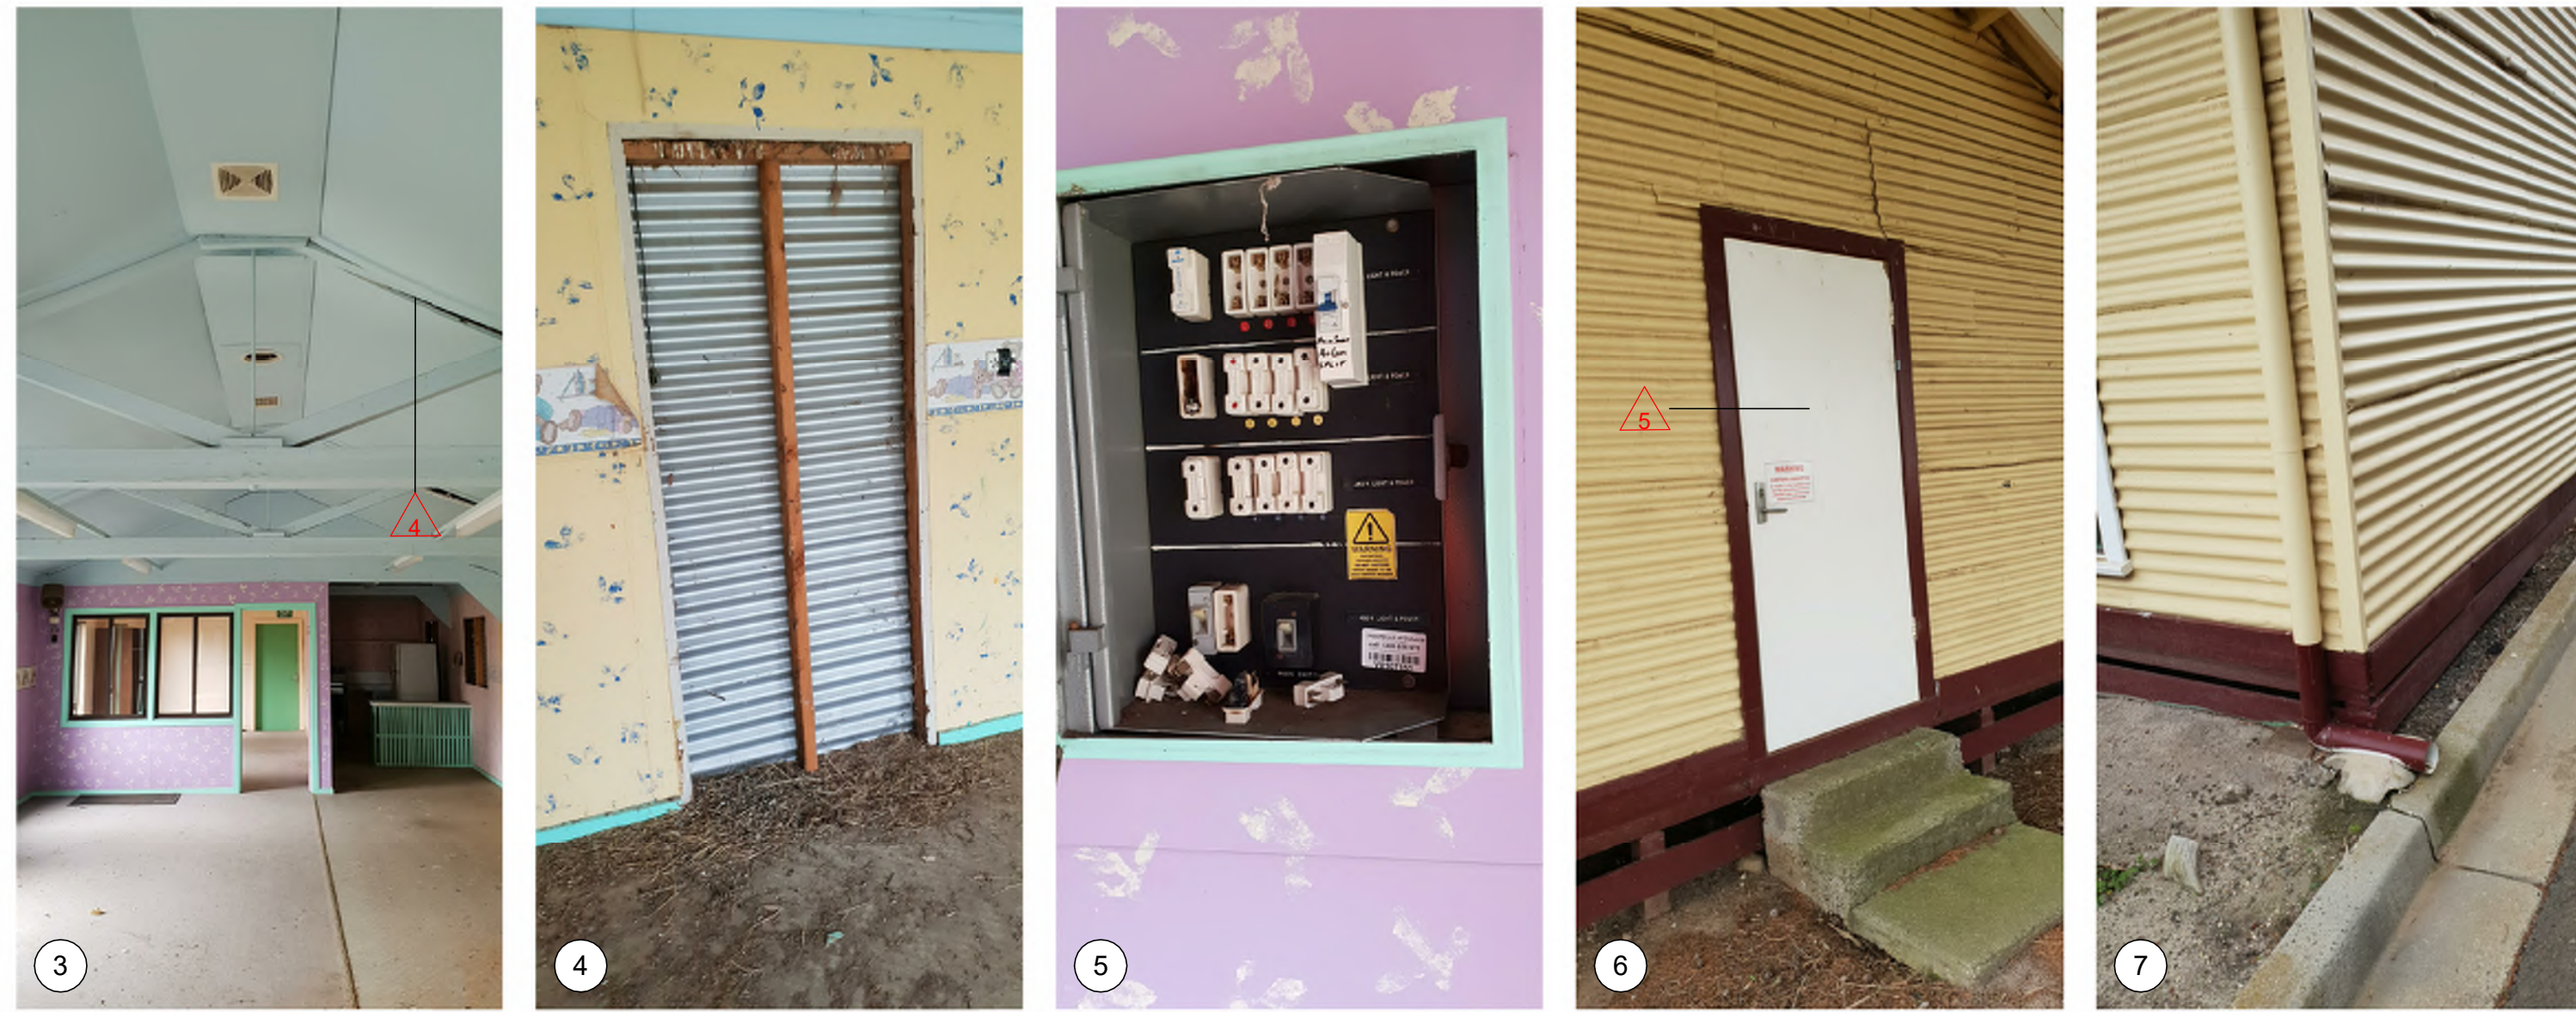
IMAGES OF TYPICAL DETERIORATION

- EXTERNAL**
- EXISTING EXTERNAL METAL SHEETING IS IN REASONABLE GOOD CONDITION AND CAN BE RETAINED. ALLOW TO CUT BACK EXISTING SHEETING AND ALLOW TO REINSTATE WINDOW OPENINGS WITH NEW ALUMINIUM WINDOWS MATCHED TO WINDOWS ON THE NORTH SIDE OF THE BUILDING. THE EXISTING SHEETING, INCLUDING FLASHINGS ARE IN GOOD CONDITION AND ONLY NEED TO BE CLEANED DOWN.

- FLOORS**
- EXISTING FLOOR STRUCTURE WILL REQUIRE SOME MINOR RE-STUMPING WHERE THE FLOOR IS NOT LEVEL, BUT OVERALL THE FLOOR STRUCTURE IS IN GOOD CONDITION. THE EXISTING FLOORING, WHICH IS A MIXTURE OF VINYL AND CARPET IS DAMAGED, AND NEEDS TO BE REPLACED WITH NEW FLOOR COVERINGS.

1. REINSTATE AND INSTALL NEW ALUMINIUM WINDOWS TO MATCH NORTH ELEVATION OF THE BUILDING.
2. CLEAN DOWN ALL EXTERNAL SURFACES OF THE BUILDING.
3. EXISTING FLOOR COVERINGS ARE TO BE REPLACED TO THE ENTIRE BUILDING, INCLUDING CARPET AND VINYL WITH NEW CARPET TILES AND NEW VINYL SHEETING.

4. REPAIR JOINTS TO CEILING SHEETING AND REFIX LOOSE CEILING PLASTERBOARD SHEETS WHERE REQUIRED. ALLOW TO PREPARE ALL SURFACES PRIOR TO REPAINTING, INCLUDING CEILINGS AND WALLS. REMOVE EXISTING WALL PAPER AND REPAINT ALL WALLS AND CEILING LININGS.

5. REPLACE EXISTING EXTERNAL HOLLOW CORE DOORS WITH NEW SOLID CORE TIMBER DOORS INCLUDING NEW DDA COMPLIANT DOOR HARDWARE AND WEATHER SEALS TO BOTTOM OF DOORS.

6. REPLACE EXISTING KITCHENETTE WITH NEW KITCHENETTE CONFIGURED TO MATCH EXISTING, INCLUDING NEW SS SINK, TAPS, CUPBOARDS, ETC.
7. DEMOLISH AND REMOVE ALL TOILETS FITTINGS INCLUDING TOILETS, BASINS, SHOWER BASES, TAPS, SHOWER ROSES, ETC. NEW TOILET FACILITIES ARE TO BE REFURBISHED AND TO COMPLY WITH CURRENT DDA REGULATIONS.

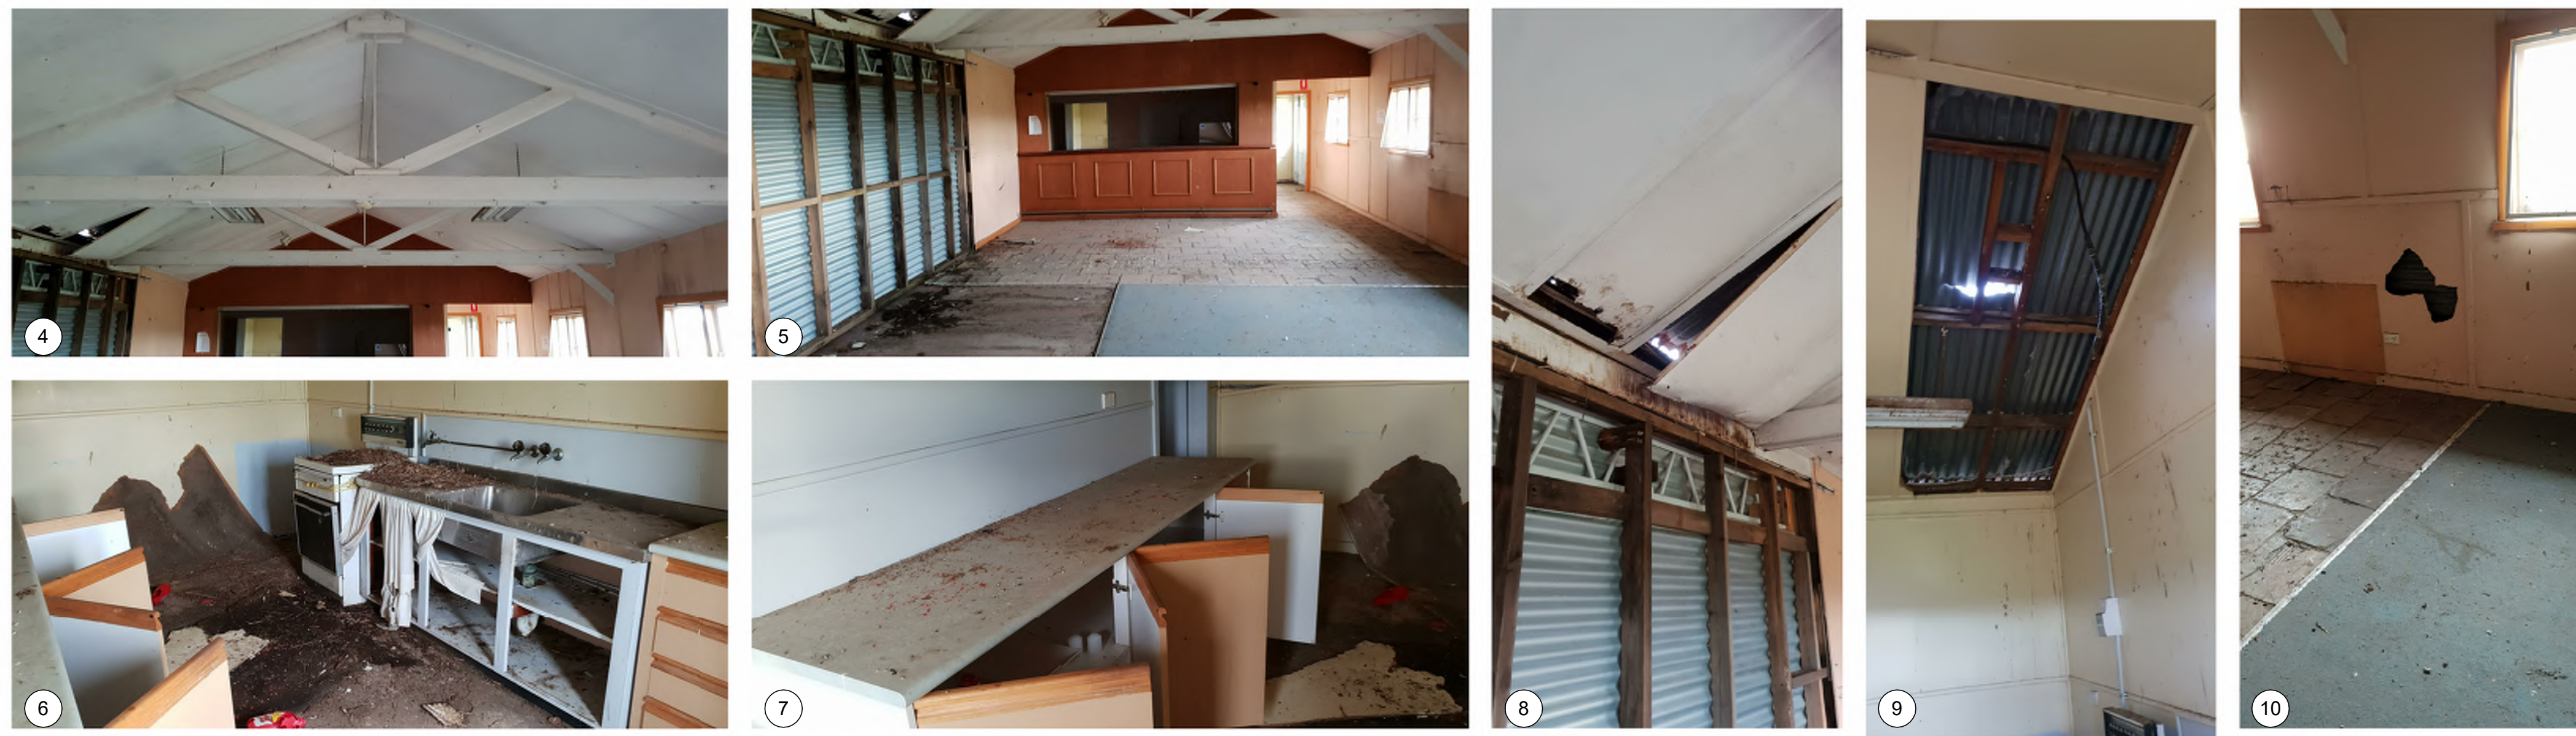
IMAGES OF TYPICAL DETERIORATION

- INSTALL NEW METAL DOWNPIPES, GUTTERS, BRACKETS, STOP ENDS, SET TO LINE AND TO FALL TO OUTLETS. NEW WORKS TO ALSO INCLUDE NEW PRIMED AND PAINTED FASCIAS AND VILLABOARD SOFFIT LININGS TO ALL EXTERNAL SURFACES.
